Cross section PR116 was installed in 1975 at the exact location of a cross-channel cableway that had been built earlier by the USGS Montana District for measuring water discharge at the gaging station, Powder River at Moorhead MT. Our intention in this 1975 installation was to be able to include previous measurements made here with those we intended to make ourselves in the coming years. Like many such USGS cableways installed on US rivers, this one's location was selected for its stability, so as to be able to develop, over the long term, a permanently stable relation between river stage and water discharge, and thereby produce a useful discharge rating curve. Section PR116 is, therefore, a "bedrock" section, which shows the least channel change with time.

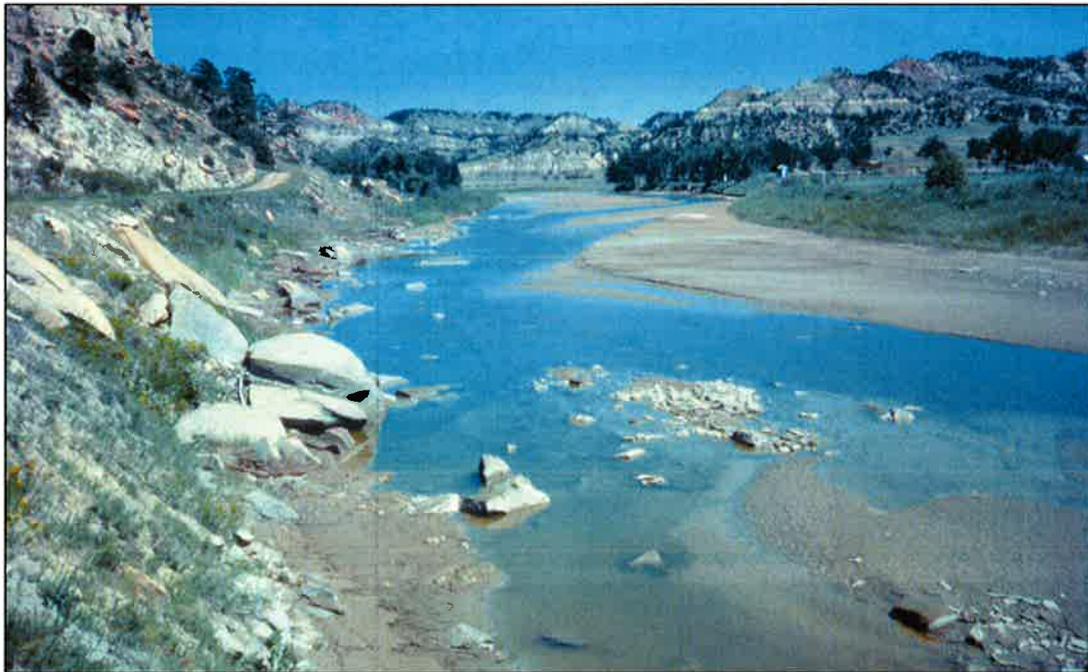
PR116. **Top.** 21 July 1977. View is downriver from PR116, showing bedrock control of this exceptionally stable reach of Powder River. **Bottom.** 16 August 1986. View is from left bank and cableway is on section. Flow is to the left.

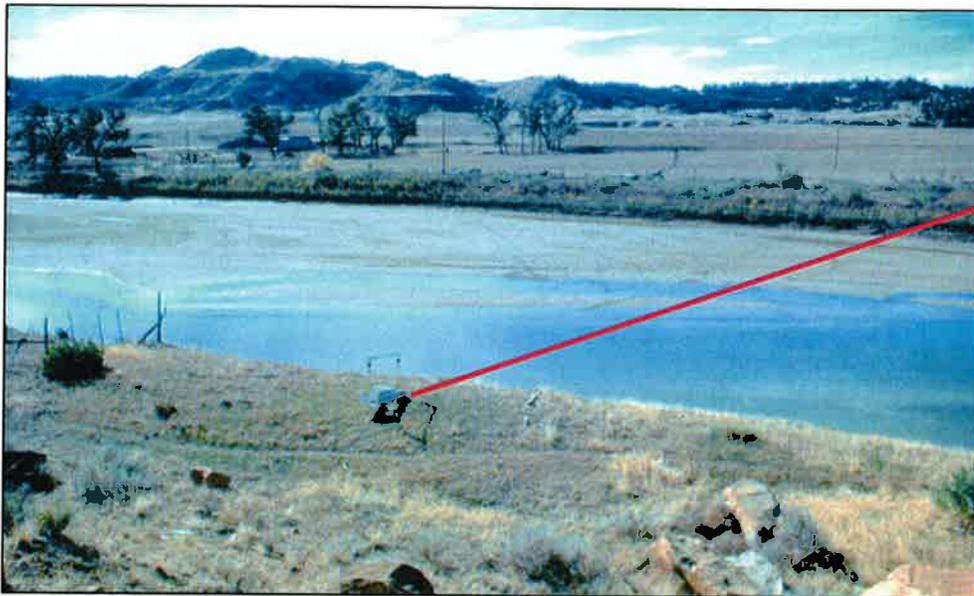
PR116. **Top.** 19 September 1988, about 10 days after removal of cableway. View is from above the left bank. Cable car is approximately on section shown by the red line. The gage site at PR116 was abandoned and moved upriver. Flow is toward the upper left. **Bottom.** 19 September 1989. View is upriver from left bank standing on PR116. The white cylindrical structure on the left bank upriver, left of the center of the photograph, is the old gage house for Powder River at Moorhead, Montana. New gage house is now at Moorhead Bridge, about 1.8 km upriver from the old gage house.

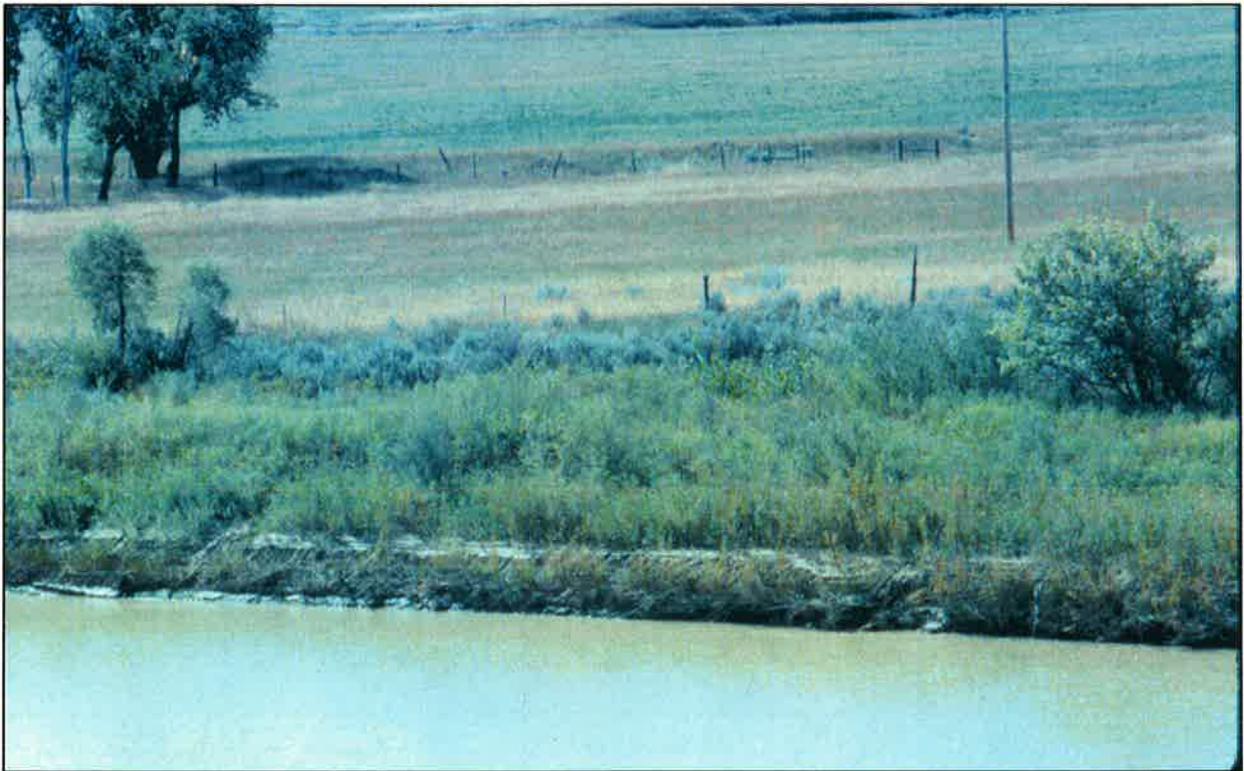
PR116. **Top.** 25 August 1993. Newly-deposited sand bench on right bank just downriver from PR116. Flow is from right to left.
