Cross section PR141 was established in 1975 in the upriver limb of a large meander bend in Powder River at the mouth of tributary Bloom Creek. Leveling surveys of section PR141 were repeated in 1977, 1978, 1979, 1980, 1984, 1998, and 2014.

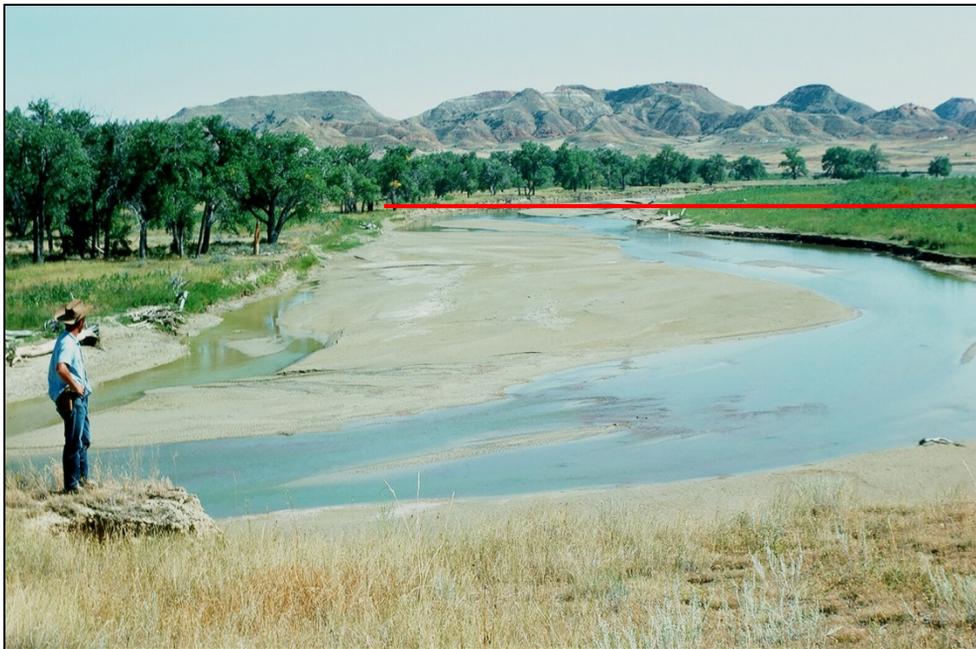
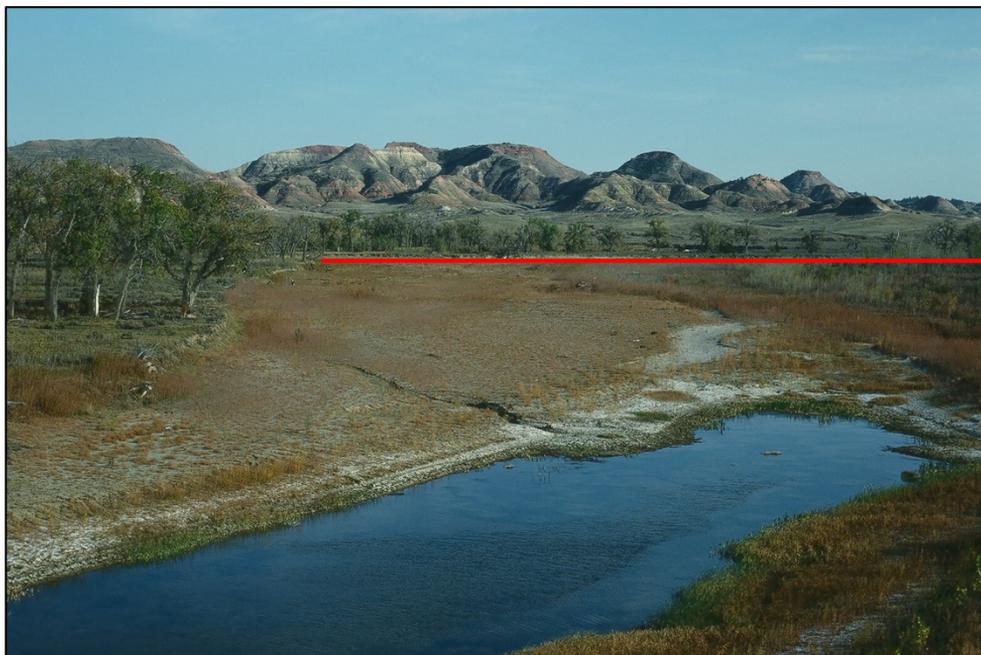
PR141. **Top.** 8 September 1975. View is upriver toward the southeast from top of bluff near old saw mill site at the end of the Bloom Creek Road. **Bottom.** 12 October 1980. View is upriver as in the top photo. This channel was cutoff by the flood of 1978. New channel is this side of the line of trees above the red line indicating the approximate location of PR141.

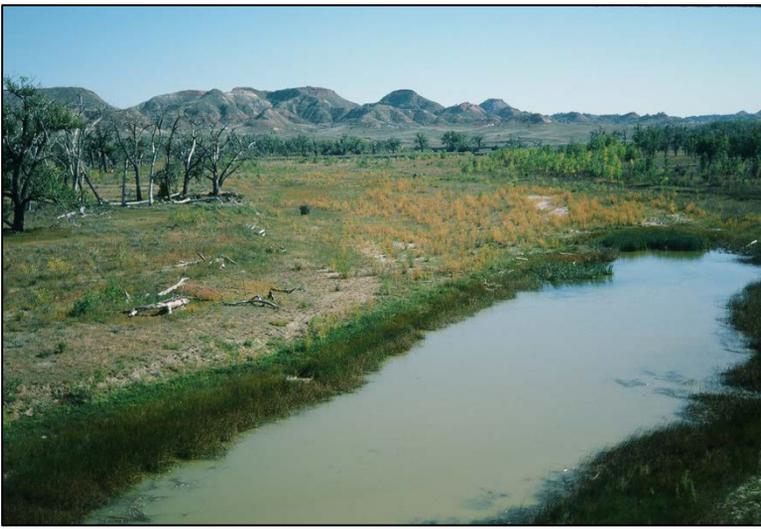
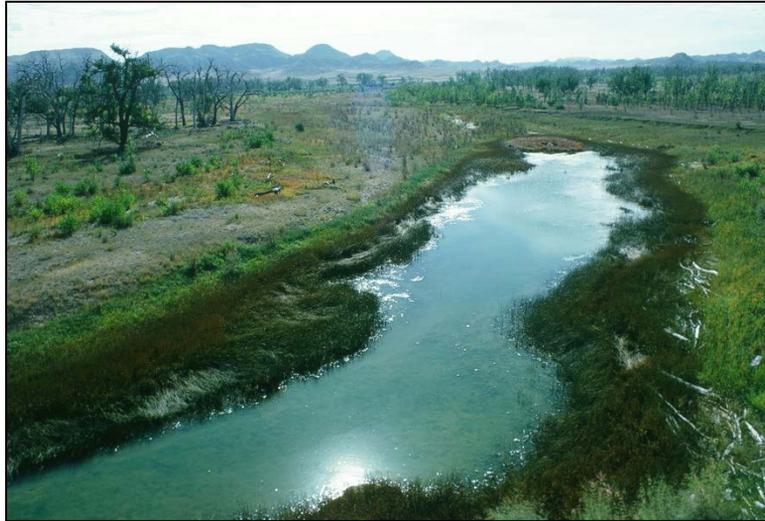
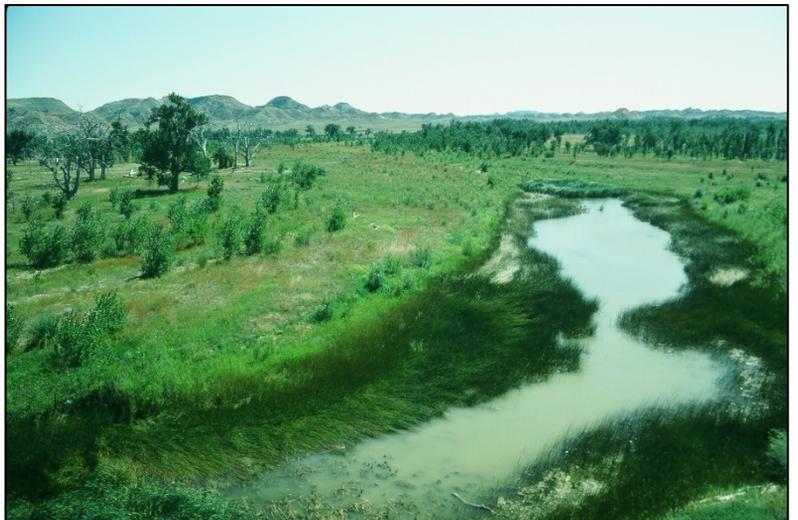
PR141. **Top.** 24 September 1987. View is upriver toward the southeast from top of bluff near old saw mill site at the end of the Bloom Creek Road. **Middle.** 18 September 1989. **Bottom.** 28 August 1993.

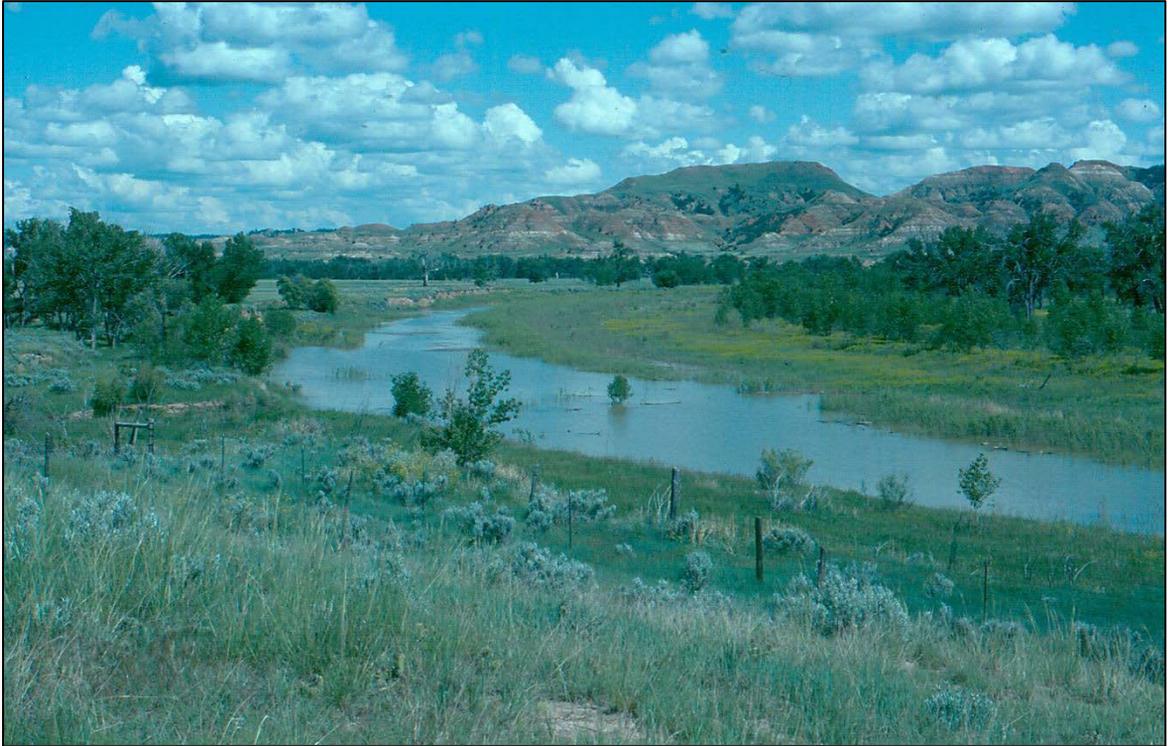
PR141. **Top.** 9 June 1993. View of water that has filled the oxbow during high flow in 1993. The oxbow was formed when the flood of 1978 cut off this part of the channel. Section PR141 is near the entrance to the cutoff and is to the right (off the photo). This view would have been downriver in 1977 and early 1978, and is near the crest of the old bend.

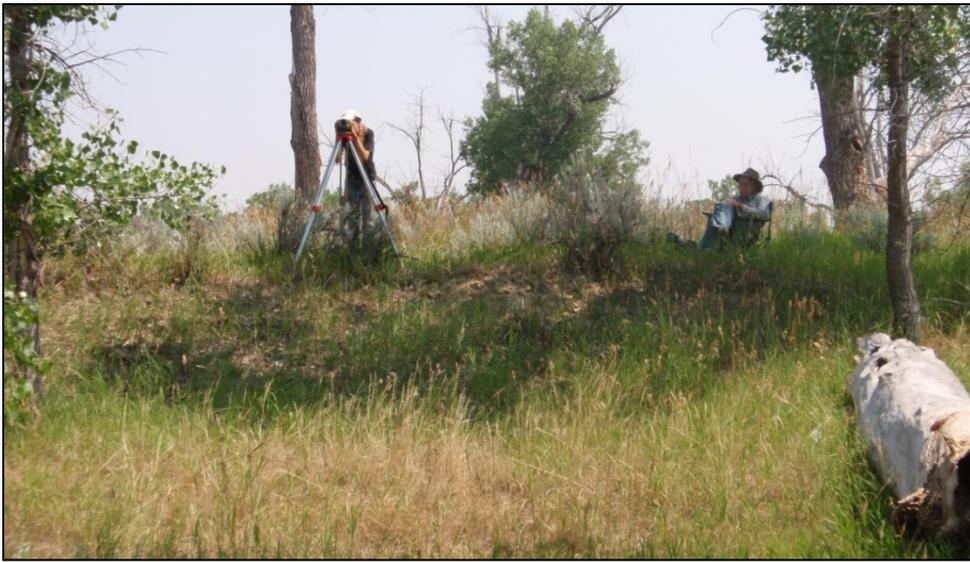
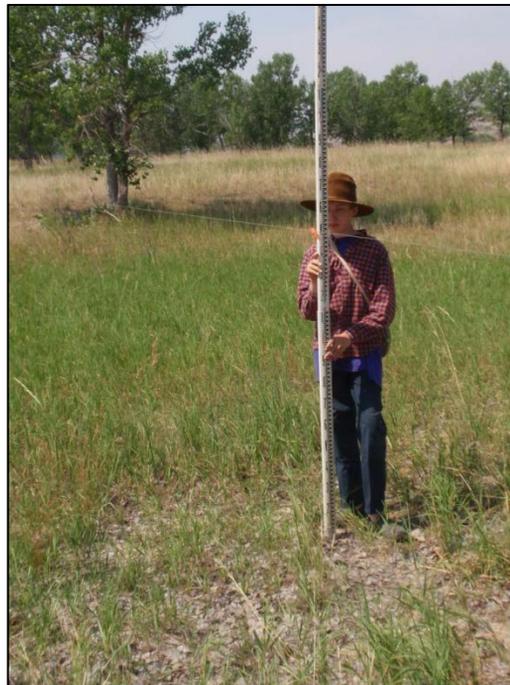
PR141. **Top.** 20 July 2014. R. Held (~1.8 m tall) is standing behind the tripod, which is about 4 m to the right of the line of section and on top of the right bank. Log at right edge of photo is in the abandoned channel, lying on top of the meter-thick layer of sand that was deposited by the flood of 1978 before it was abandoned. **Bottom.** 20 July 2014. J. Held (~1.7 m tall) is standing with the rod at station +50.0. Cottonwood tree behind and to his right is at the edge of the left bank. Grass is well developed on top of the meter-thick 26-year-old sand layer deposited in the channel by the flood of 1978
