Section PR113 was first monumented and surveyed in 1975. It was resurveyed annually during the 4 consecutive years 1977-1980, resurveyed in 1982, resurveyed annually during the 19 consecutive years 1984-2002, and, after a 9-year hiatus, resurveyed in 2012.

Cross section PR113 is located 1.5 km downvalley and 2.5 km downchannel from the narrows at the proposed Moorhead damsite. At the cross-section location, the valley is sufficiently wide to allow the river channel to make a nearly orthogonal 1.5-km-long cross-valley excursion from the valley's left-side bedrock wall to the right-side bedrock wall. Section PR113 was placed near the midpoint of this 1.5-km-long segment, about 0.4 km upchannel of the Moorhead bridge. The right bank of Powder River at this section is formed by the lower floodplain surface developed after the 1978 flood (Moody et al., 1999) and the left bank is the Lightning terrace (Moody and Meade, 2008).

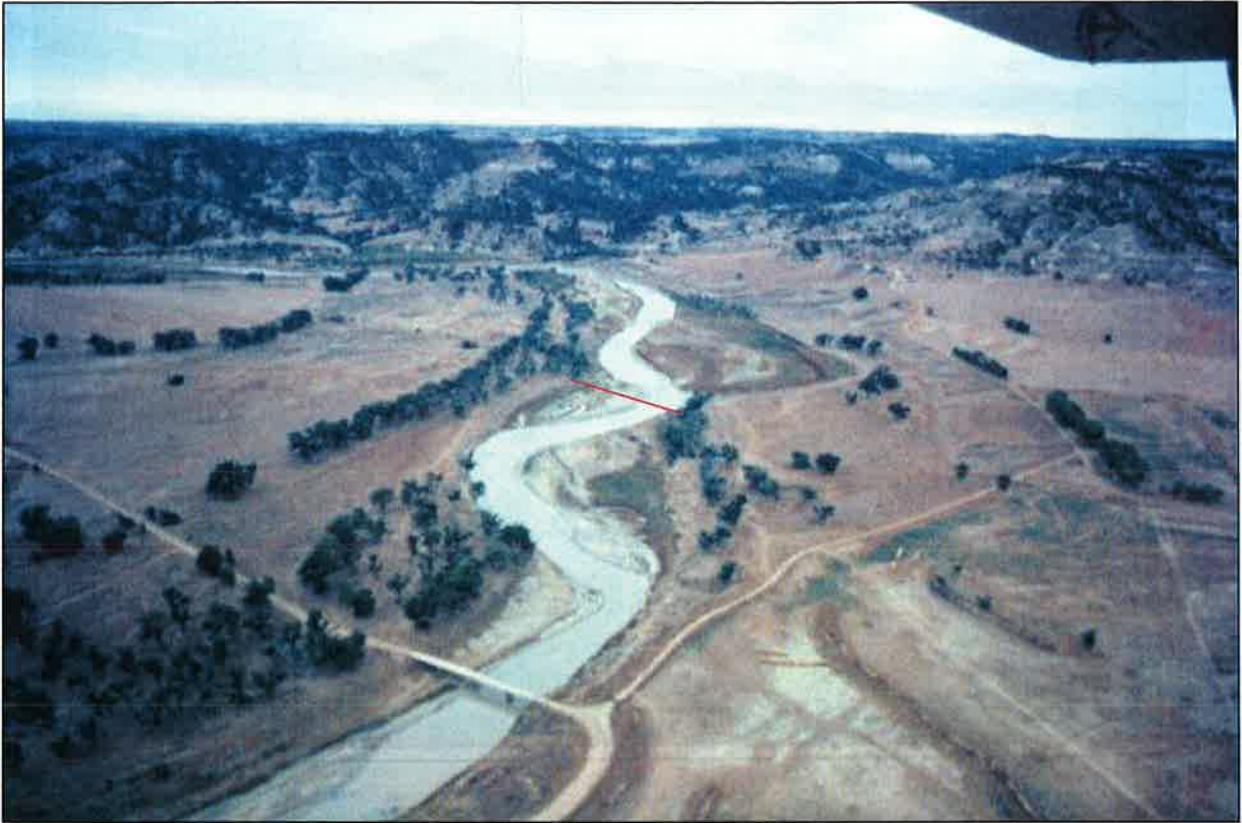
PR113. **Top.** 22 September 1989. Aerial view upriver of Powder River at the Moorhead Bridge. The approximate location of cross-section PR113 is shown by red line.

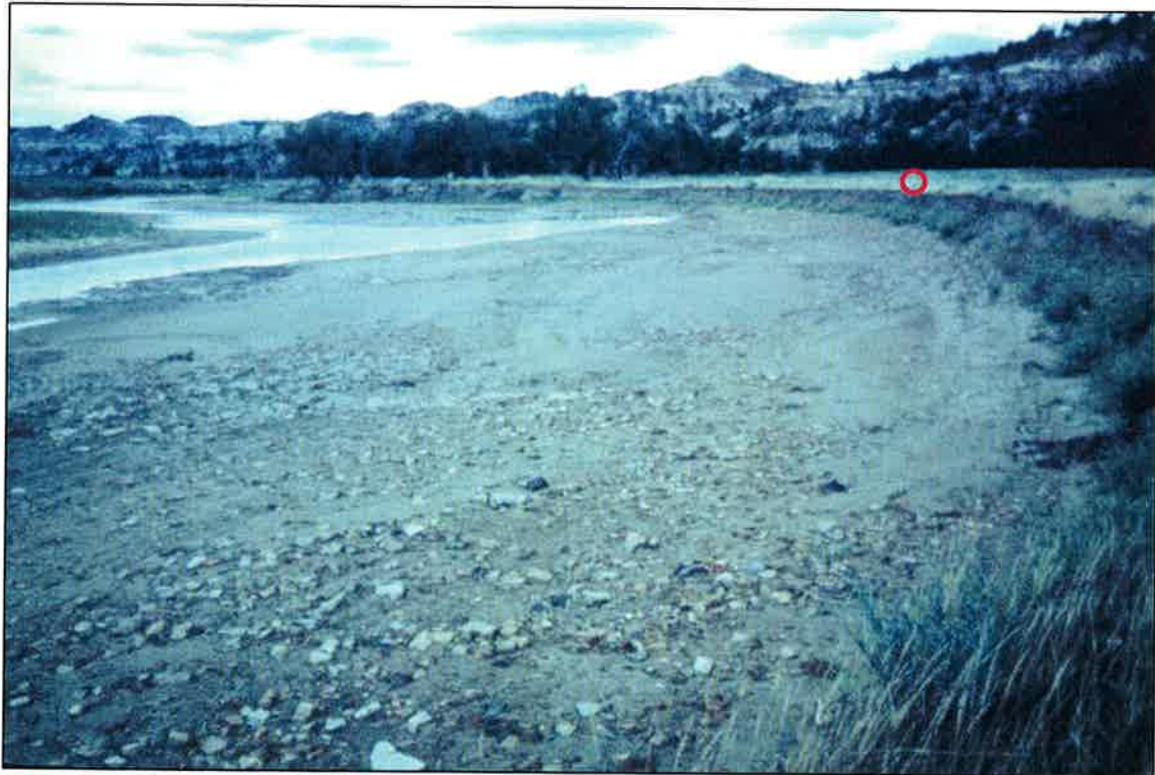
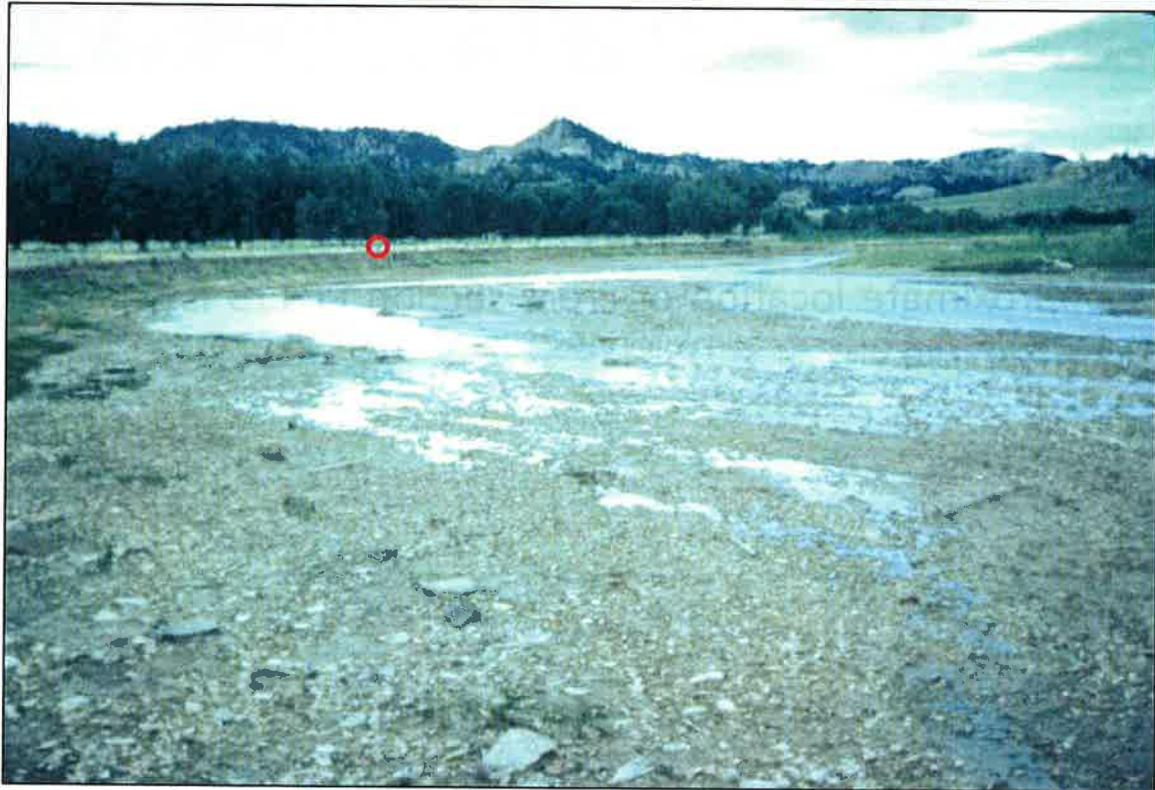
PR113. 20 July 1977. **Top.** View downriver. Person (~1.6 m tall) in red circle is on the section. **Bottom.** View upriver. Person in red circle is on the section.

In section PR113, the flood of 1978 caused substantial changes, which we were able to record by comparing our survey data for 1977 and 1978. The principal change was a complete shift in the lateral arrangement of the section from cutbank-on-the-right-side-and-point-bar-on-the-left to its opposite, cutbank-on-the-left-side-and-pointbar-on-the-right. The thalweg of the river channel here shifted, during two weeks of flood flows in May 1978, about 44 meters leftward. Our surveys indicated that the flood waters had removed most of the pre-flood pointbar from the left bank, and had deposited a large new pointbar, 0.5-1.5 m in thickness, across a lateral distance of about 40 m on the right bank. Data showing the effects of the 1978 flood on section PR113 have been portrayed and discussed by Meade and Moody (2013, see especially their Figures 14 and 17).

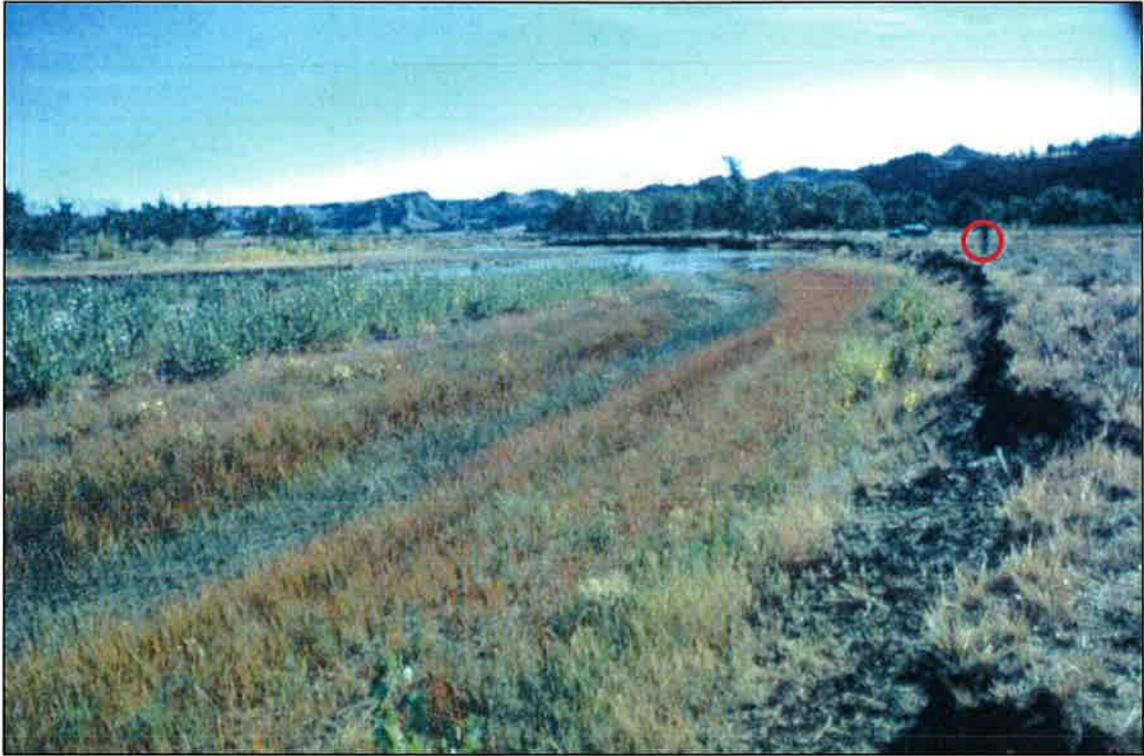
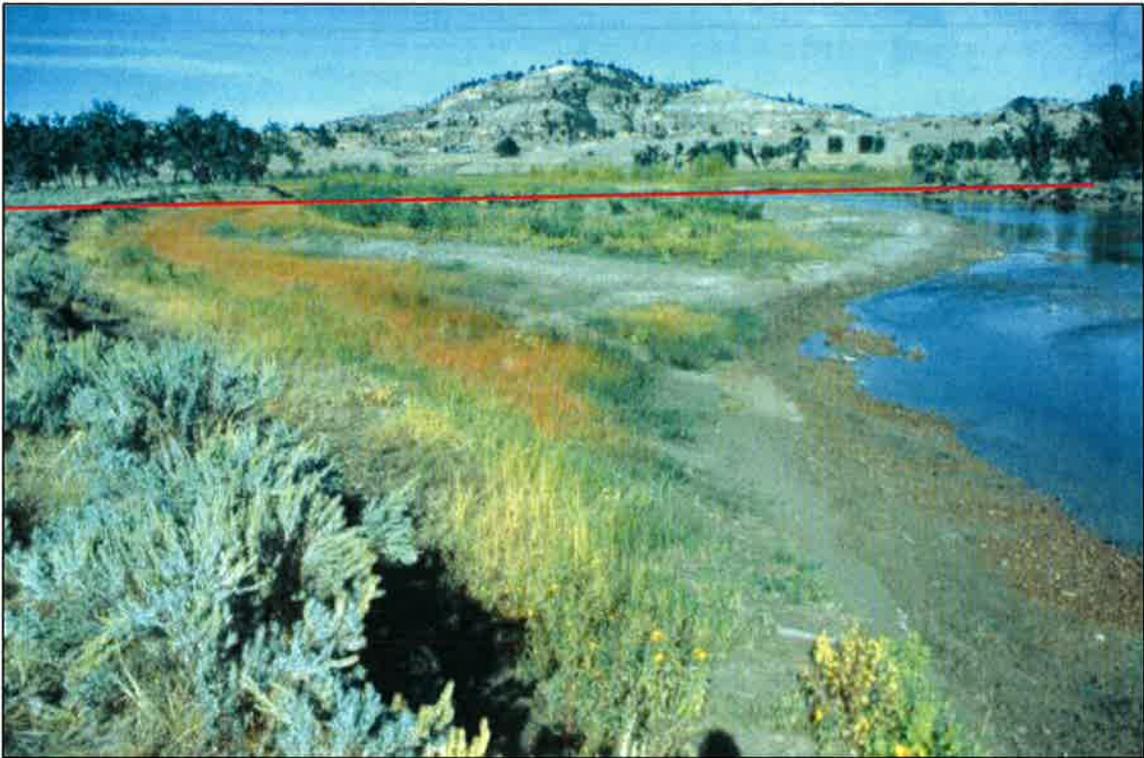
PR113. 19 September 1978. **Top.** View downriver. Person (~1.9 m tall) in red circle is on the section. **Bottom.** View upriver. Red line indicates the approximate line of section.

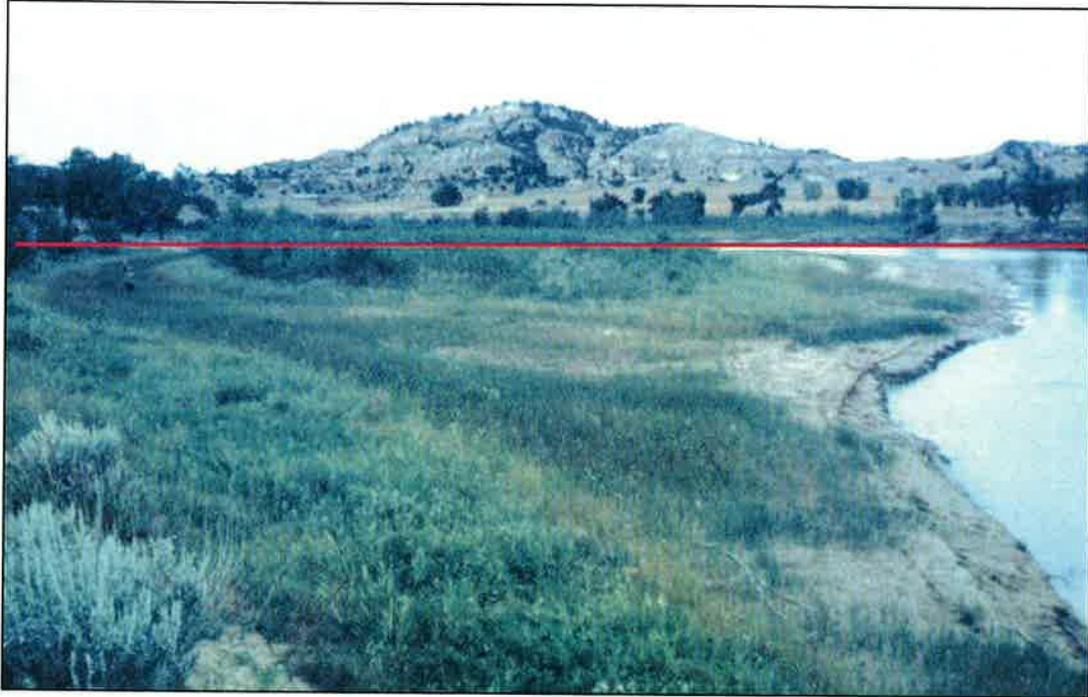
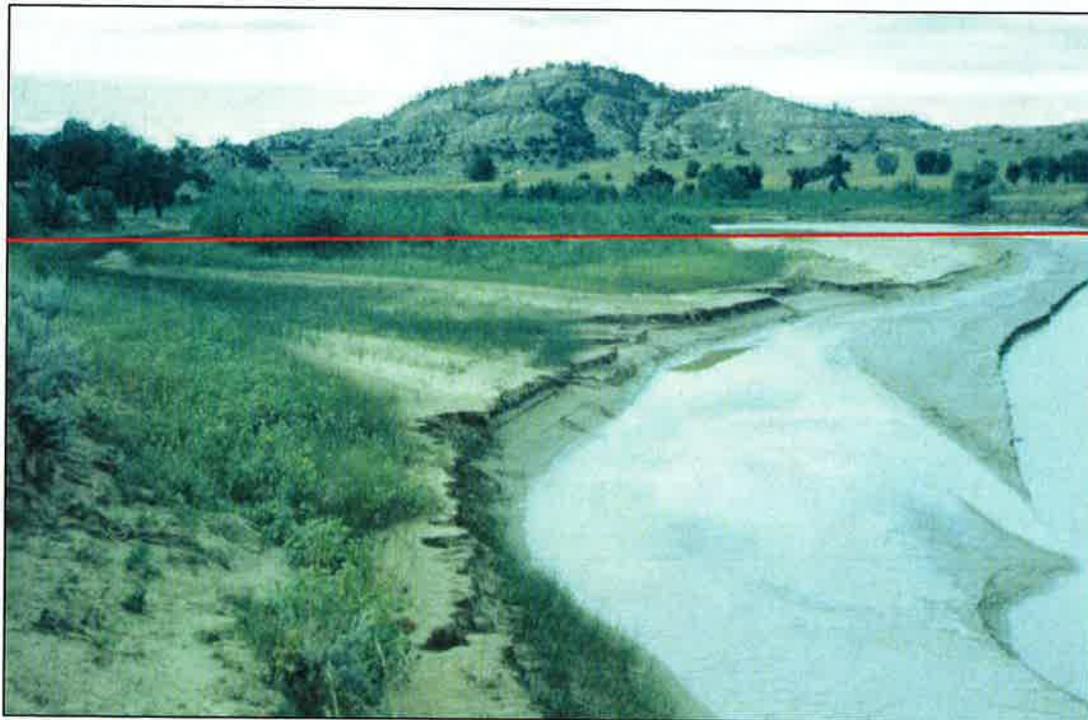
PR113. **Top.** 25 August 1992. View upriver. **Bottom.** 25 August 1993. View upriver. Red line indicates approximate line of section.

The leftward shift continued during the decades following the 1978 flood. The channel thalweg shifted leftward another 56 m in the 17 years between 1978 and 1995. The left-side cutbank was eroded back 54 m during the same period; more than half of this bank recession (a total of 32 m) took place during only four of the 17 years (1987, 1991, 1993, 1995). By 1995, the right-bank pointbar had grown leftward about 40 m and upward by an average of about one meter, with most of the growth happening during the three years, 1987, 1993, and 1995.

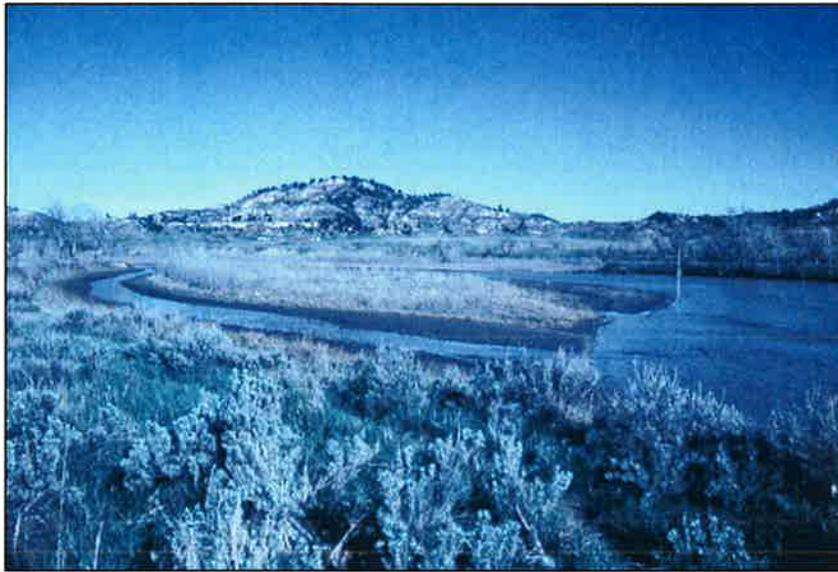
PR113. 10 May 1993.  
View upriver. White  
vertical survey rod is  
on section. Discharge  
is  $82 \text{ m}^3 \text{ s}^{-1}$

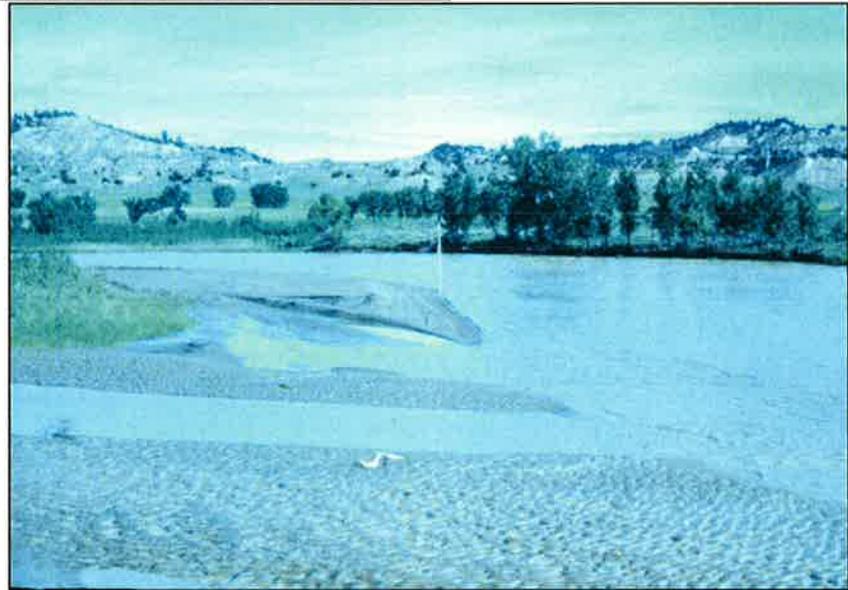
PR113. 10 June 1993.  
View upriver. White  
vertical survey rod is  
on section. Discharge  
is  $93 \text{ m}^3 \text{ s}^{-1}$

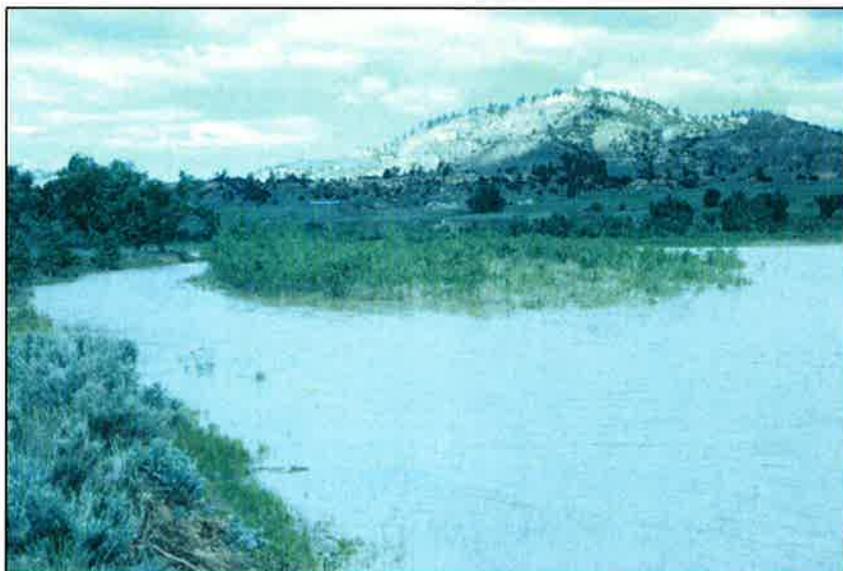
PR113. 19 June 1993.  
View upriver. Discharge  
is  $176 \text{ m}^3 \text{ s}^{-1}$ .
