Cross section PR120 was first monumented and surveyed in 1975. It was resurveyed annually during the 4 consecutive years 1977-1980, resurveyed in 1982, resurveyed annually during the 18 consecutive years 1984-2001, and, after a 10-year hiatus, resurveyed in 2012, 2013, and 2014. Additional surveys were made during 1993, 1994, and 1998, and a complete cross valley cross section (1600 m long) was surveyed in 2006 and is included in the data file for PR120.

Section PR120 crosses a gently curving reach of Powder River, about 0.3 km down river of the mouth of Thompson Creek. The left bank of Powder River is developed on a Moorcroft-level terrace that covers most of the area locally known as “Reynolds Battlefield” (Moody and Meade, 2008; Vaughn, 1961). The right bank of the low-water channel is formed by a flood plain developed after the 1978 flood (Moody et al., 1999), which grades laterally onto the Lightning Terrace.

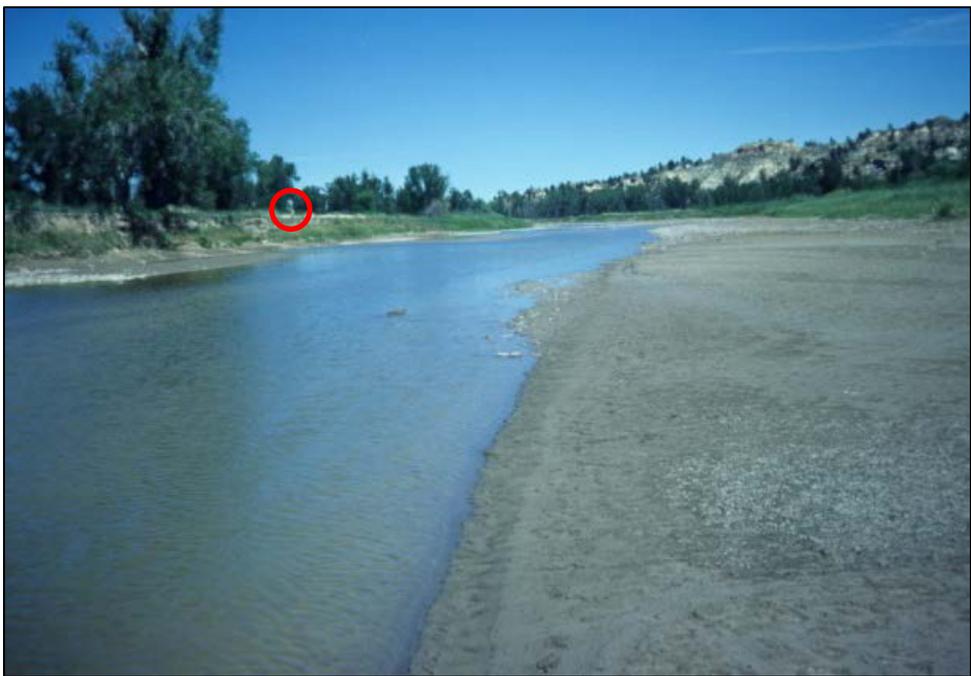
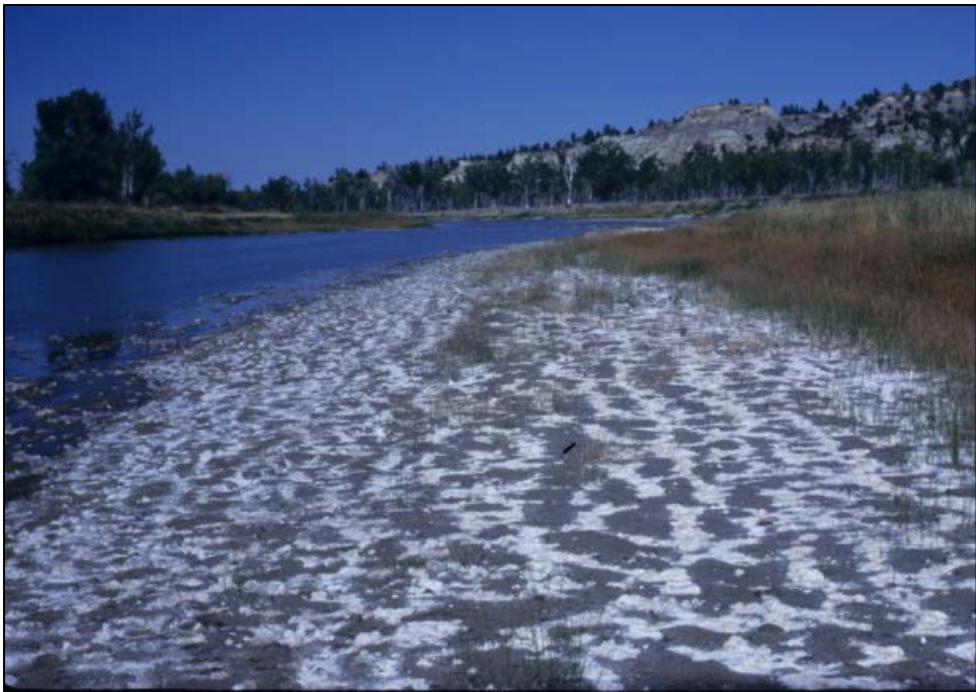
PR120. **Top.** 21 July 1977. View downriver. Person (1.6 m tall) in red circle is standing on the section. **Bottom.** 16 September 1989. View is downriver from station 53.

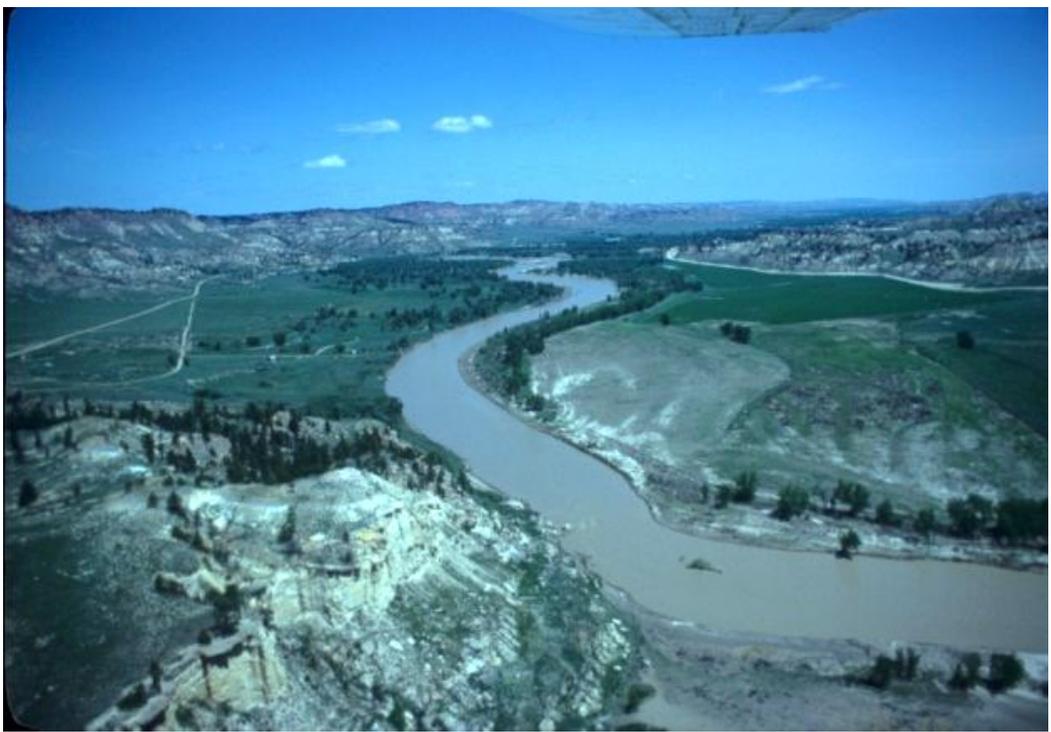
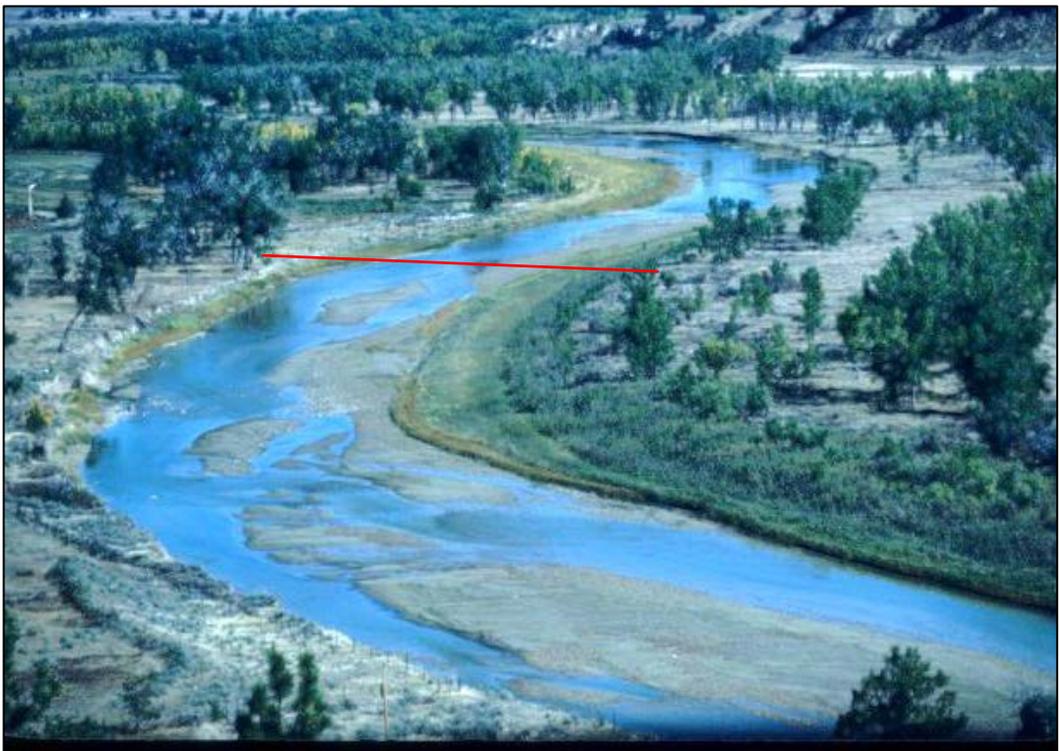
PR120. **Top.** 25 May 1978. Aerial view downriver during the waning stage of the flood. New sediment (mud and sand) is deposited on right bank starting just upriver of the section. **Bottom.** 19 September 1988. Zoom lens view downriver from bluff shown in the bottom left of the top photo. Red line indicates the approximate line of section.

In section PR120, the principal effect of the flood of May 1978 was an increase in the area of the channel cross section. The enlargement was accomplished mainly by 11 meters of lateral erosion of the 3½-meter-high left bank on the Moorcroft-level terrace. This channel enlargement was not compensated during the flood by the deposition of new sediment on the right-bank flood plain, although the flood did leave some new sediment (averaging half a meter’s thickness between stations 80 and 100) on the right-side Lightning terrace.

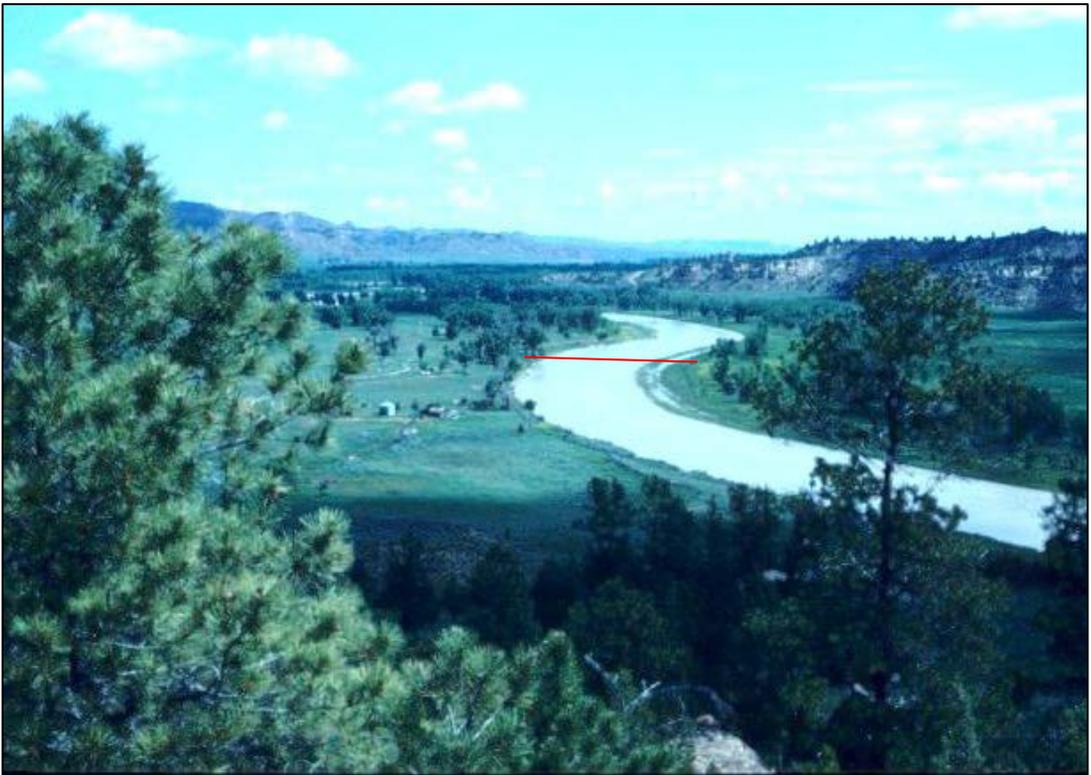
PR120. **Top.** 13 May 1993. View downriver. Discharge $34 \text{ m}^3 \text{ s}^{-1}$.
Bottom. 9 June 1993. View downriver. Discharge $170 \text{ m}^3 \text{ s}^{-1}$.
Note water in trough between new inset floodplain and old bank along right bank above and below section. Red lines indicate the approximate line of section.

New flood plain was constructed in section PR120 during the two decades following the 1978 flood -- mostly during the years 1982, 1987, 1993, and 1995 (Moody and others, 1999). By 1995, new sediment had accumulated to thicknesses mostly between 1.0 and 1.5 m from station 56 to about station 80. A 23-meter-long trench dug through these deposits in 1998 revealed their stratigraphic relations and their correspondence (or lack of it) with the annual survey data (Pizzuto and others, 2008).

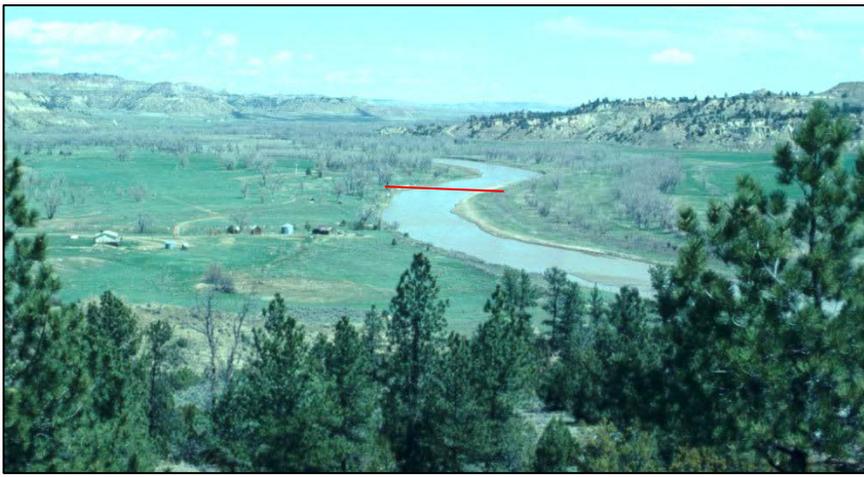
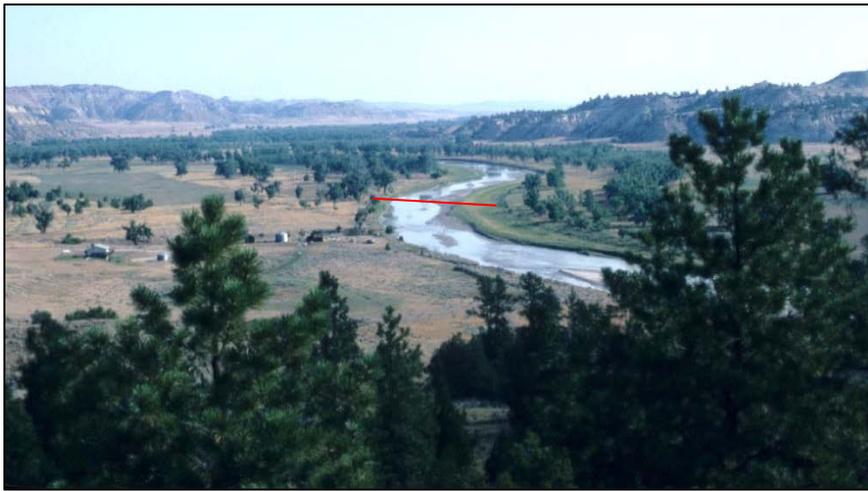
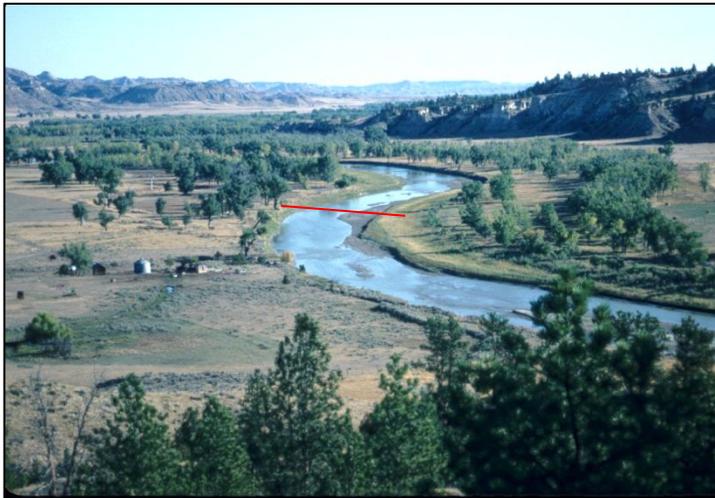
PR120. **Top.** 9 May 1994. View downriver, discharge $17 \text{ m}^3 \text{ s}^{-1}$.
Middle. 23 August 1994. View downriver, discharge $0.23 \text{ m}^3 \text{ s}^{-1}$.
Bottom. 24 September 1994. View downriver, discharge $\sim 1.5 \text{ m}^3 \text{ s}^{-1}$.
Red lines indicate the approximate line of section.

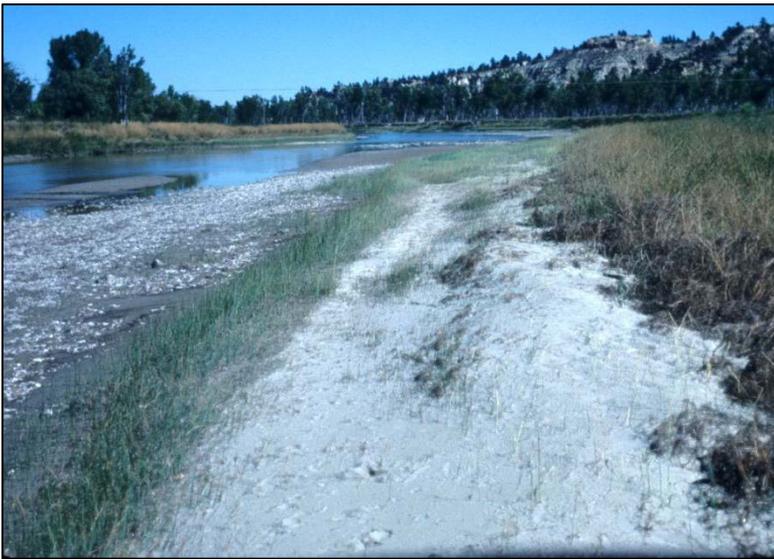
PR120. 14 September 1990. View downriver through station 60.

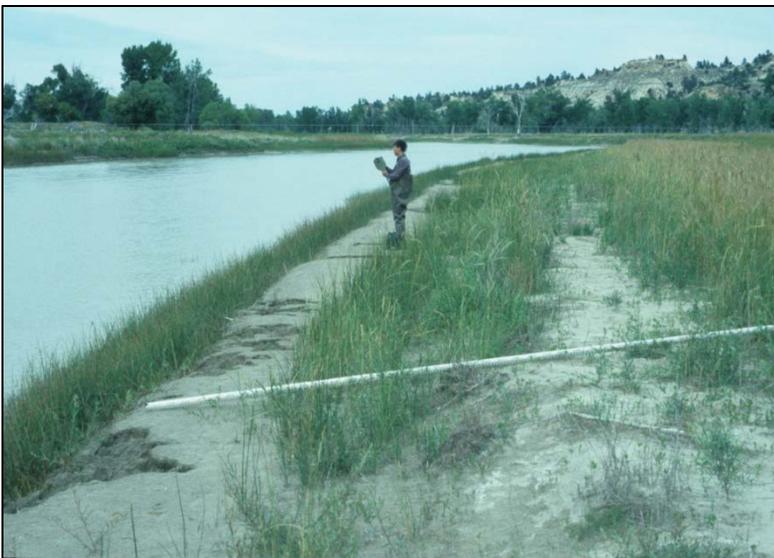
PR120. 25 August 1993. View is downriver and white survey rod is on the section.

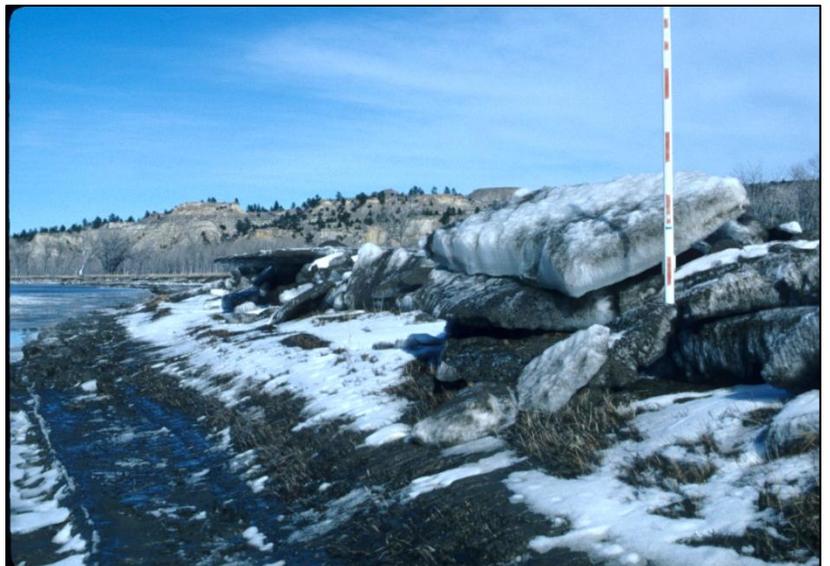
PR120. 10 March 1995. View downriver and white survey rod is on the section.

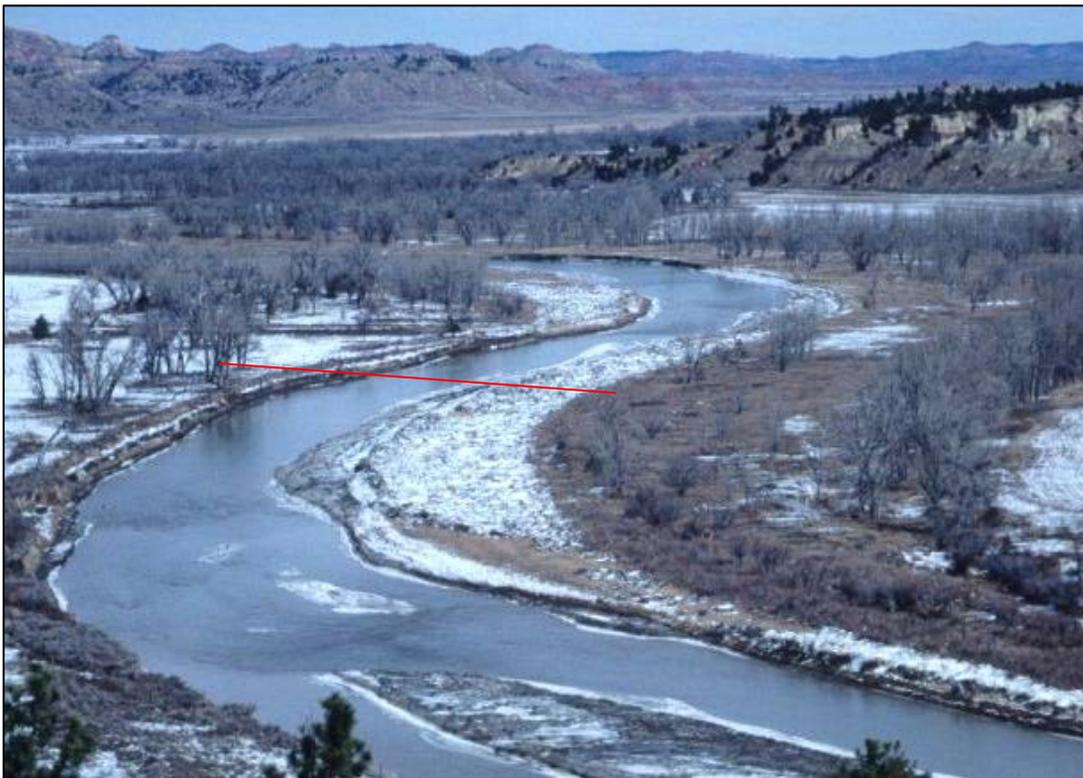
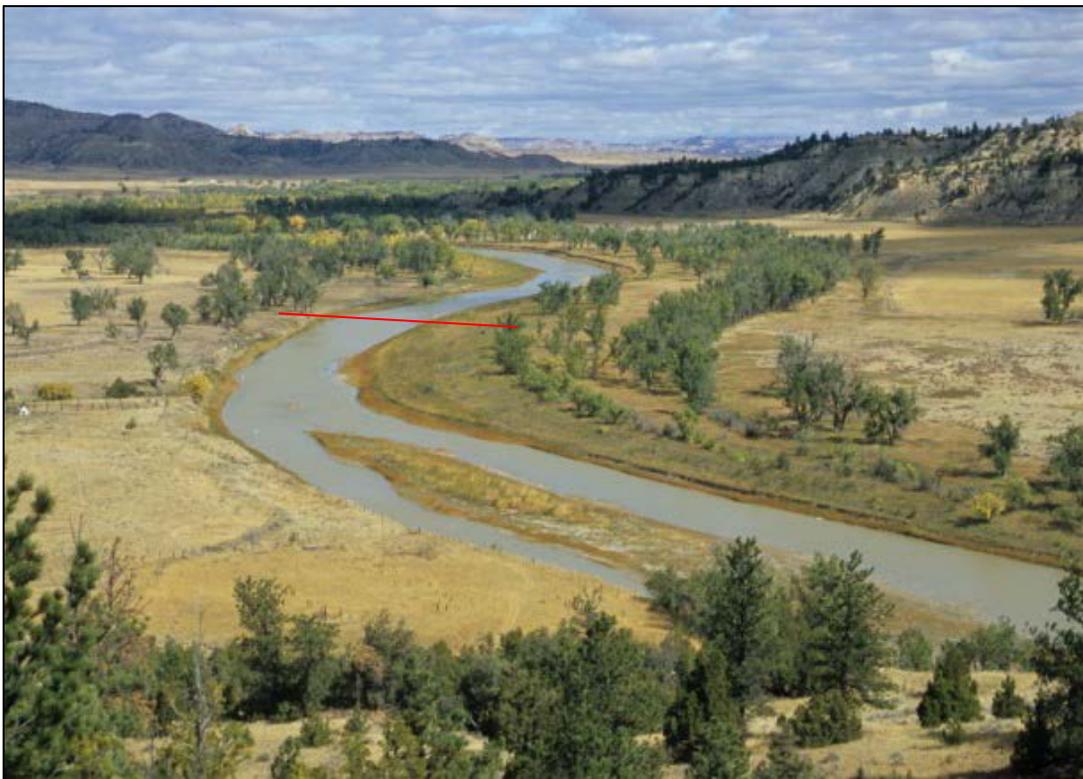
PR120. **Top.** 10 March 1995. View downriver, discharge $3.1 \text{ m}^3 \text{ s}^{-1}$
Bottom. 27 September 2006. View downriver. Red lines indicate the approximate line of section.

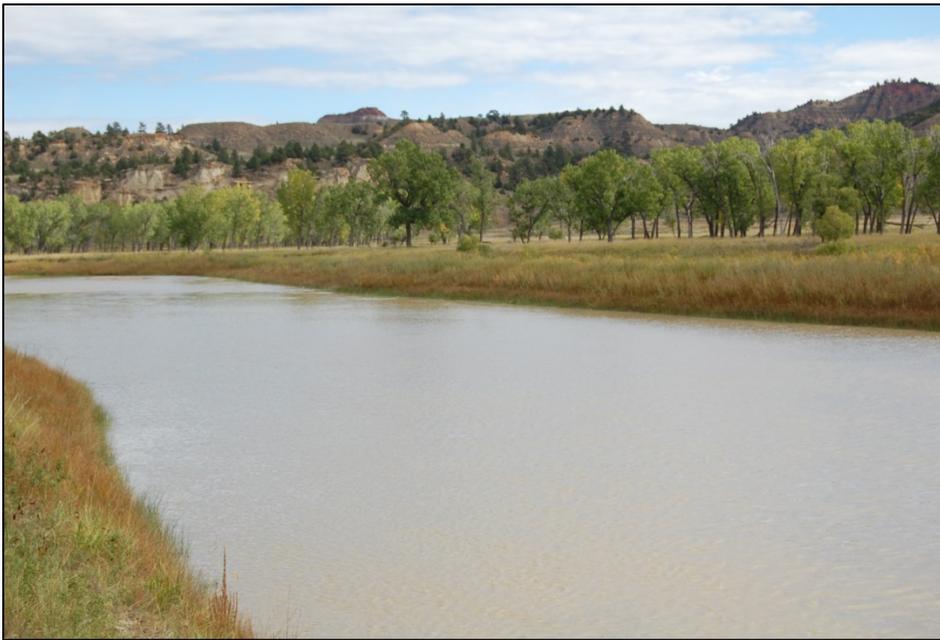
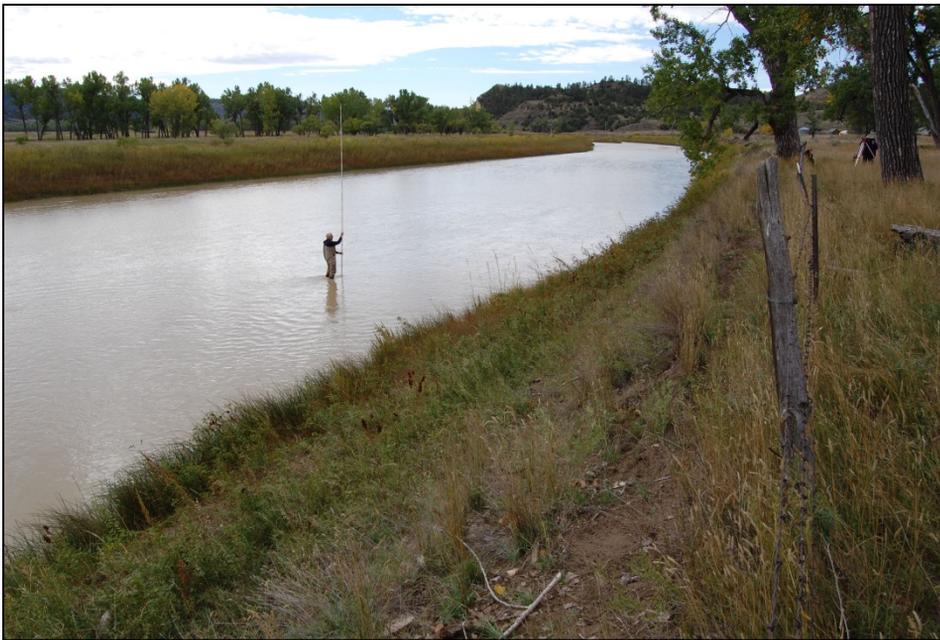
PR120. **Top.** 28 September 2013. View downriver below section. **Bottom.** 28 September 2013. View upriver. Tripod and D. Martin are 15 m upriver of station -7. Fence along left bank crosses the section at station -4.7. Rodman (J. Moody) is standing at station +10, which was the approximate location of the top of the left bank in 1977 before the Flood of 1978, which eroded the left bank back 11 m. (See Meade and Moody, 2013, Fig. 6).

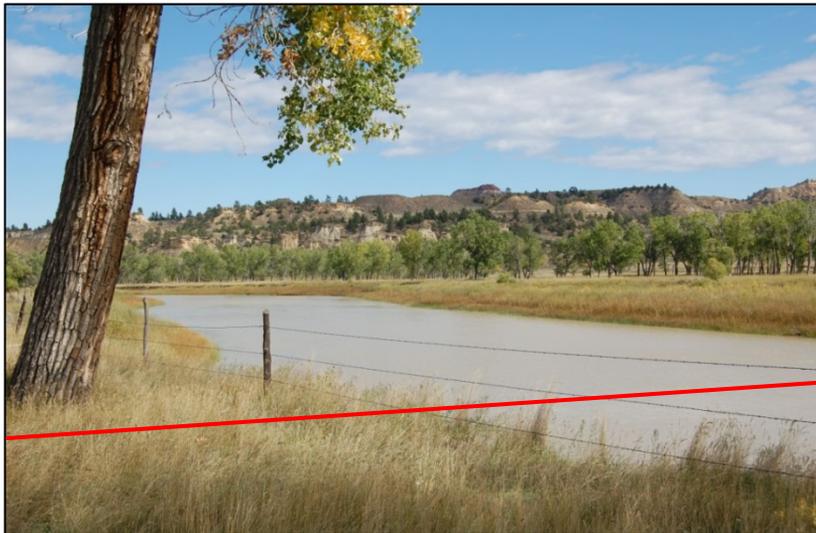
PR120. **Top.** 28 September 2013. Cross-river view of left bank (tripod and D. Martin are 15 m upriver of station -7). River flows from left to right in photo. Elevation of the top of the left bank at the tripod is about 1014.5 m, and two cores of bank sediment were collected for OSL (optical stimulated luminescence) dating below the tripod. One core at 1014.12 m above sea level was taken in sediment presumed to have been deposited during the Flood of 1923, and one core at 1012.68 m is presumed to represent sediment from the Lightning Terrace.

Bottom. 28 September 2013. View downriver. Red line indicates the line of section.

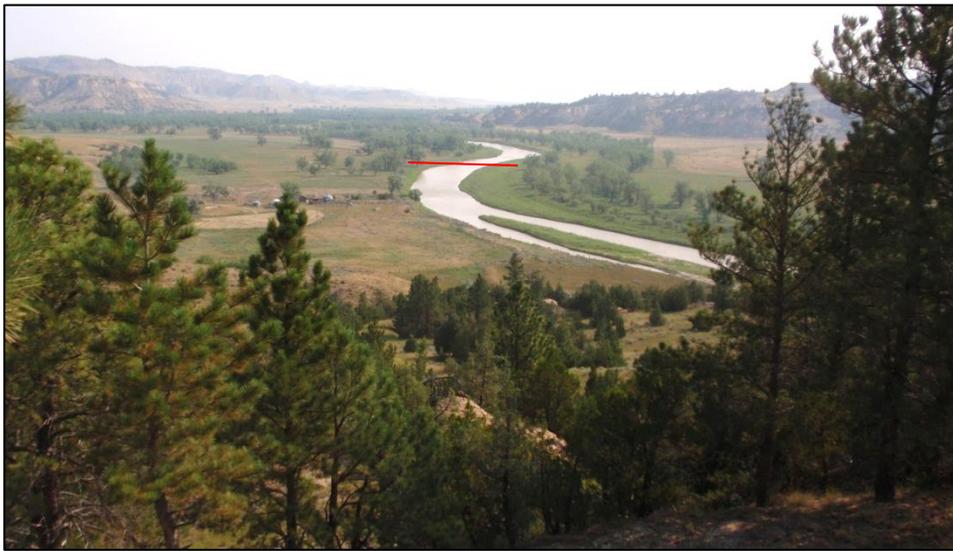
PR120. **Top.** 18 July 2014. View downriver. Discharge is $15 \text{ m}^3 \text{ s}^{-1}$. Red line indicates the line of section. **Bottom.** Cross-river view of left bank (taken in 2013—see previous page). River flows from left to right in photo. Elevation of the top of the left bank at the tripod is about 1014.5 m, and two additional cores of bank sediment were collected for OSL (optical stimulated luminescence) dating below the tripod. One core at 1013.57 m above sea level and one core at 1013.22 m.

During the last decade (judging from the most recent surveys conducted in 2001, 2012, 2013, and 2014), the flood plain has expanded leftward by another 6 meters, further decreasing the width of the low-water channel at section PR120. The low-water channel width here is now less, by some 10-15 meters, than it was in 1977, the year before the large flood.
