Cross section PR122 was established in 1975 in the crest of a large meander bend in Powder River at the mouth of tributary Flood Creek. The bend had been migrating steadily downvalley, having shifted at least half a kilometer in 80 years (Martinson and Meade, 1983, Sheet 1; Gay *et al.*, 1998, *their* Figure 8). The 6-7-m-high left bank of the section cuts into a large deltaic fan that has formed at the mouth of Flood Creek.

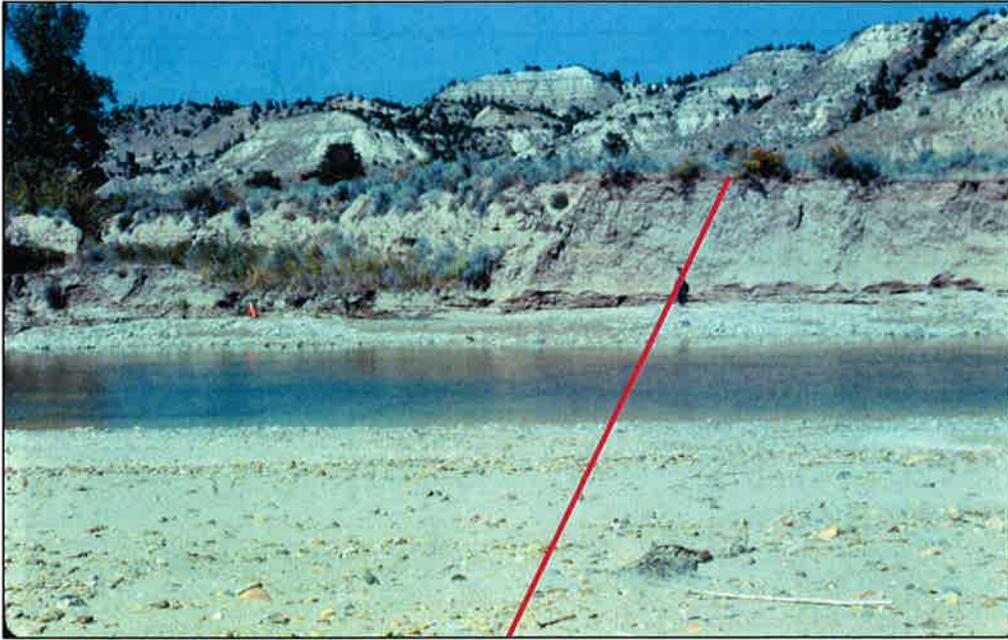
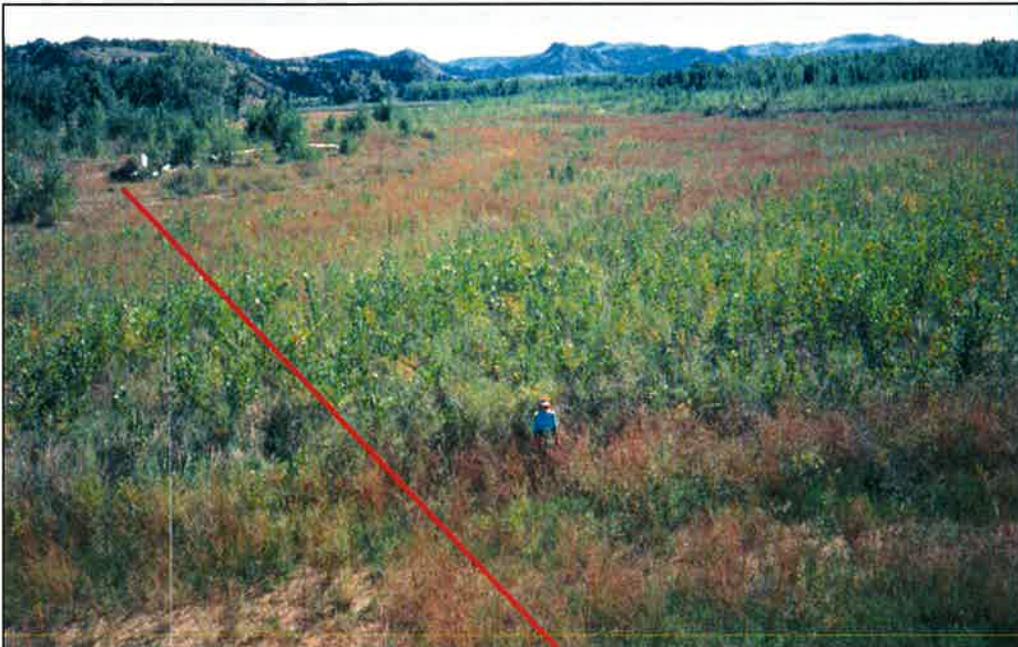
PR122. **Top.** 5 September 1975. Cross-channel view from right bank toward left bank along the line of section. N. Andrews is standing on section and is about 1.7m tall. **Bottom.** 17 September 1982. View from top of left bank of new vegetation in cutoff. S. Stewart (about 1.5 m tall) is 6 m upriver from station 30. Red line shows approximate line of section

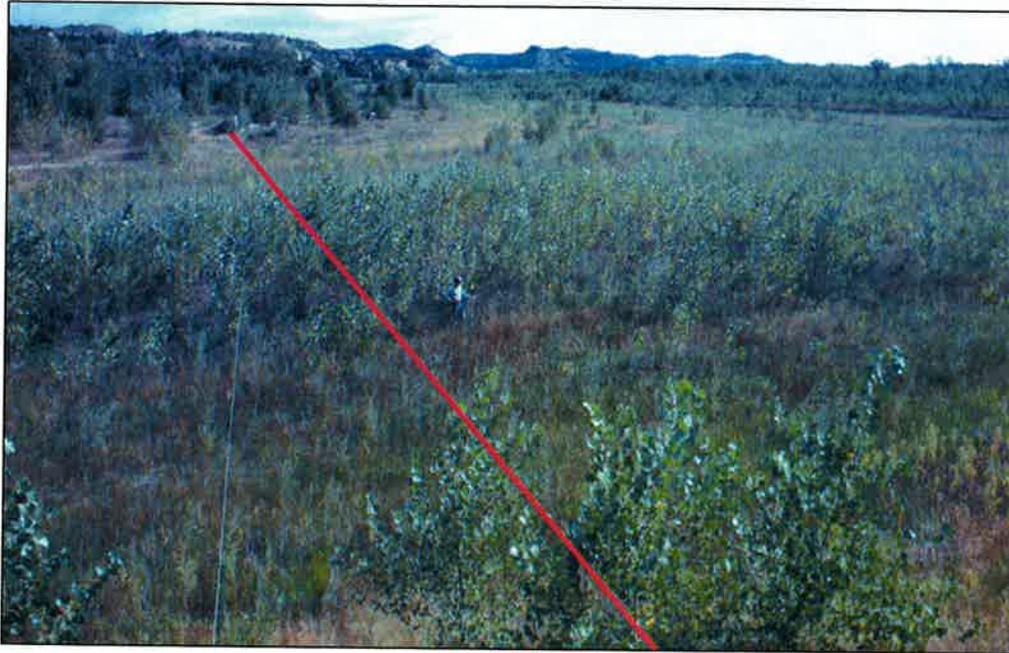
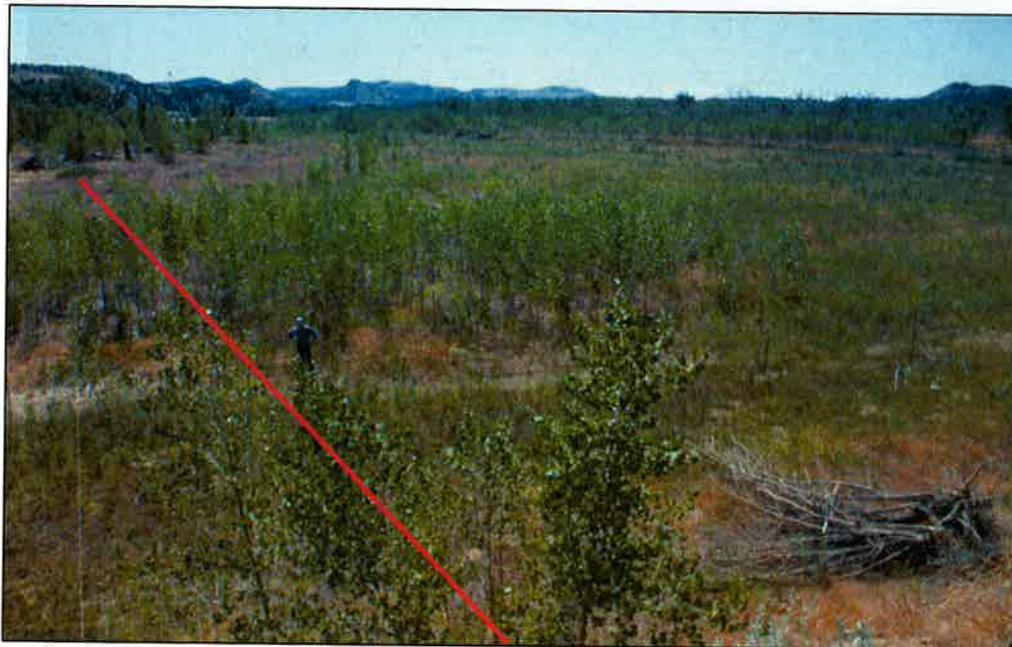
PR122. **Top.** 3 September 1984. View from top of left bank of vegetation in cutoff. J. Moody (~1.9 m tall) is 6 m upriver from station 30. **Bottom.** 17 August 1986. Red line shows approximate line of section.

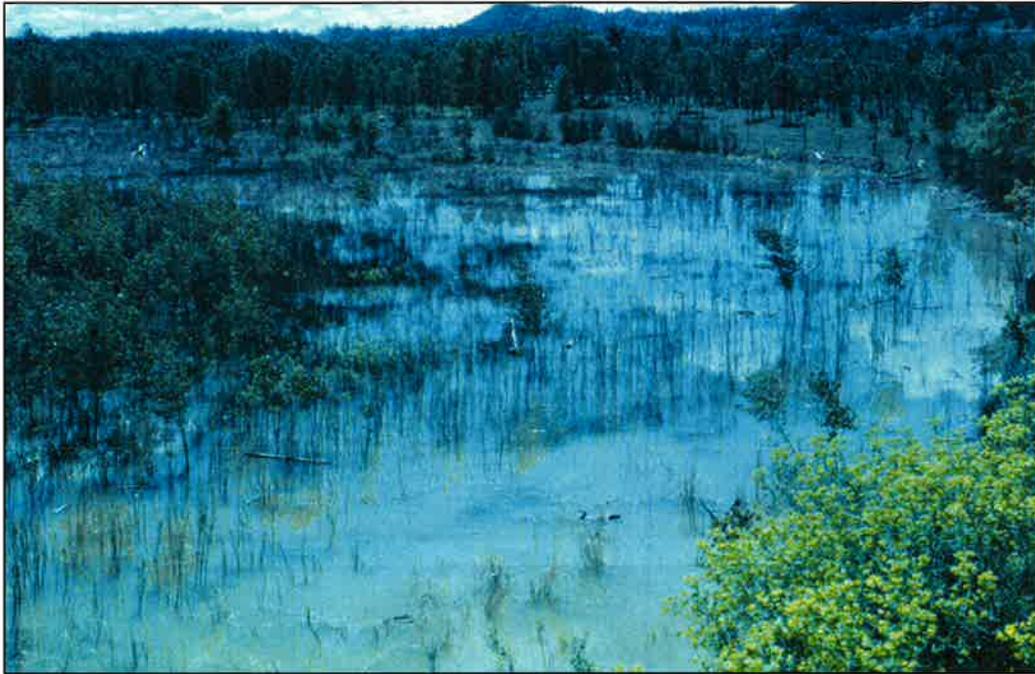
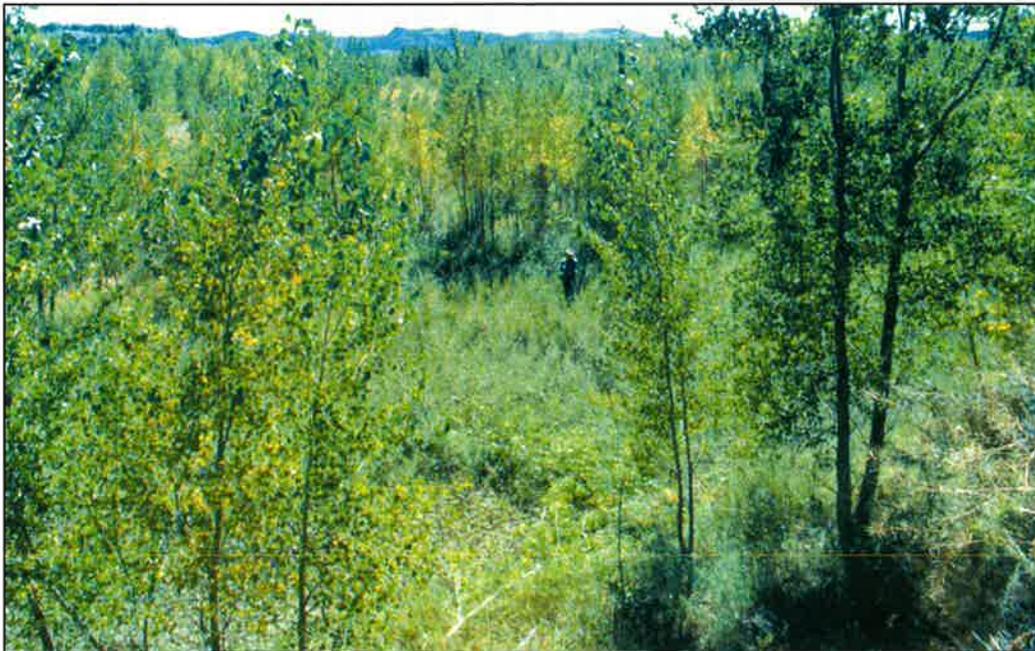
PR122. **Top.** 9 June 1993. View is upriver from PR122 showing water in the channel that was abandoned by Powder River during the Flood of 1978. **Bottom.** 26 September 1995. View is from the left bank along the line of section. J. Moody is standing between stations 20 and 30.

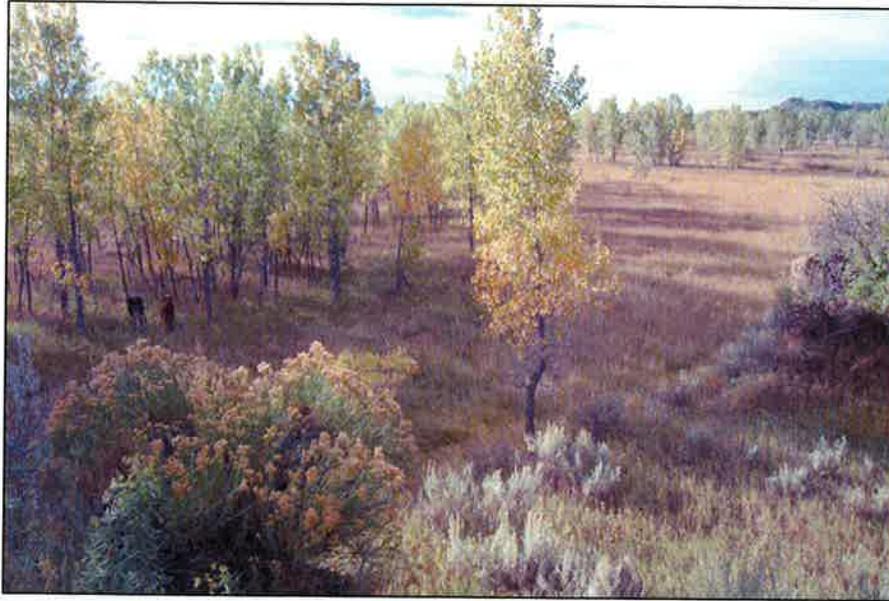
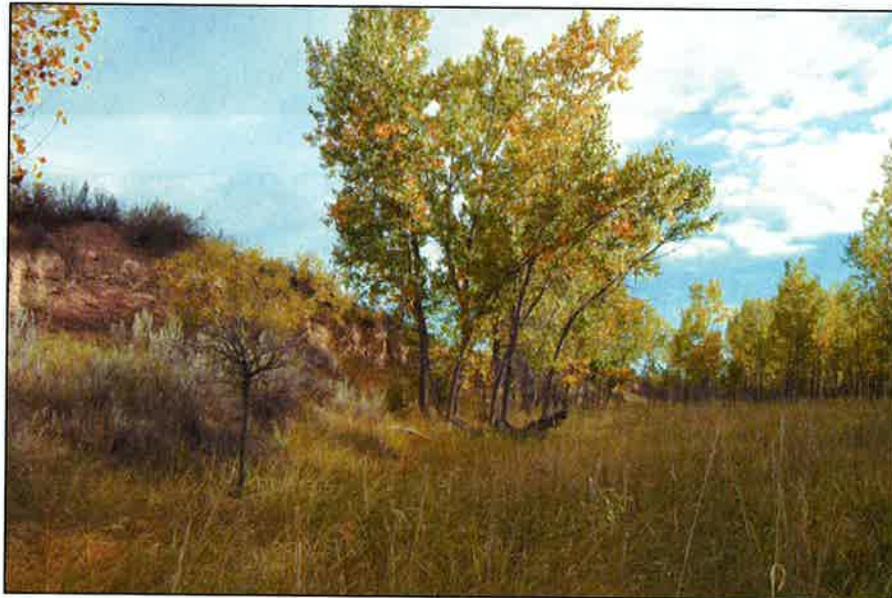
PR122. **Top.** 29 September 2013. View is upriver from PR122 showing channel abandoned during the Flood of 1978. J. Moody is standing between stations 20 and 30. Distant skyline is no longer clearly visible because of the height of the cottonwoods. **Bottom.** 29 September 2013. Downriver view through section PR122, showing the left bank of the pre-flood channel (in the alluvial fan of Flood Creek) that was eroded back 7 m during the Flood of 1978 (see Fig. 6 of Meade and Moody, 2013). Clump of cottonwood trees in center of photo grew since the Flood of 1978 (at approximately the same location where N. Andrews was standing in the photo taken on 5 September 1975).
