Section PR125 was first monumented and surveyed in 1975. It was resurveyed annually during the 4 consecutive years 1977-1980, resurveyed in 1982, resurveyed annually during the 18 consecutive years 1984-2001, and, after a 9-year hiatus, resurveyed in 2011, 2012, and 2013.

Cross section PR125 is located about 1.5 km down Powder River valley from the point where the channel of Flood Creek enters the left side of the valley. The section is located near the crossover point of a large bend in Powder River. The left bank of the channel is formed by the floodplain surface developed after the 1978 flood (Moody et al., 1999), which steps upward onto a piece of the Moorcroft terrace. The right bank is a Lightning/Moorcroft terrace (Moody and Meade, 2008).

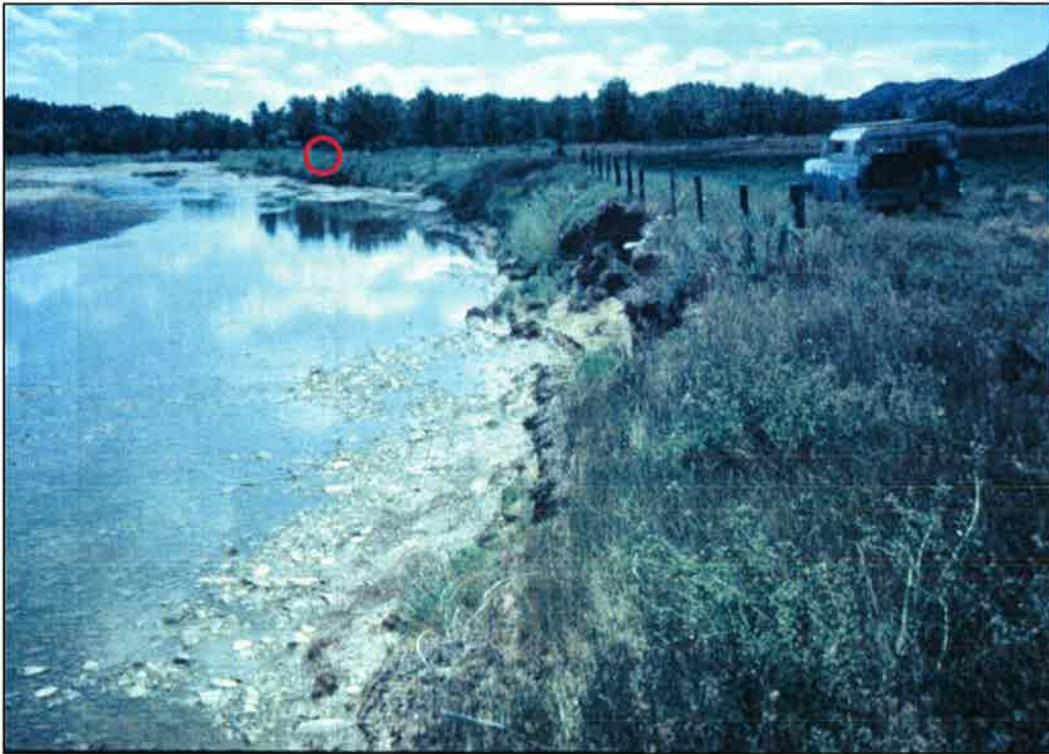
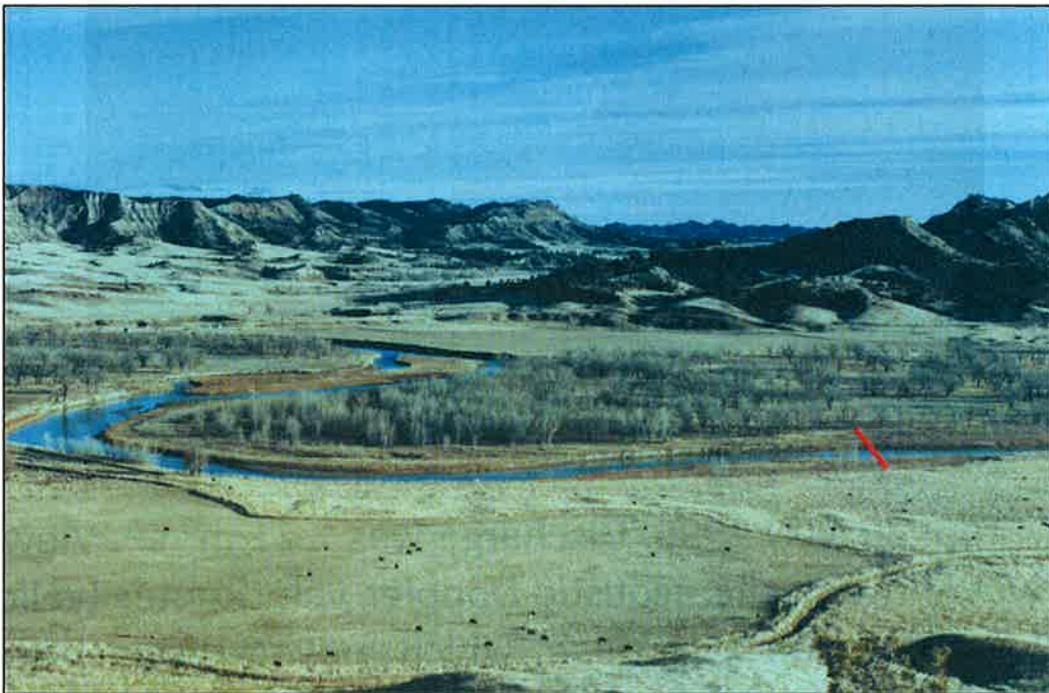
PR125. **Top.** 22 July 1977. View upriver. E. Meade (~1.6 m tall) in red circle is standing on the section. **Bottom.** May 1996. View from the Kaycee Terrace above the left bank. Flow is from right to left in the channel in the foreground. Red line indicates the line of section.

The flood of 1978 produced one massive change in section PR125: a shift in the lateral arrangement of the channel from cutbank-on-the-left-side-and-pointbar-on-the-right to cutbank-on-the-right-and-pointbar-on-the-left. The thalweg of the river channel here shifted, during two weeks of flood flows in May 1978, some 70 meters toward the right bank. This lateral shift appears to have been produced by the downriver transport of a large gravel bar (some 40 meters wide and about a meter in thickness, Meade and Moody, 2013, see *their* Figures 14 and 15), toward the left bank. Bank erosion during the 1978 flood amounted only to 3 meters of cutback of the right bank. The combination of large (70-m) thalweg shift and small (3-m) cutbank erosion probably was due to section PR125's being located near the inflection point (or, more likely, in the inflection *zone*) between the downriver limb of one meander bend and the upriver limb of the next meander bend downstream.

During the decades following the 1978 flood, the left-side gravel bar at section PR125 has become a new vegetated inset flood plain by the incremental addition of new sand (Moody and others, 1999; Pizzuto and others, 2008). A total thickness of 1-2 meters of new sand has accumulated between station 20 and station 50, mostly during years 1982, 1987, 1993, 1995, and, probably, 2008. The right-side cutbank meanwhile has eroded some 8 meters laterally, mostly during the same 5 years.

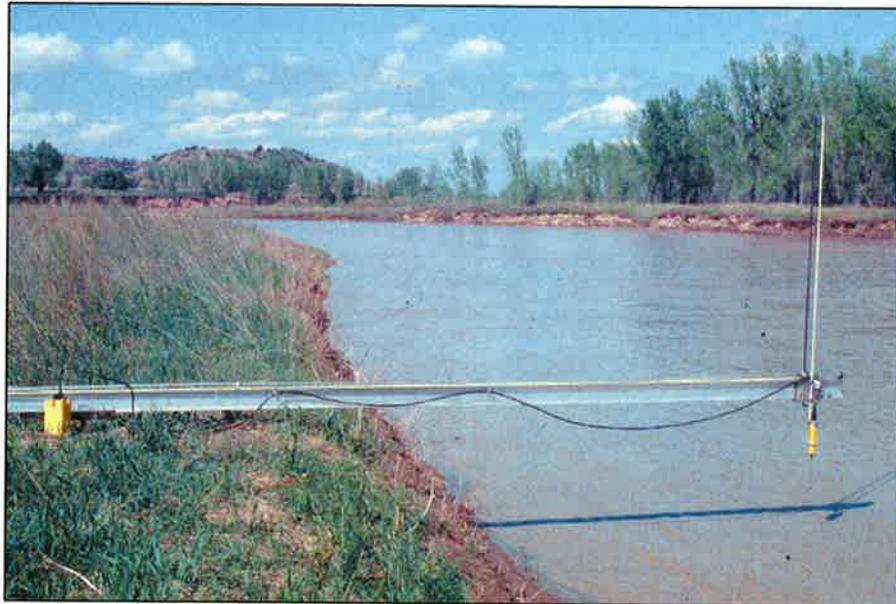
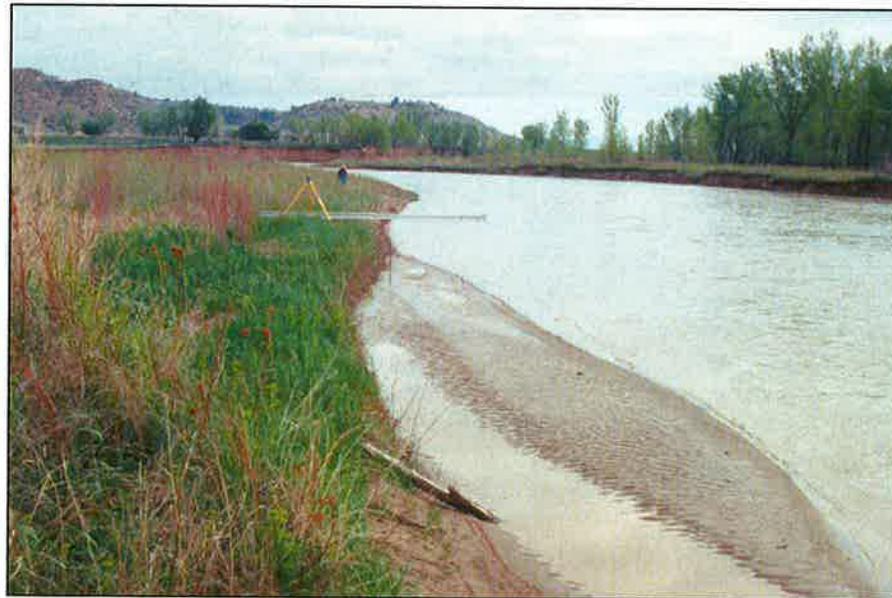
PR125. **Top.** 28 May 1996. Discharge was  $\sim 71 \text{ m}^3 \text{ s}^{-1}$ . View is downriver showing the acoustic Doppler velocimeter (yellow object) mounted on a carriage, which moved on an I-beam deployed out over the edge of the left bank of the new inset flood plain built since 1978. **Bottom.** 30 May 1996. Discharge was  $\sim 62 \text{ m}^3 \text{ s}^{-1}$ . View is downriver showing the tripod, I-beam, and D. Martin ( $\sim 1.5 \text{ m}$  tall) who is down river from the I-beam. The exposed sediment along the right bank was deposited between 28 May and 30 May 1996.

Measurements of Reynolds stress were made in 1996 at the edge of the new vegetated inset flood plain. An acoustic Doppler velocimeter (ADV) was mounted on a carriage, which could move the velocimeter horizontally out over the channel and vertically in the water (Moody and Smith, 2002). Measurements were made on 28 May 1996 at six verticals between station 26.5 and 30.0 in water depths ranging from 0.1 m to 0.6 m at a quasi-steady discharge of  $71 \text{ m}^3 \text{ s}^{-1}$ .

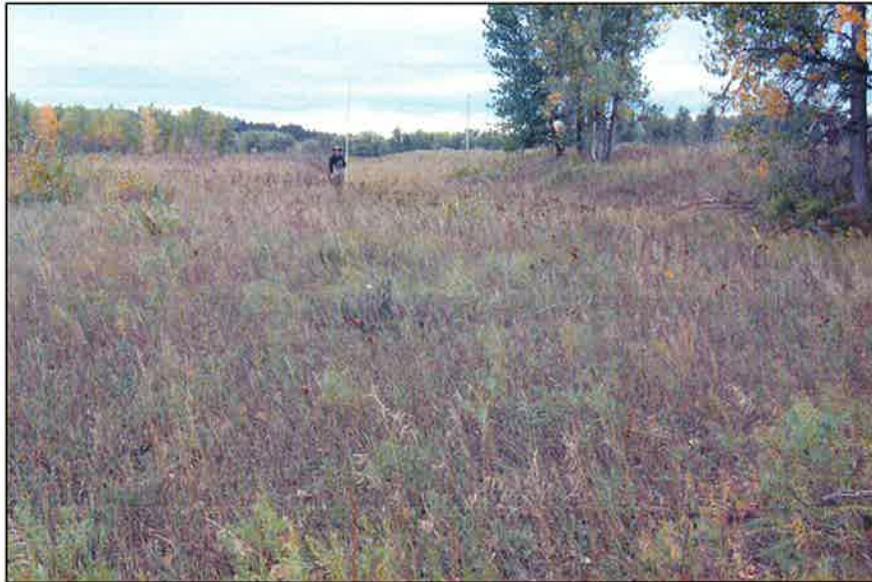
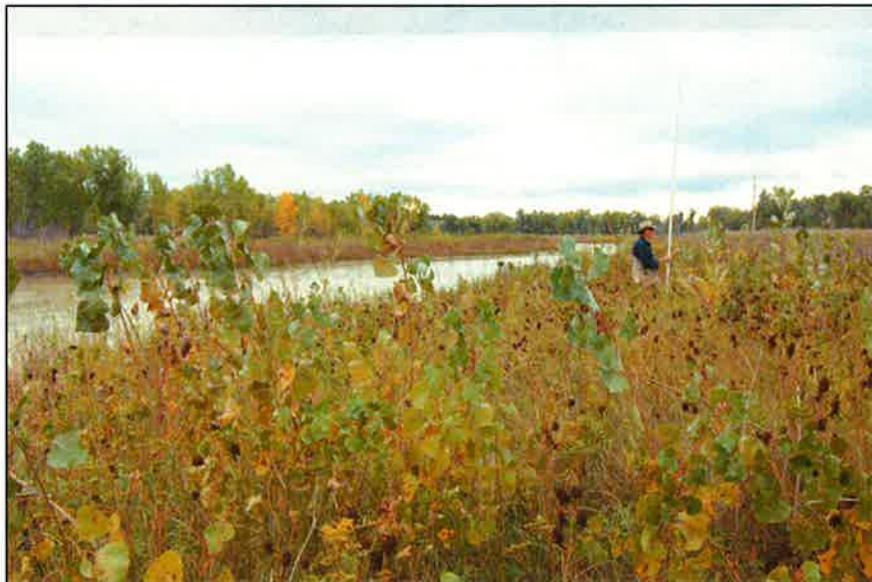
PR125. **Top.** 29 September 2013. View upriver. Tripod and D. Martin (at right edge of photo and behind the trees) are about 7m downriver of station 4. Rodman (J. Moody) is on section at station 38, and is standing on vegetated top of floodplain sediment deposited since 1978, when the main channel of Powder River shifted from the left bank to the right bank (see also Meade and Moody, 2013, *their* figures 14 & 15). **Bottom.** 29 September 2013. J. Moody is standing at station 38.

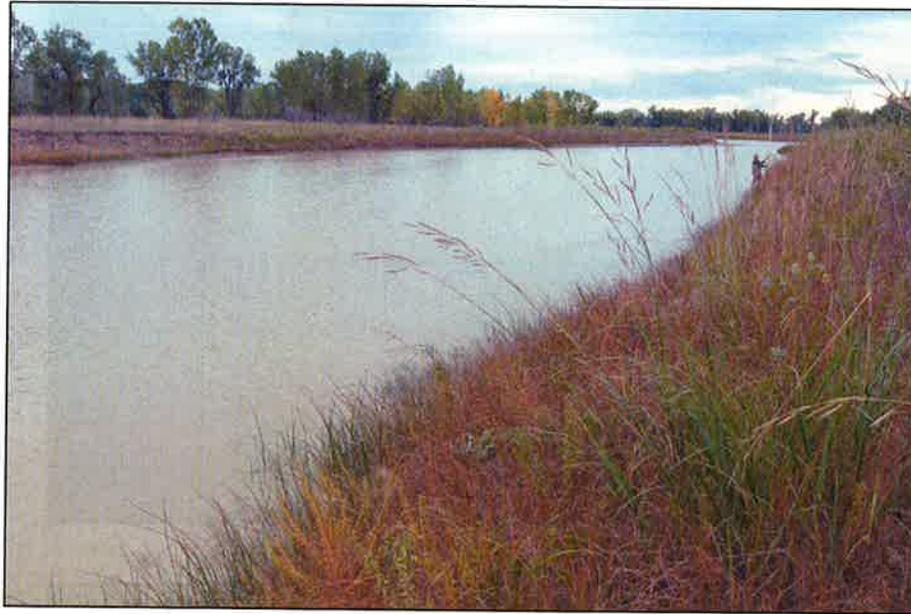
PR125. **Top.** 29 September 2013. View upriver. J. Moody (~1.9 m tall) is on section at left edge of water at station 50.6.
