Section PR136 was a symmetrical cross section with a central bar in the middle of the channel when it was established in 1975. Both banks are on Moorcroft-level terraces. It was resurveyed annually during the 4 consecutive years 1977-1980, resurveyed in 1982, resurveyed annually during the 15 consecutive years 1984-1998, and, after a 13-year hiatus, was surveyed in 2012.

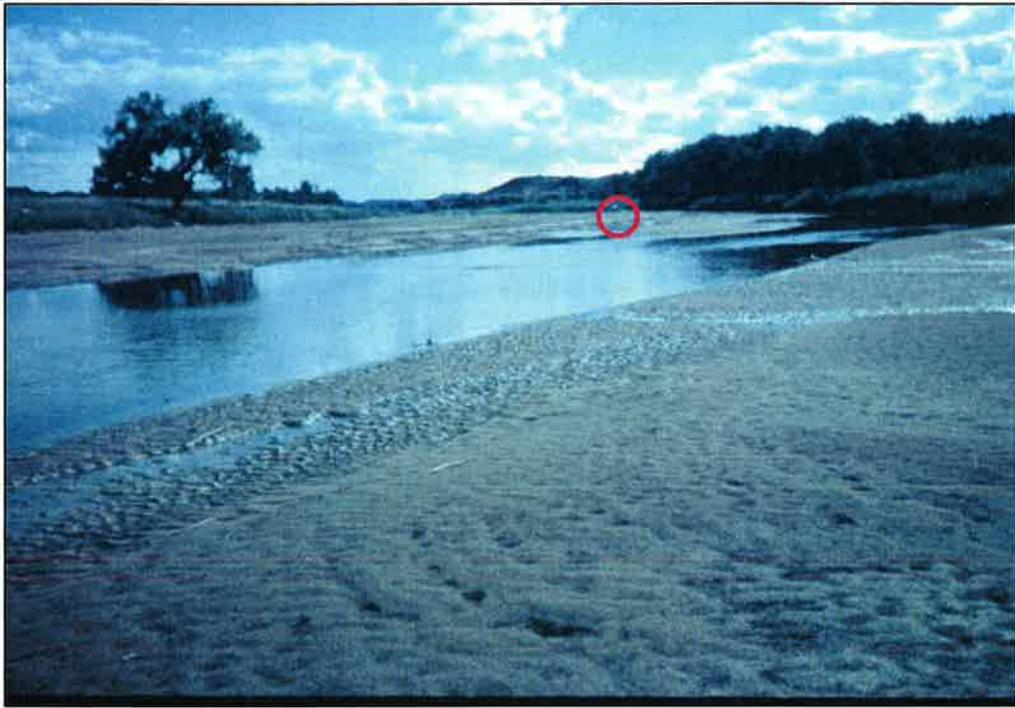
PR136. **Top.** 22 July 1977. View upriver. E. Meade (~1.6 m tall) in red circle is standing on the section. **Bottom.** 16 August 1979. View is downriver from bedrock knoll, about half a kilometer upriver of section. Red line is approximate line of section.

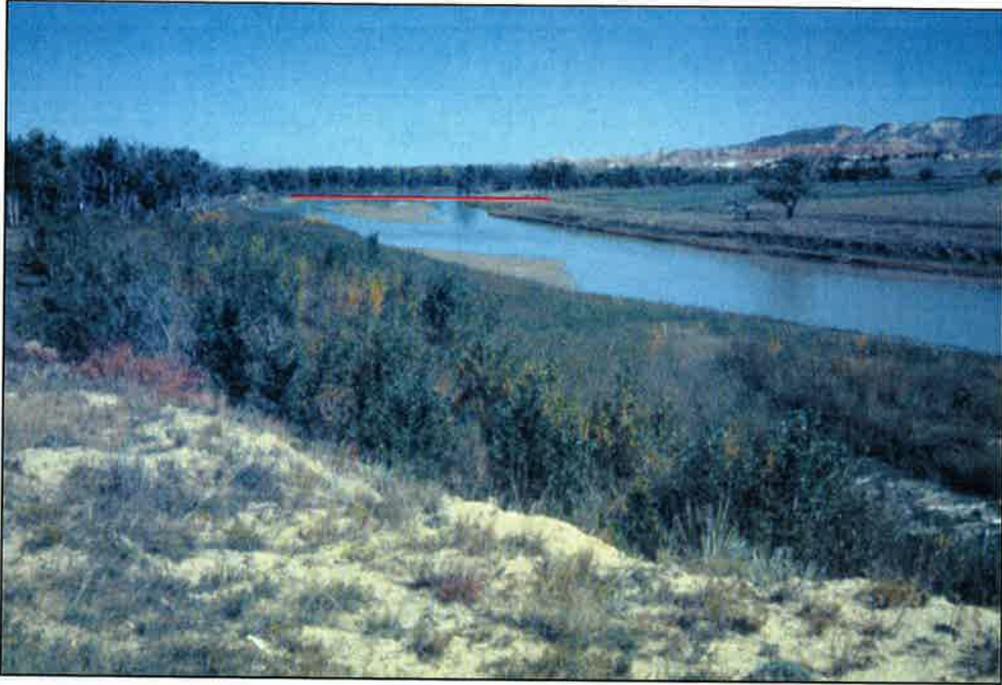
PR136. **Top.** 26 September 1987. View downriver from knoll. **Bottom.** 21 September 1988. Zoom lens view downriver from knoll. Red lines indicate the approximate line of section.

The flood of May 1978 caused no erosion of the approximately 3.5-m high banks or of the central bar, and thus had little effect on the shape and size of the channel cross section. The secondary channel along the right bank was deepened by about 50 cm during 1979. The greatest change came between 1980 and 1982 when the elevation of the central bar was raised 20-30 cm, and again by about 10 cm during the spring runoff in 1987. Photos taken in 1987 (see photo section) show the central bar vegetated so that it could be designated as an island.

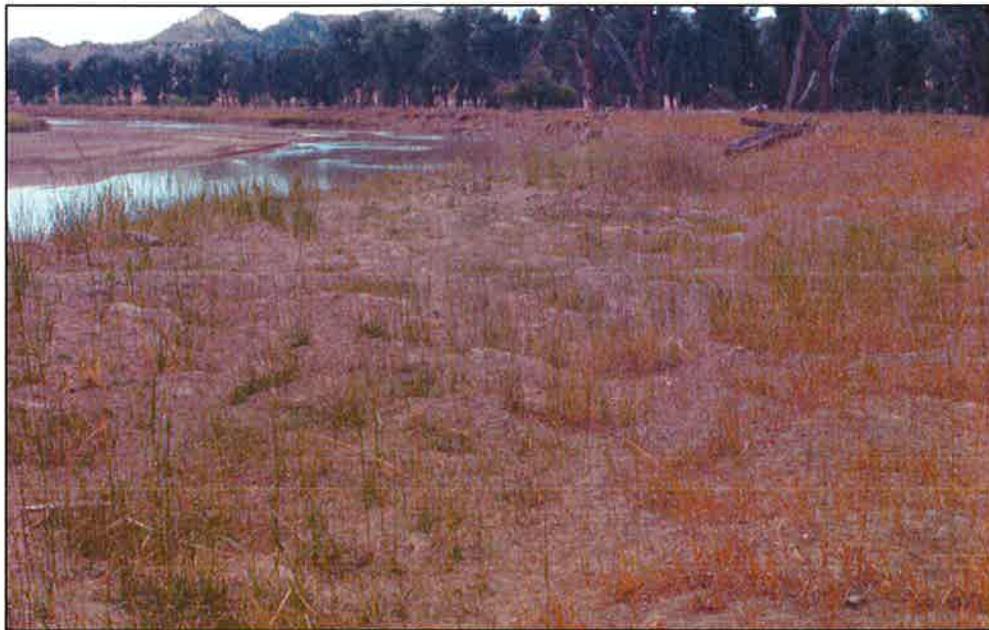
PR136. **Top.** 3 September 1994. Sediment deposits that surrounded ice blocks about 500 m downstream from PR136 on the left bank. View is upriver. **Bottom.** 11 March 1995. View upriver with ice on upriver end of emerging island. Survey rod in orange cover is on the section. Knoll (under white arrow) from which other pictures were taken is in the upper right.

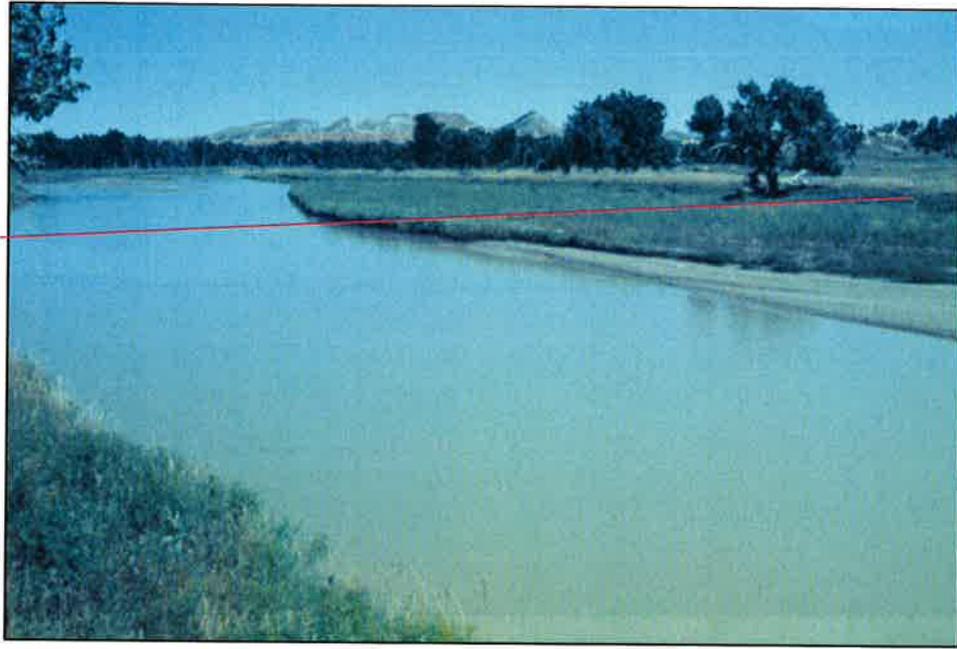
PR136. **Top.** 27 August 1993. View downriver with red line indicating the approximate line of section.

This island was essentially new flood plain that was augmented again in 1993 along both edges as levees 10-20 cm in height and then raised an additional 20-40 cm across the entire island during 1995 (Moody and others, 1999). During the entire time from 1978 to 1995 there was essentially no erosion of either bank. Between 1995 and 2012, the left bank was eroded about 3.5 m near the top of the bank, a possible bench-like feature (Page and Nanson, 1982) was deposited at the base of the left bank of the island, and the secondary channel along the right bank of the cross section degraded by about 1.0 m.
