Cross section PR163 was established in 1977 near the apex of a bend in Powder River whose active features included a 2.5-m-high cutbank in the Lightning terrace that formed the left margin of the channel, and a point bar and flood plain on the right margin that had been developing steadily at this site since at least 1939 (the year the first aerial photographs were taken; see Martinson and Meade, 1983, *their* sheet 2). This cross section was resurveyed annually (except for 1981 and 1983) through 2002. After a hiatus of eight years it was again surveyed in 2011, 2012, 2013, and 2014.

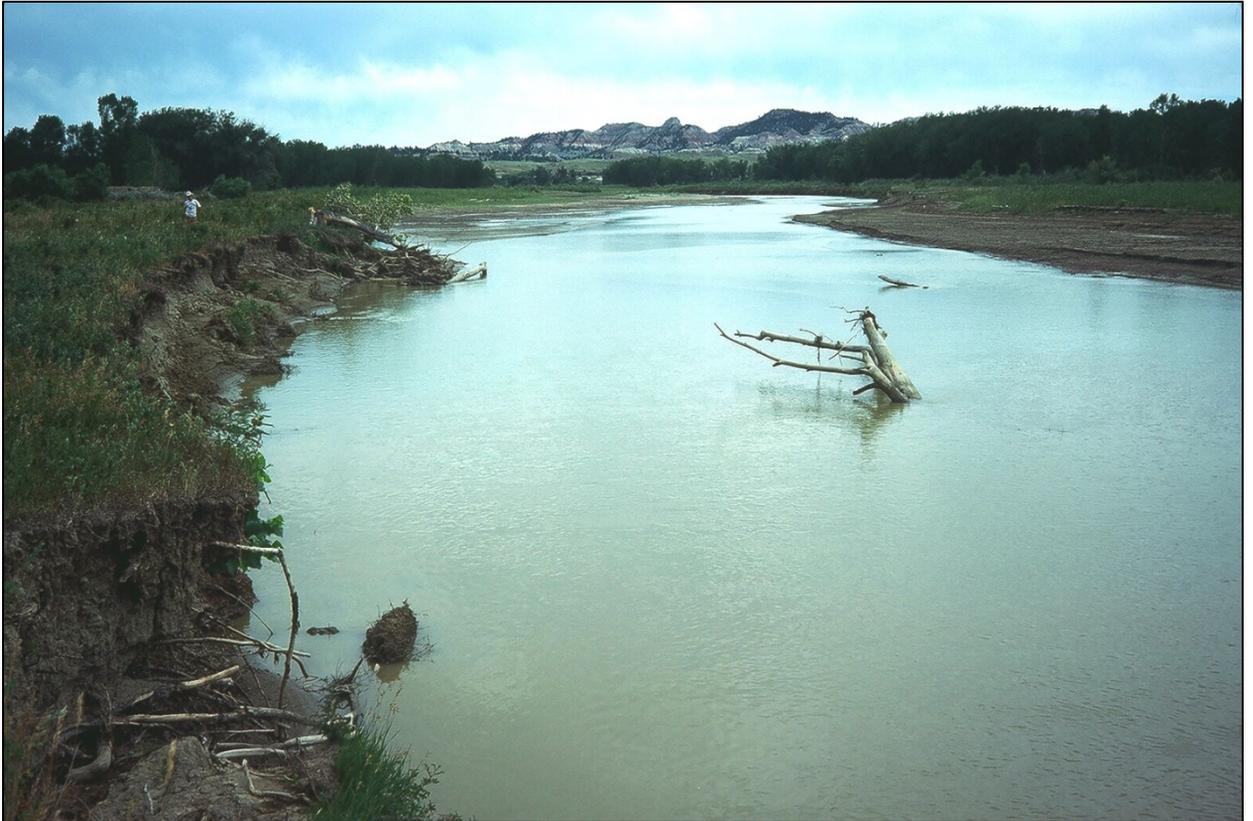
PR163. **Top.** 13 July 1977. View downstream along the left-side cutbank, which, at the time of this photo, was eroding the Lightning terrace. E. Meade (~1.6 m tall) is standing on the line of section at about station 8. The left-side cutbank was eroded by the Flood of 1978 and moved laterally 65 m to the left during the flood.

The greatest accretionary channel displacement during the flood of May 1978 that we were able to document fully on Powder River was measured at cross section PR163 (Meade and Moody, 2013, *their* Figure 19). During two weeks of flooding, the left-bank Lightning terrace was eroded back a lateral distance of 65 m, displacing some 160 m³ of terrace sediment for each meter of channel length. The right-bank flood plain was extended leftward some 55 m by the deposition of a ~2-m thickness of new sediment in the pre-flood river channel (stations 10 to 45) and a ~1-m thickness of new sediment atop the old point bar (stations 45-65). A new point bar, about a meter thick, was deposited in a segment of the cross section (stations -20 to +10) where, two weeks earlier, had stood a 2.5-m-high fluvial terrace. Flood waters that crossed the neck of the bend left overbank deposits of silt and sand, mostly 0.1-0.3 m thick, on a 500-m rightward extension of cross section PR163 (Moody and Meade, 2008, *their* Figure 6). Overbank material was also deposited by flood waters that overtopped the left-side Lightning terrace, but most of this freshly-deposited sediment was remobilized and carried away downstream as the cutbank receded during the flood; only a thin (~0.1 m thick) remnant survived the flood at stations -55 to -60.

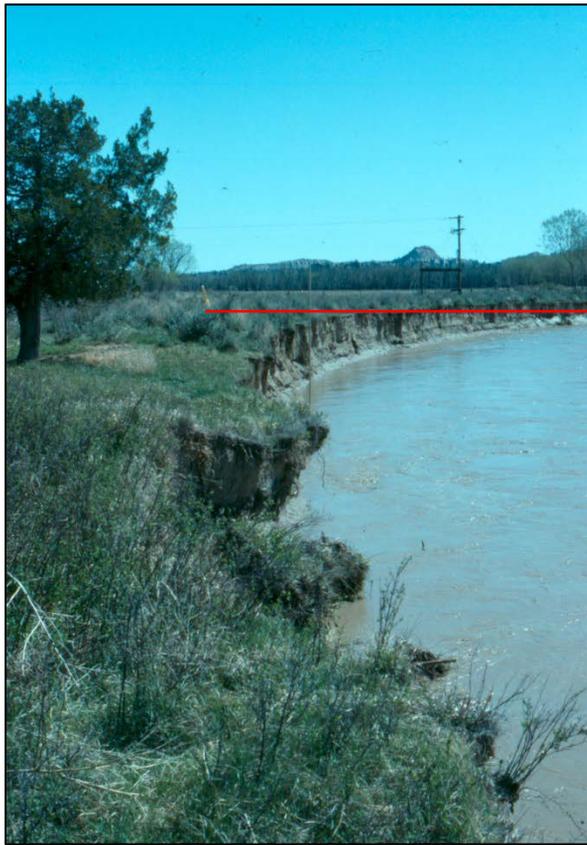
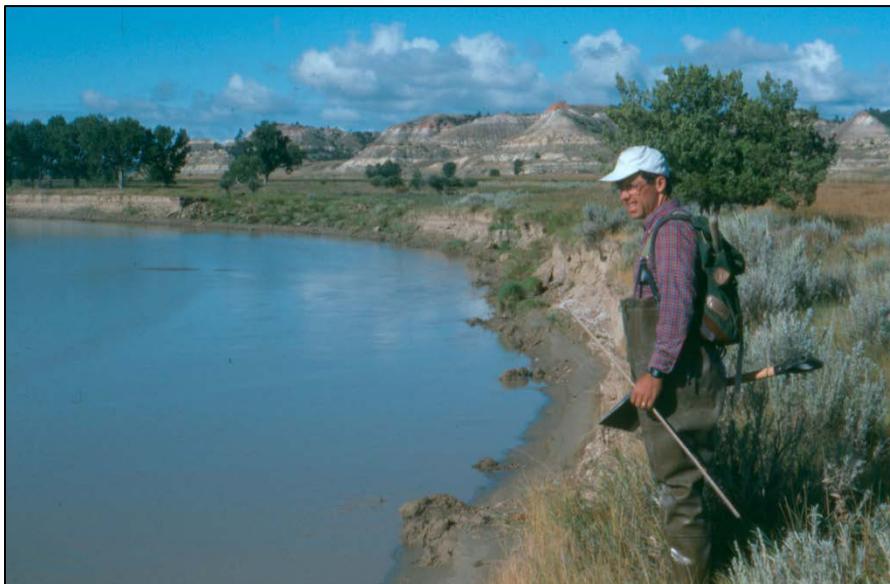
PR163. **Top.** 11 May 1993. View downstream along the left bank, which is on the Moorcroft terrace. Water elevation is 963.10 m. **Bottom.** 30 August 1993. View upriver of left bank with J. Pizzuto is about 1.8 m tall and is standing on the line of section.

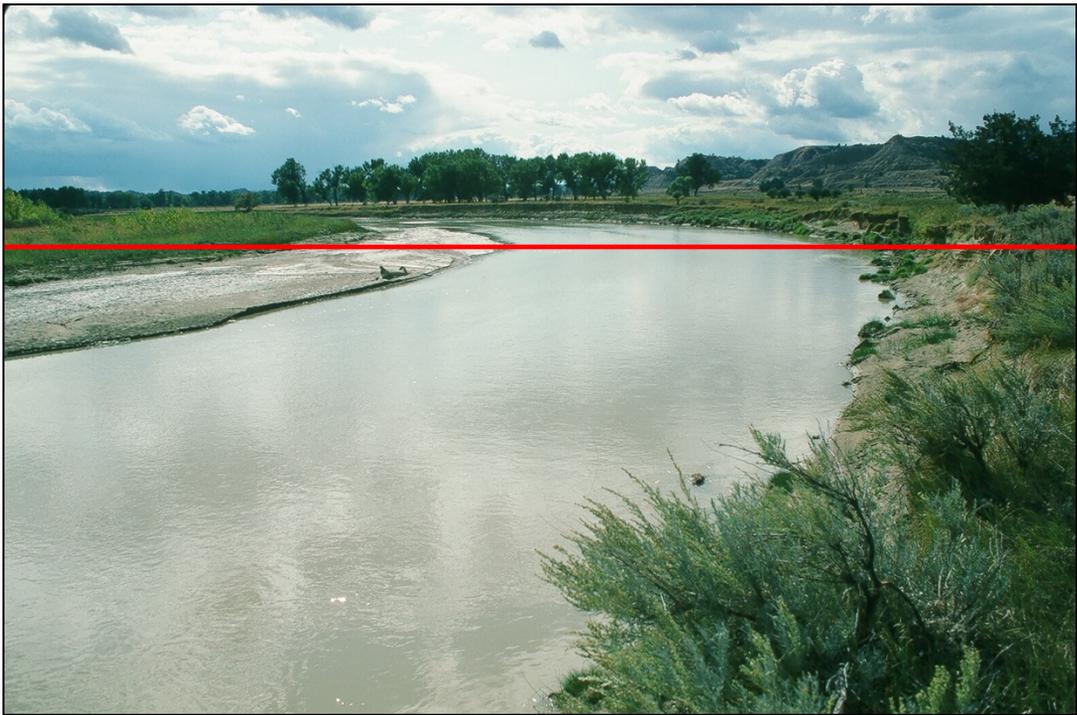
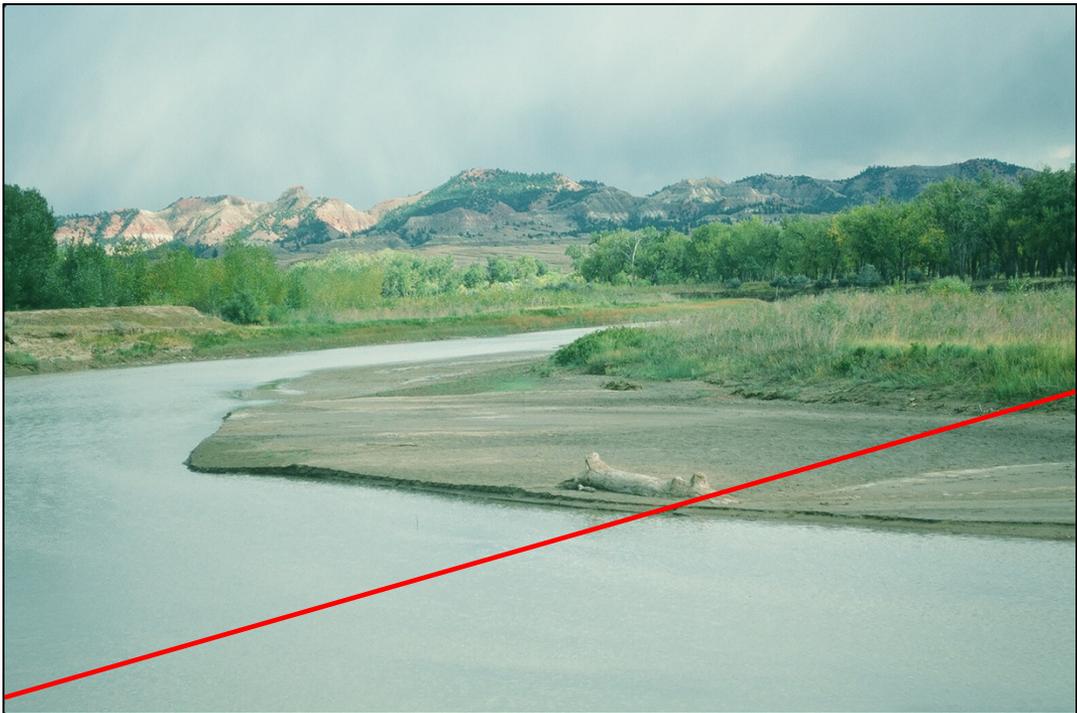
PR163. **Top.** 21 September 1994. View upriver of section. **Bottom.** 21 September 1994. View downriver from point ~80 m above section. Water discharge is about $1.5 \text{ m}^3 \text{ s}^{-1}$. Red lines indicates approximate line of section.

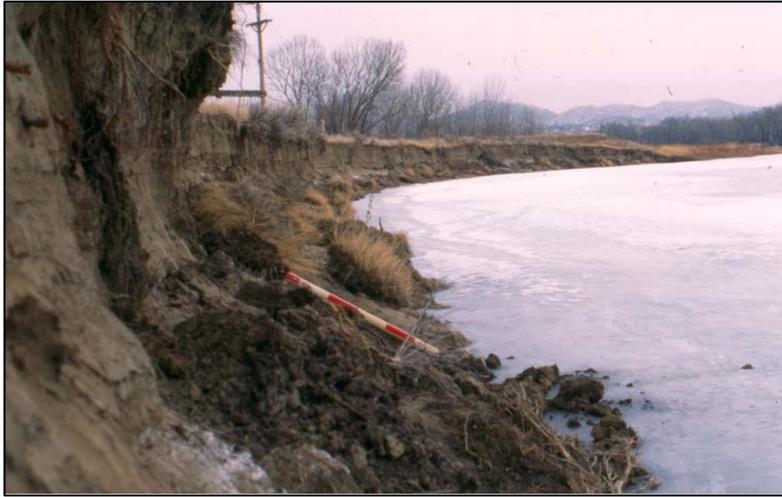
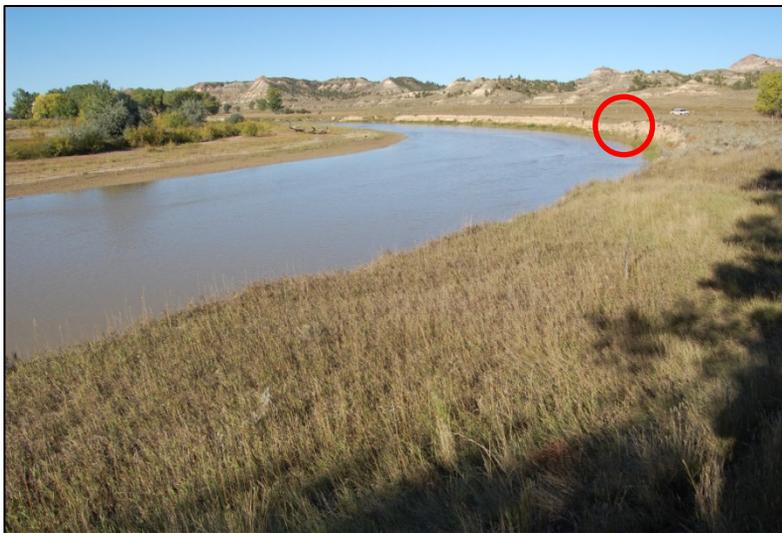
PR163. **Top.** 14 January 1996. View downriver of left bank. Erosion of bank is caused by melting snow on this bend that faces approximately southwest. Power pole appears in the photo taken on 11 May 1993. **Bottom.** 1 October 2013. View upriver of section. Tripod, level and D. Martin (~1.5 m tall) are 3 m downriver from station -94 (inside red circle on right edge). Vehicle (Chevrolet Suburban) is parked along the riverward side of a fence, which cross the section at station -122.0. The tailgate is about 4 m downriver of the line of section. Rodman (J. Moody (~1.9 m tall) is standing on the line of section, on top of left bank at station -91.5 (inside red center on left edge).

Since the flood of 1978, the left bank has continued being eroded back into the Lightning and (since 1985) Moorcroft terraces. As of 2014, the terrace bank had lost another 35 m, or an average of a meter per year. Larger-than-average amounts of erosion of the left bank were recorded in the surveys conducted in 1984 (2.9 m), 1991 (3.0 m), 1993 (2.0 m), 1995 (3.4 m), 1996 (5.0 m), 1999 (2.0 m), and 2011 (9.7 m, most of which probably was eroded in 2008).

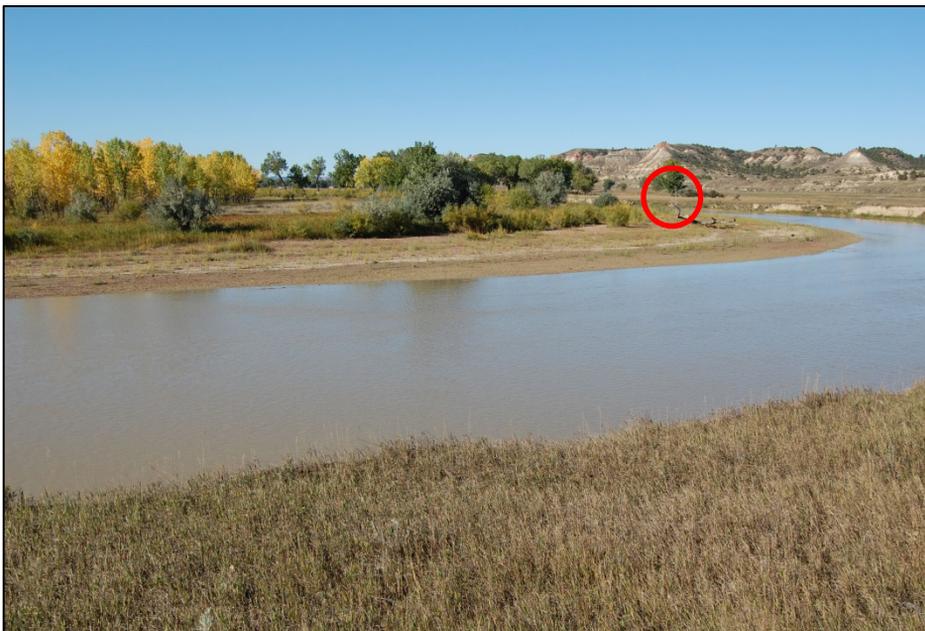
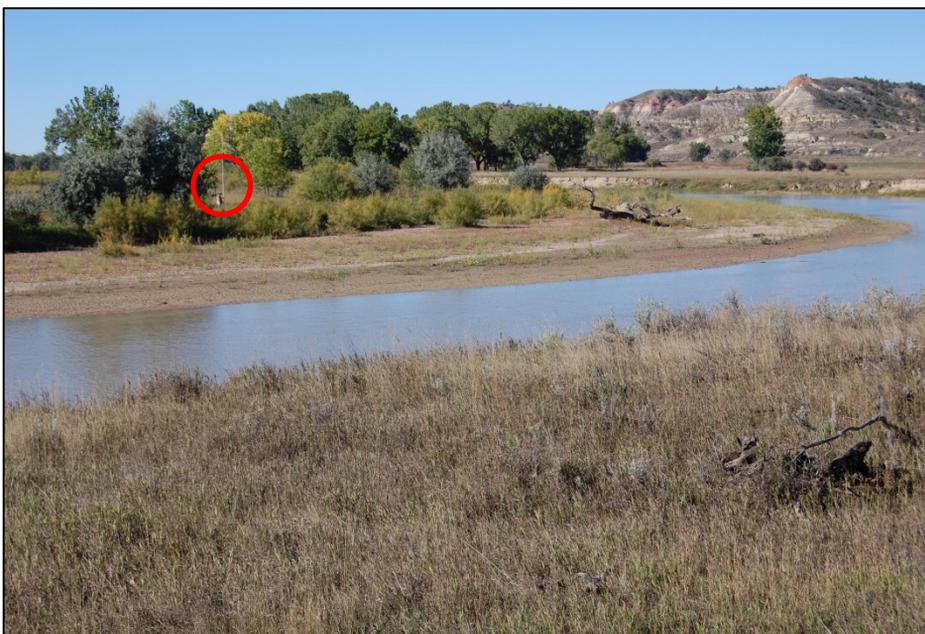
PR163. **Top.** 1 October 2013. View upriver of point bar. J. Moody (~1.9 m tall) is standing at station -27 (inside red circle). Log on point bar is the same log seen in photo taken on 21 September 1994. **Bottom.** 1 October 2013. Upriver view of point bar. A point at elevation 953.0 m above sea level on the point bar (see data files) has moved laterally 30 m, and the thalweg has moved 55 m since the Flood of 1978. J. Moody, with white rod, is on the line of section at station +7 (inside red circle). Station +10 was the left-side cutbank in 1977 (see photo above).

From 1978 through 1995, the new point bar that began to develop during the 1978 flood accumulated sediment intermittently (on a year-to-year time scale) between stations -15 and +15, until its upper surface lay near the level of the existing flood plain. Meanwhile, an even newer point bar developed between stations -15 and -35 (Moody and Meade, 2014). Between 1995 and 2008, the riverward edge of this newest point bar was extended laterally leftward to about station -55.

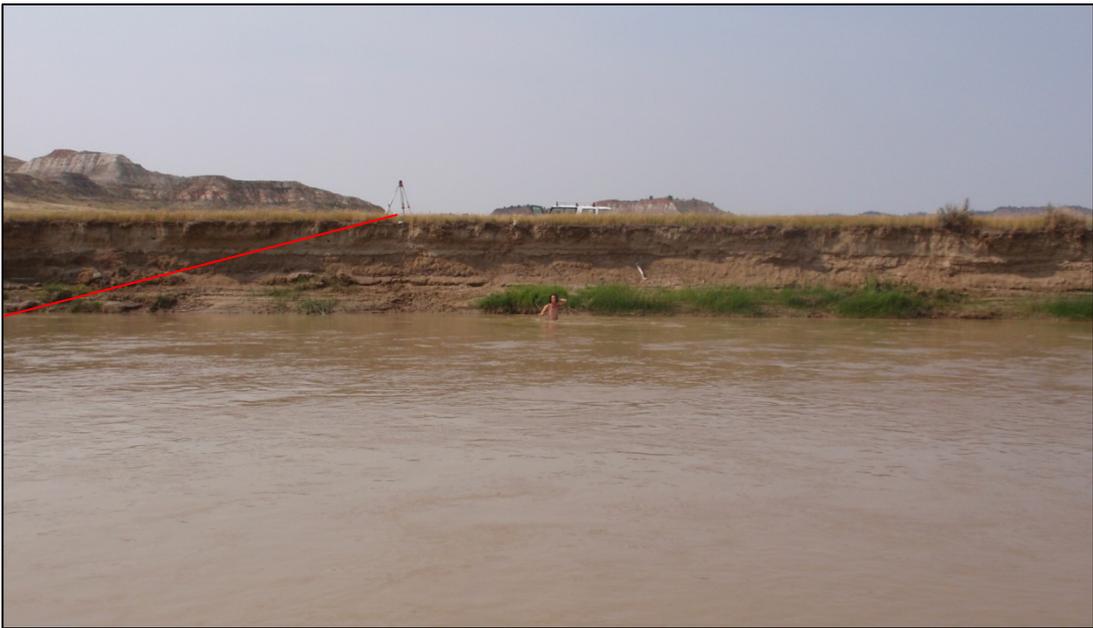
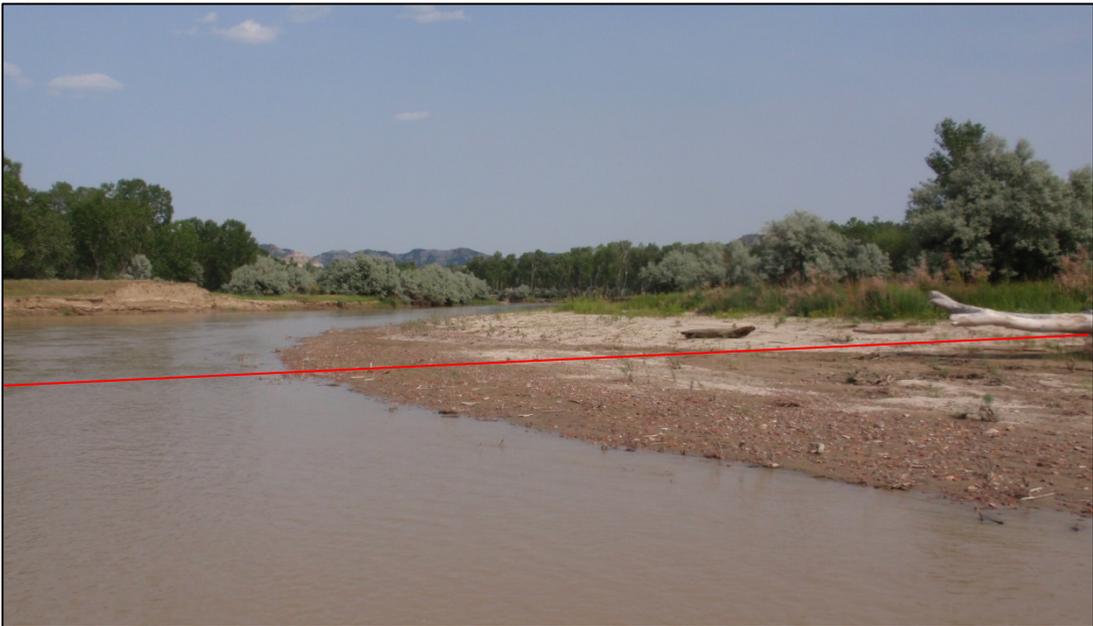
PR163. **Top.** 17 July 2014. View left bank. Water level is at 962.73 m above sea level and is 2.68 m below top of bank. Tripod is on the line of section shown approximately by the red line. Water discharge is $16.7 \text{ m}^3 \text{ s}^{-1}$. **Bottom.** 17 July 2014. Downriver view of point bar along right bank. Right edge of water is at station -46.0. Red line is the approximate line of section.
