Cross section PR167 was established in 1977 in the upriver limb of a large meander bend of Powder River in Sections 21 and 28 of T6S, R50E (the bend described as “near Daily Ranch” by Gay *et al.*, 1998, *their* Figure 9). Resurveys were conducted during the years 1978-1980, 1982, 1984-1998, 2011, and 2014.

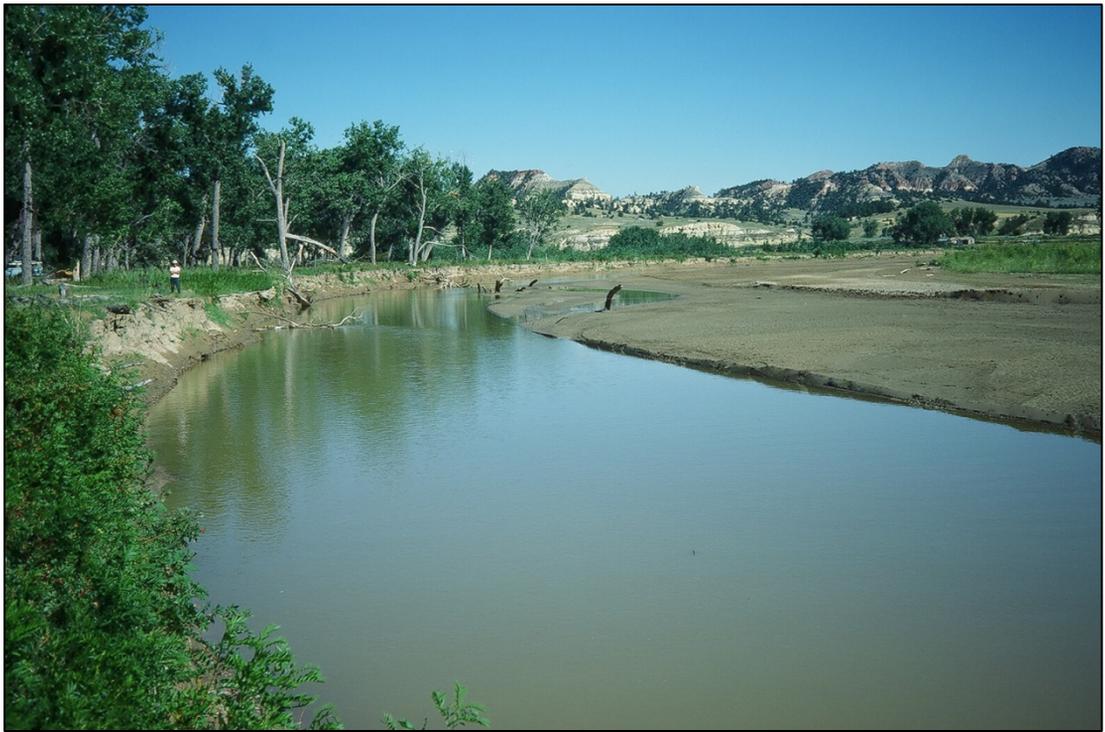
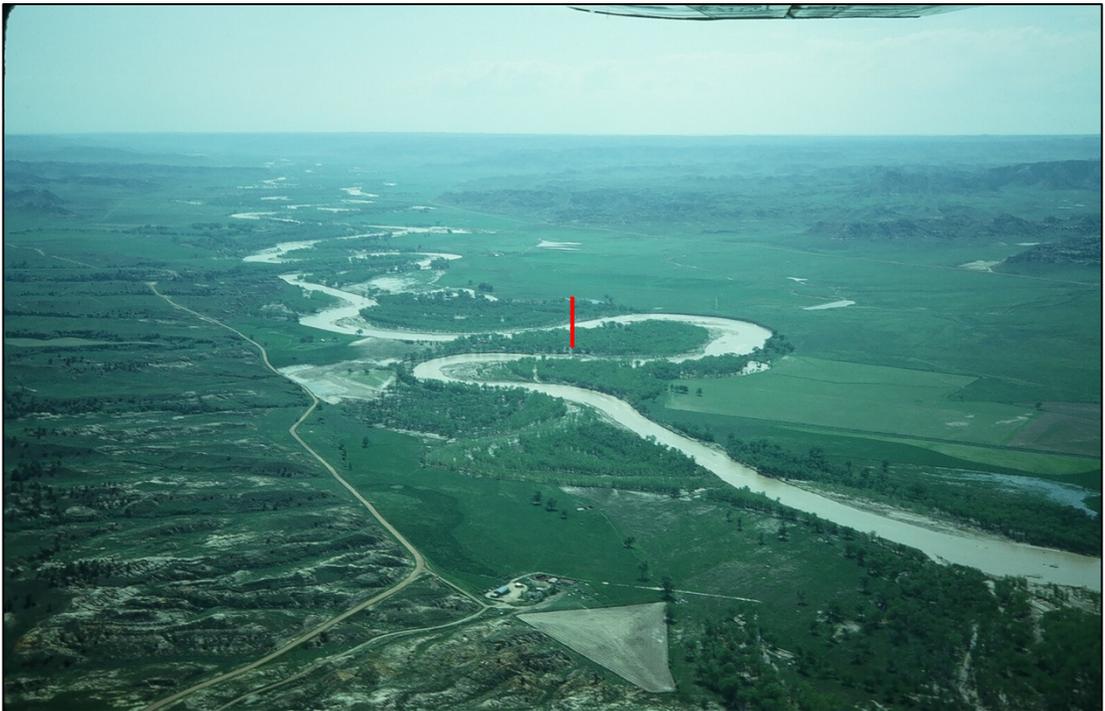
PR167. **Top.** 13 July 1977. View upriver along the right bank. E. Meade (~1.6 m tall) is standing on the line of section. **Bottom.** 25 May 1978. View upriver of bend near John Daily's Ranch during the Flood of 1978. Approximate line of section is shown by the red line.

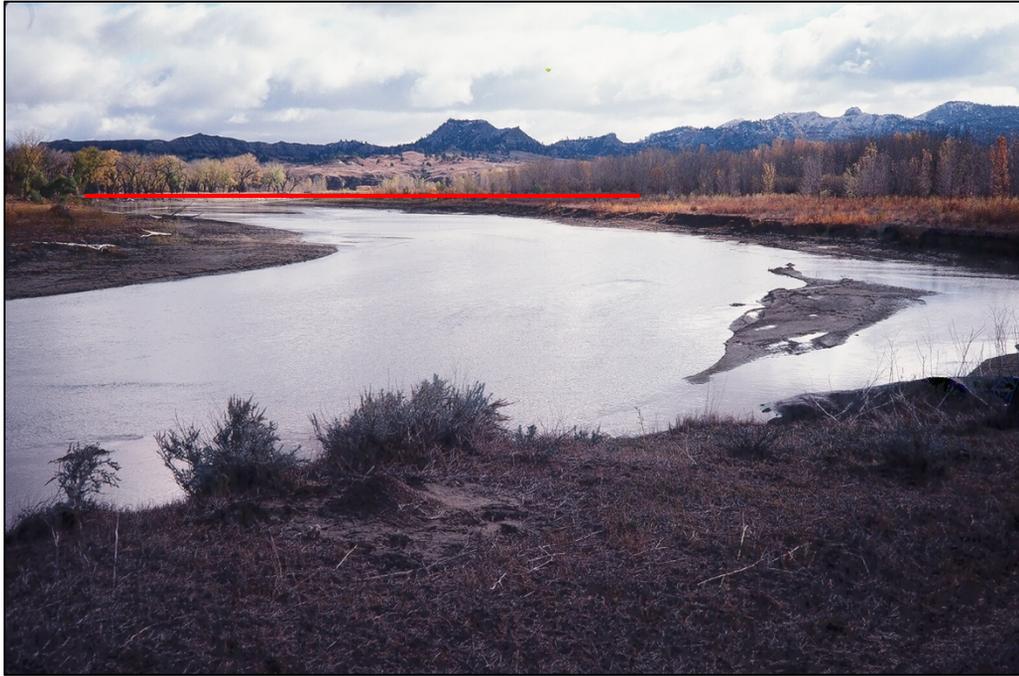
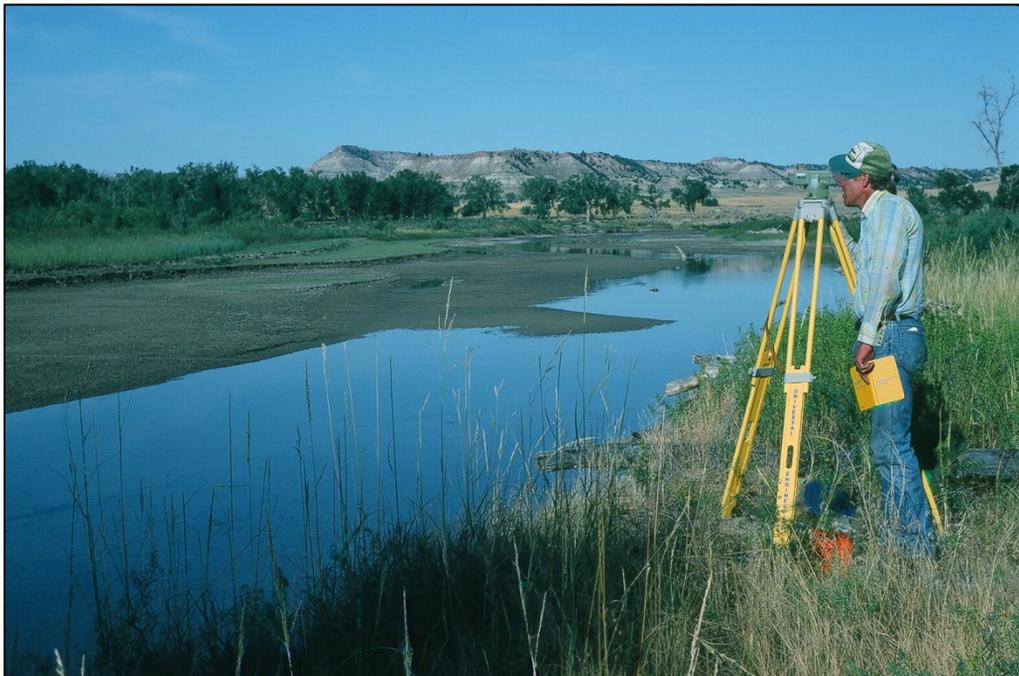
PR167. **Top.** 21 October 1979. View downriver. Left bank has seedlings of Russian olives brought in the Flood of 1978. Approximate location of the section is indicated by the red line. **Bottom.** 4 September 1991. View downriver from section. J. Moody (~1.9 m tall) is standing approximately on the line of section.

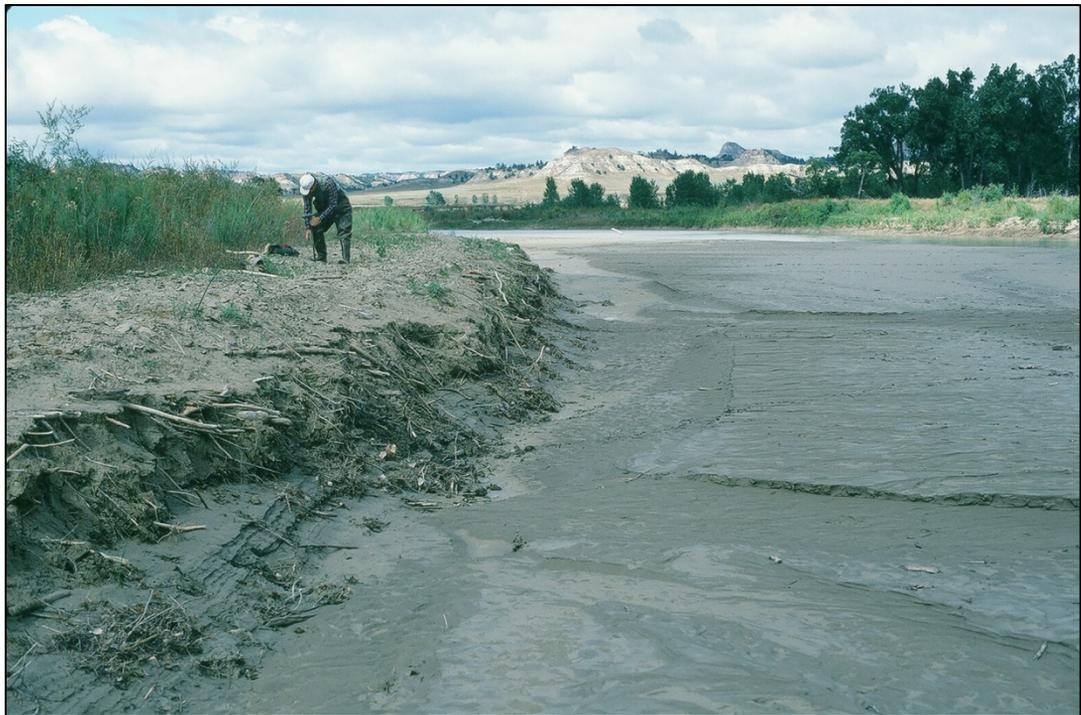
PR167. **Top.** 2 September 1993. View downriver. J. Pizzuto (~1.8 m tall) is on the line of section near station 60. **Bottom.** 2 September 1993. View downriver of new sand on point bar on left bank. J. Pizzuto is on the line of section near station 57. Red line indicates approximate location of section

Since the early 1990s, however, the shape of the cross-channel profile of section PR167 has altered significantly as the volume of new material that was deposited and accumulated on (and in) the left side of the channel, not only exceeded somewhat the volume of material eroded from the right-side cutbank, but accumulated in such a way as to narrow the width of the low-water channel of the river. The left bank of Powder River at cross section PR167, instead of being a gently-sloping surface as it was formerly, now has a levee (station 57-67), which is about 2 m above the sand bar along the left bank in 2014. The left bank is now stabilized (as of 2014) by a small but dense forest of Russian-olive trees that stand 3-4 m tall and extends from station

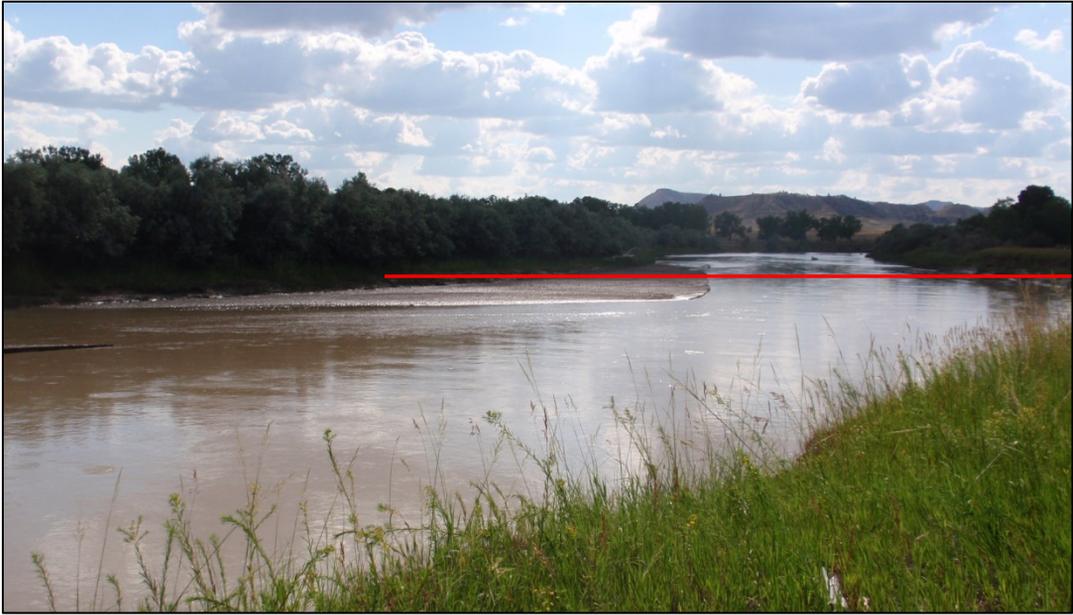
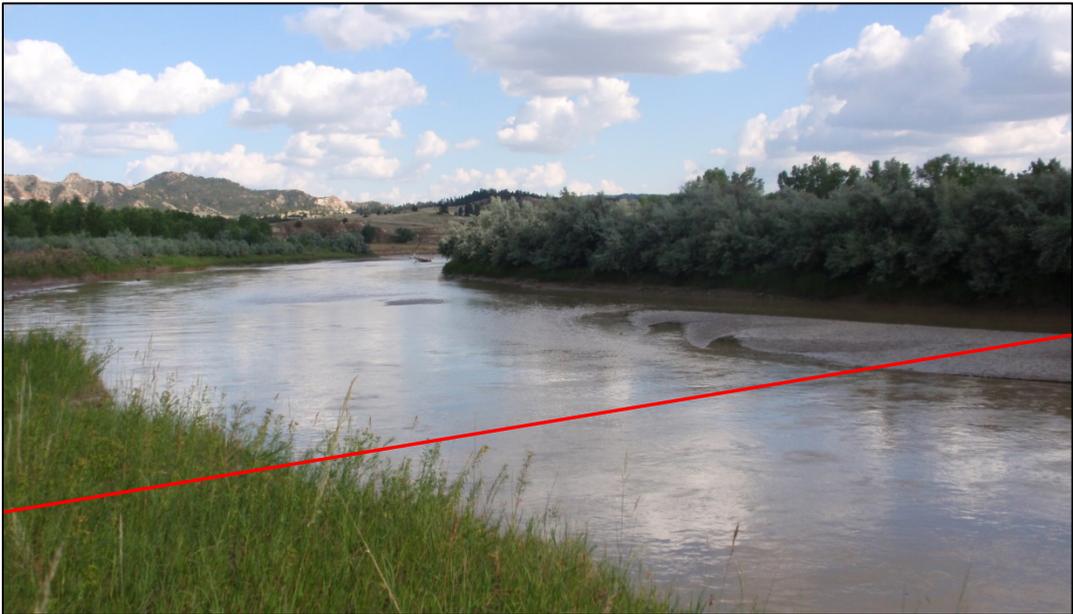
PR167. **Top.** 16 July 2014. View downriver from the right bank. Red line indicates the approximate line of section. **Bottom.** 16 July 2014. View upriver from the right bank. Red line indicates the approximate line of section.

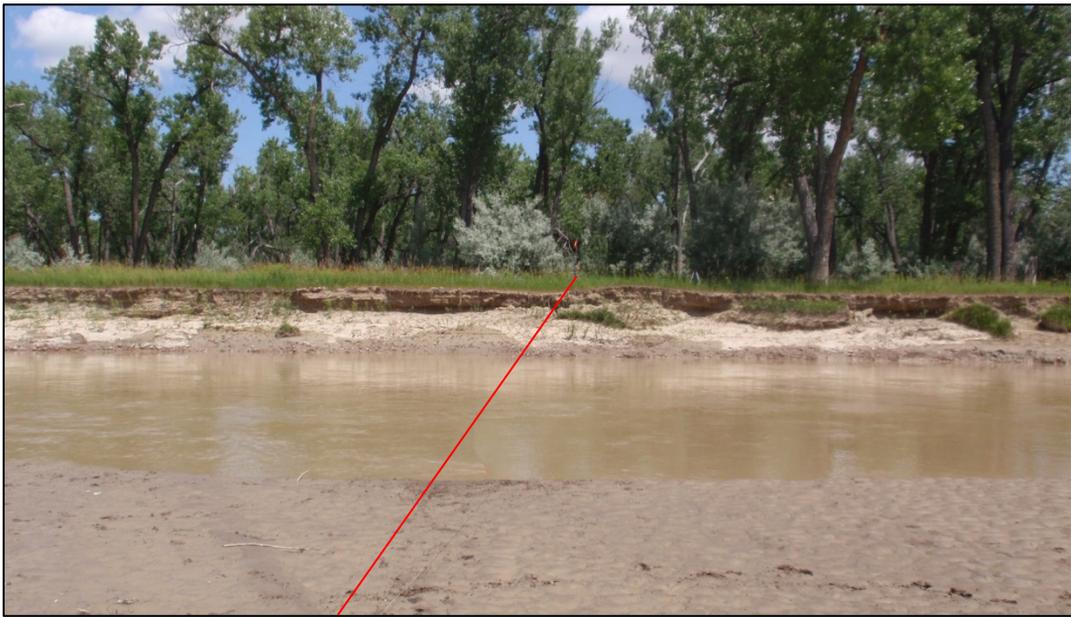
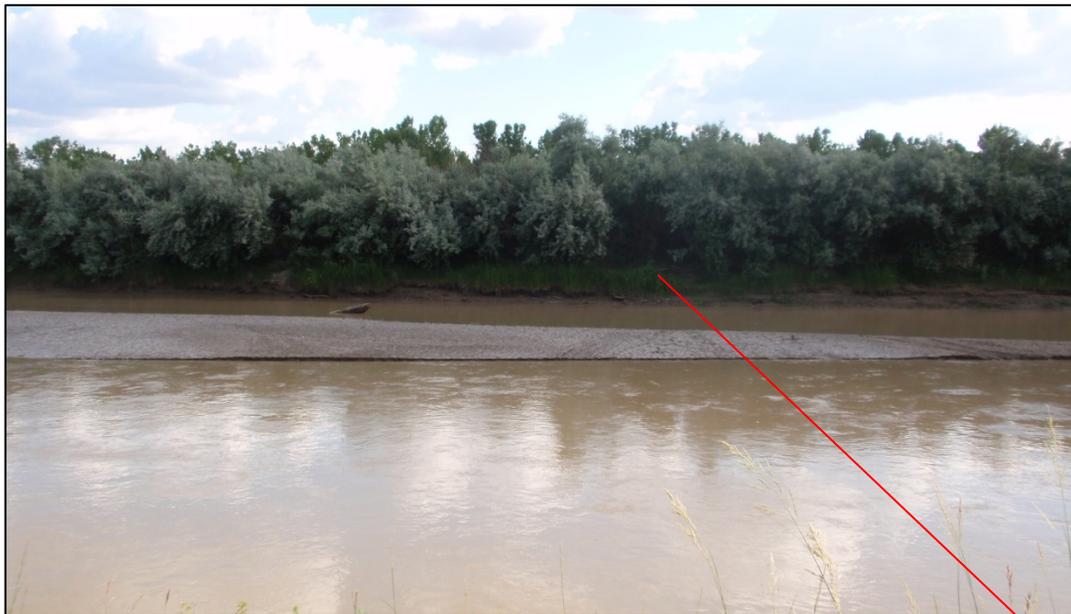
PR167. **Top.** 16 July 2014. Cross-channel view of the right bank. A metal pole with orange flagging is on the line of section. Red line indicates approximate location of section. **Bottom.** 16 July 2014. Cross-channel view of the left bank. Left-bank flood plain has a 60-m-wide thicket (from station 10 to station 70 that is approximately at the edge of the left bank) of 3-to-4-m-tall Russian olives, which have been trimmed along the line of section forming a narrow tunnel through the trees. Red line indicates approximate location of section.

70 to station 10. From 1998 to 2014 under the Russian olives, no sand was deposited between stations 10 and 25 and about 0.03-0.05 m of sand was deposited between stations 25 and 57.
