## EVOLUTION OF CUTOFFS ACROSS MEANDER NECKS IN POWDER RIVER, MONTANA, USA

GLENN R. GAY<sup>1</sup>, HUBERT H. GAY<sup>1</sup>, WILLIAM H. GAY<sup>1</sup>, HOLLY A. MARTINSON<sup>2</sup>, ROBERT H. MEADE<sup>2\*</sup>,  
AND JOHN A. MOODY<sup>2</sup>

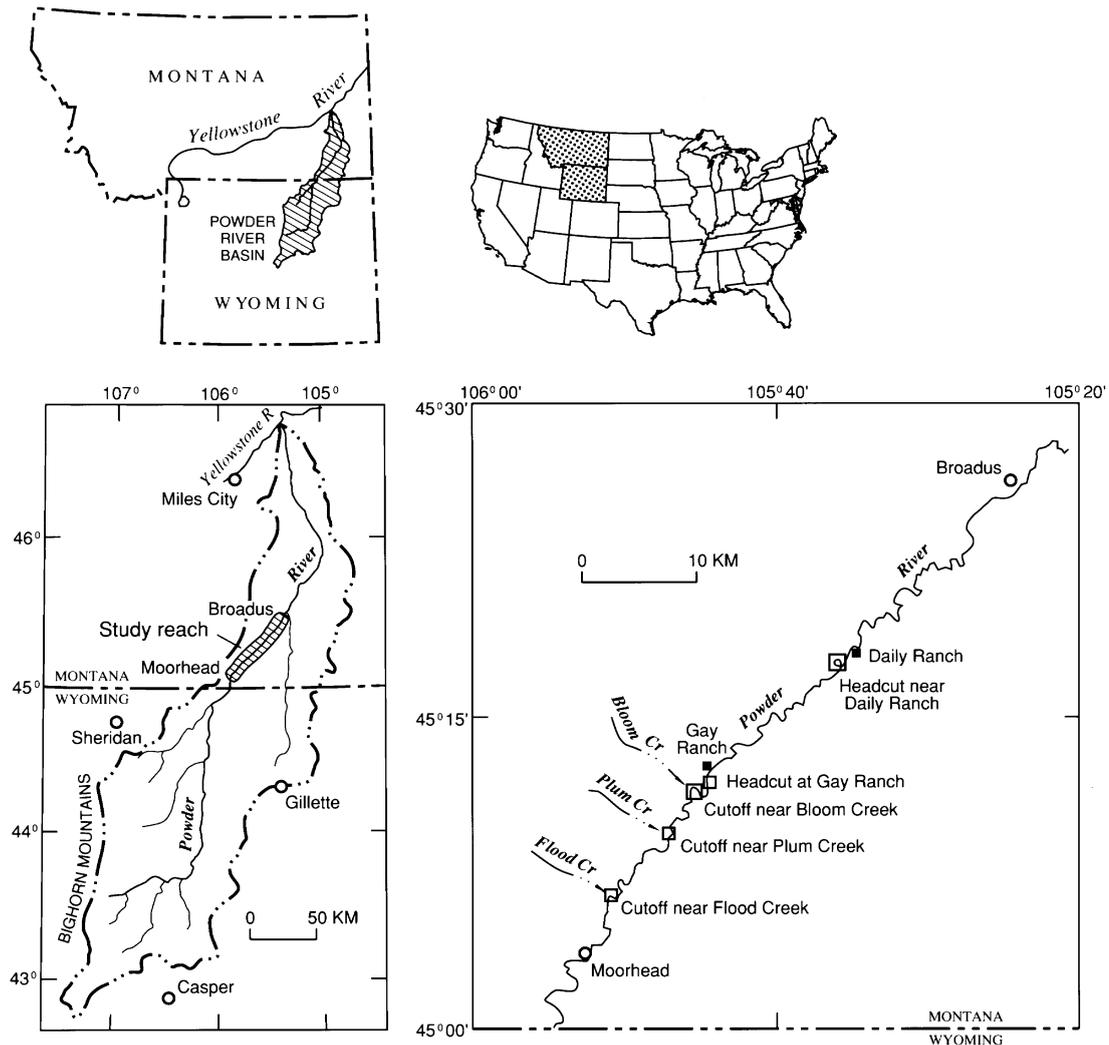
Figure 1. Maps showing location of selected gullies and cutoffs in Moorhead-to-Broadus reach of Powder River in southeastern Montana, USA

Powder River collects water from the eastern slopes of the Bighorn Mountains of north central Wyoming, flows onto the western edge of the northern Great Plains, and turns north-northeast to flow 400 km (valley distance) to join the Yellowstone River in eastern Montana (Figure 1). The reach of Powder River with which this paper is concerned lies between Moorhead and Broadus, Montana; it drains an area of about 21 500 km<sup>2</sup> and discharges an average of 13 m<sup>3</sup> s<sup>-1</sup> of water and 2–3 × 10<sup>6</sup> tons of suspended sediment per year. The average river slope through the reach is 1 m km<sup>-1</sup>. Bankfull width at mean annual high flow averages about 50 m. No mainstem reservoirs or other large works of river engineering such as dykes, levees, or bank-protection devices inhibit the natural processes of the river. The only significant anthropogenic influence on Powder River is the withdrawal of irrigation water, mostly to grow alfalfa for cattle feed. Further details of the geology and hydrology of Powder River drainage basin are given by Hembree *et al.* (1952) and Hubert (1993).

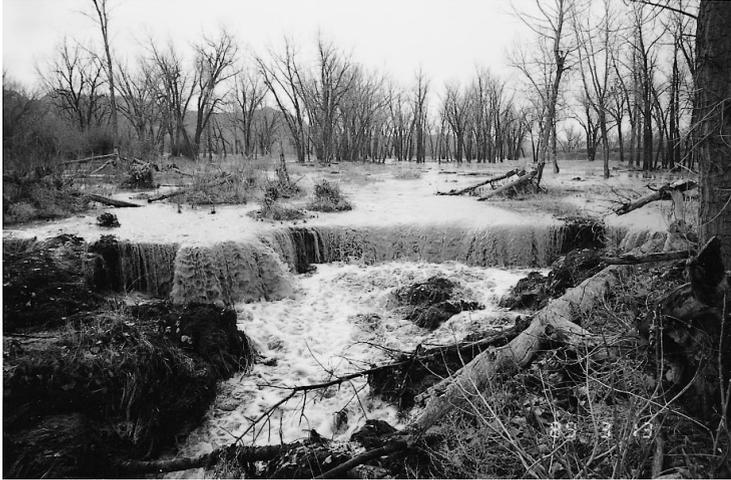
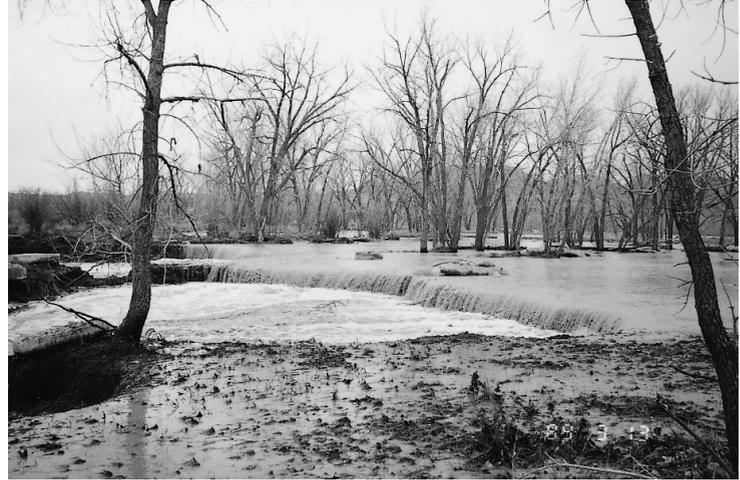
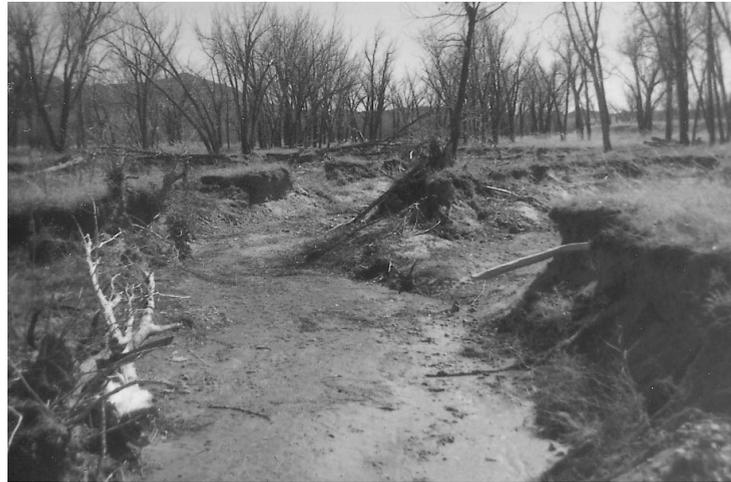
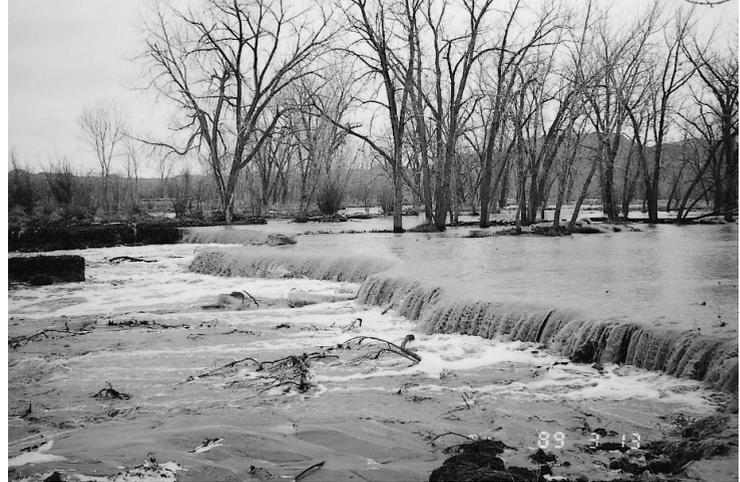
Figure 3. Three photographs taken 13 March 1989, during the formation of a gully across the neck of a meander on Powder River at Gay Ranch, NE corner of Section 29 of T7S, R49E; and one photograph taken several weeks later, after ice jam had broken and river level had fallen. Upper left: up-river view of flow across meander neck and of the active headcut after it had cut 10–20 m into the down-river edge of the neck. Upper and lower right: successive views, taken about 2 h apart, of active headcut at distances 70–80 m up-river of the down-river edge of the neck. lower left: approximately same view as in upper left, taken several weeks later; depth of gully about 2 m

The headcutting proceeded at a variable rate. Most of the trench (the first 150 m) was cut during the first day, 13 March (Figure 3). The maximum observed rate of knickpoint migration was on the order of  $10\text{ m h}^{-1}$ . The cutting rate was slowed in places by the roots of mature cottonwood trees (*Populus sargentii*) growing on the neck. Early in the cutting, the gully widened as it was being cut back, but eventually the width stabilized at about 5–6 m.

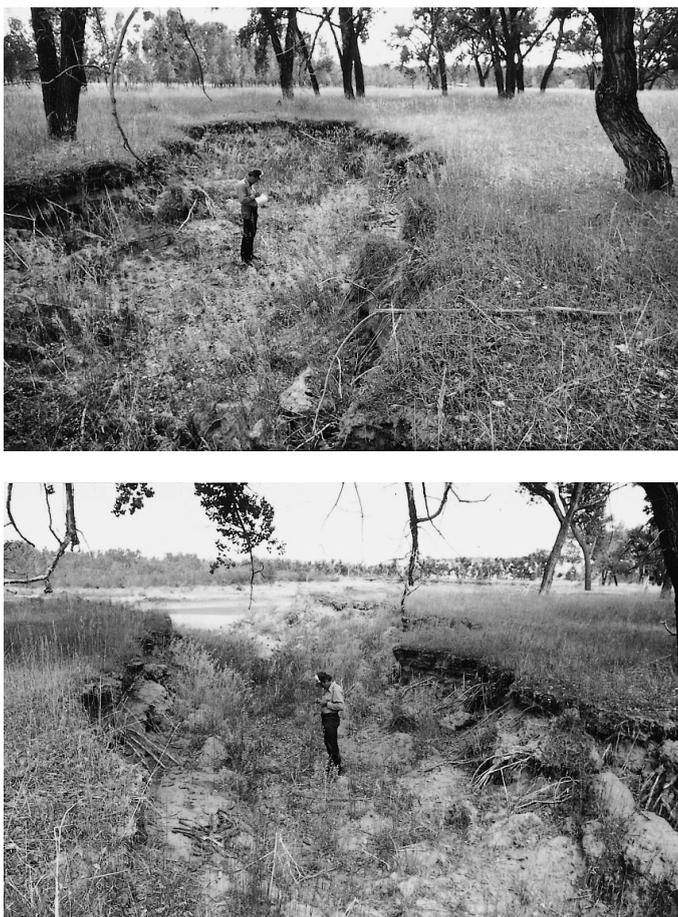
Figure 10. Photographs taken 20 August 1986 of gully that formed in April 1985 near Daily Ranch, Section 28 of T6S, R50E. Upper: up-valley view showing headcut and blocks of collapsed sod. Lower: down-valley view showing mouth of gully and Powder River (in distance). John Moody, 2 m tall, is standing in same location in both photographs

During an ice-jam flood near the beginning of April 1985, water flowed across the narrow neck of a large meander in the northeast corner of Section 28 of T6S, R50E, 1700–1800 m southwest of the main buildings of the John Daily ranch. During at least the years since 1939 (when the first aerial photographs were taken), the meander neck had become more constricted until, by 1985, the distance across the neck at its narrowest point was only about 200 m (Figure 9, upper left). During the ice-jam flood of 1985, a headcut formed that eventually migrated about one-fourth of the way across the meander neck, beginning, as usual, at the down-riber end. Other smaller headcuts also began cutting into the down-riber edge of the meander neck (Figure 9, right). Before any of the headcuts was able to complete the breach, however, water stopped flowing across the neck. Like the large headcut gully at Gay Ranch, this gully waits for the next overbank flood to reactivate it and perhaps complete the cutoff process (Figure 10).
