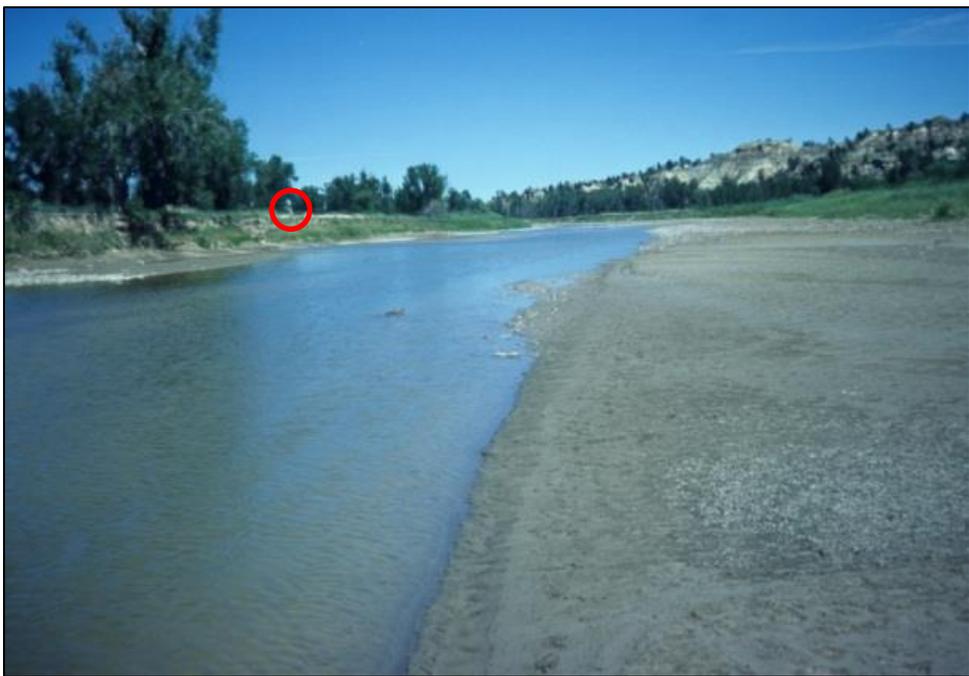
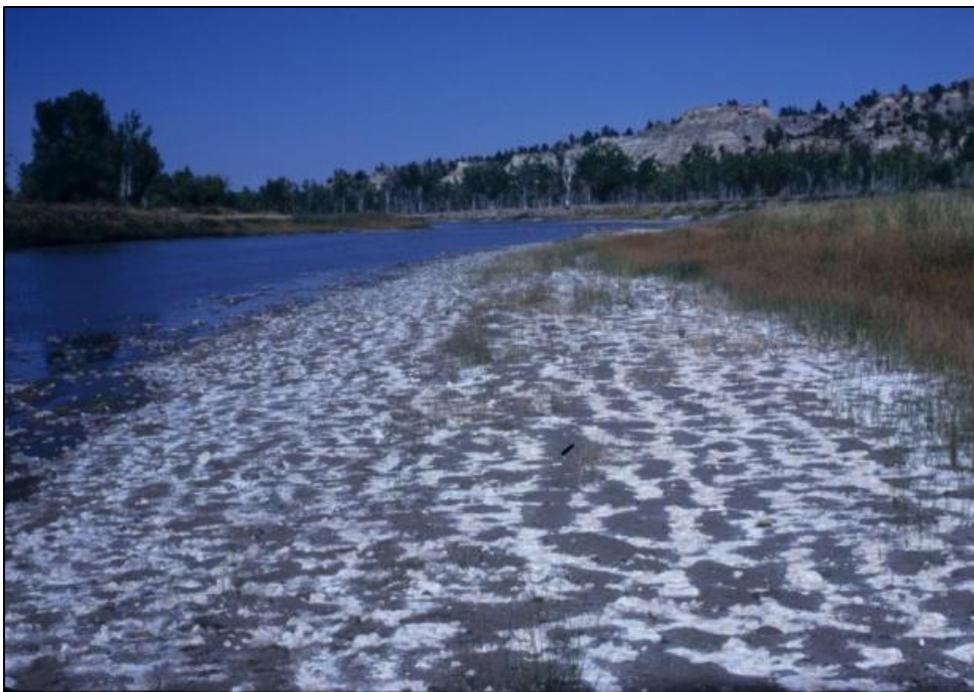
PR120. Top. 21 July 1977. View downriver. Person (1.6 m tall) in red circle is standing on the section. Bottom. 16 September 1989. View is downriver from station 53.

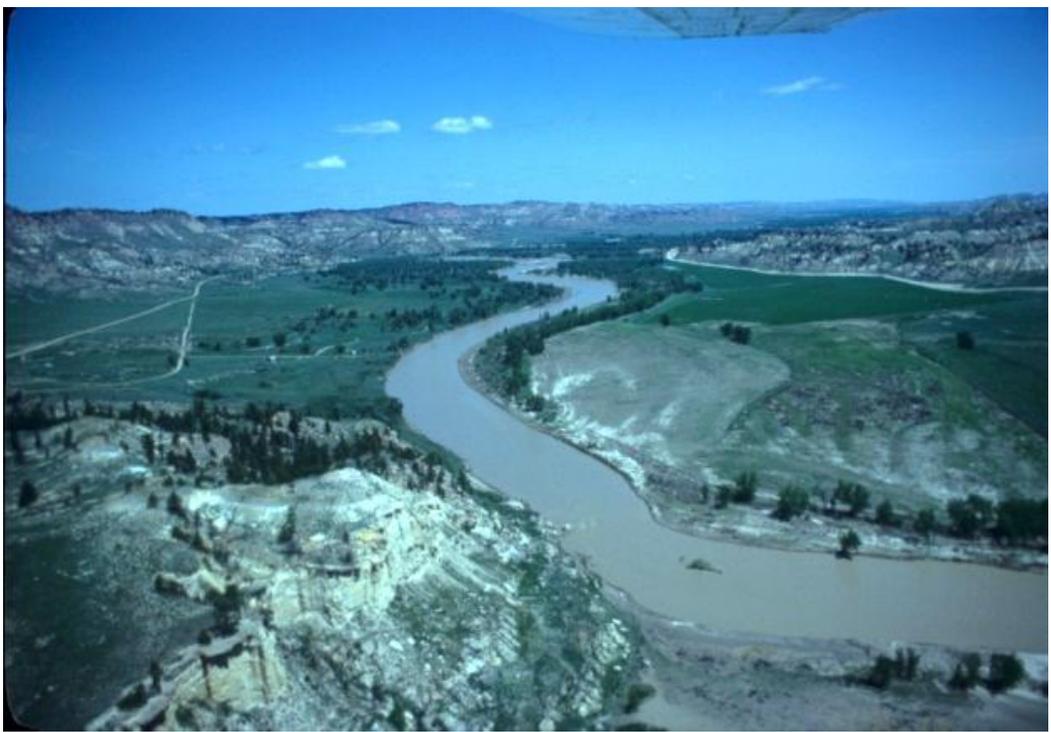
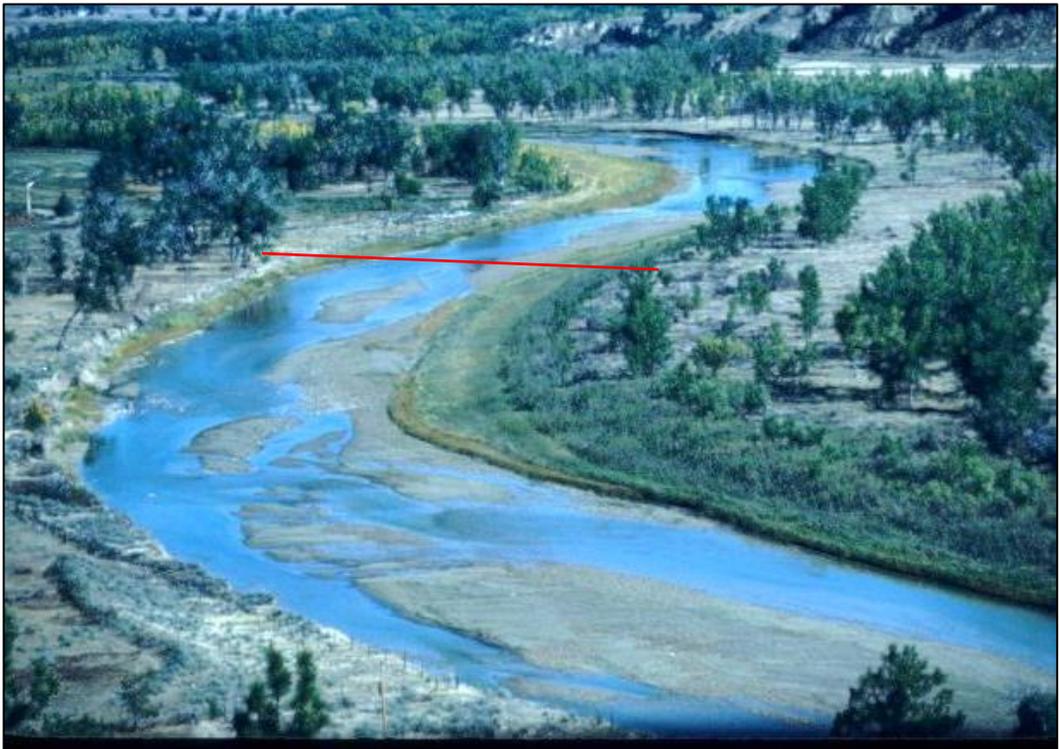
PR120. Top. 25 May 1978. Aerial view downriver during the waning stage of the flood. New sediment (mud and sand) is deposited on right bank starting just upriver of the section. Bottom. 19 September 1988. View downriver from bluff shown in the bottom left of the top photo. Red line indicates the approximate line of section.

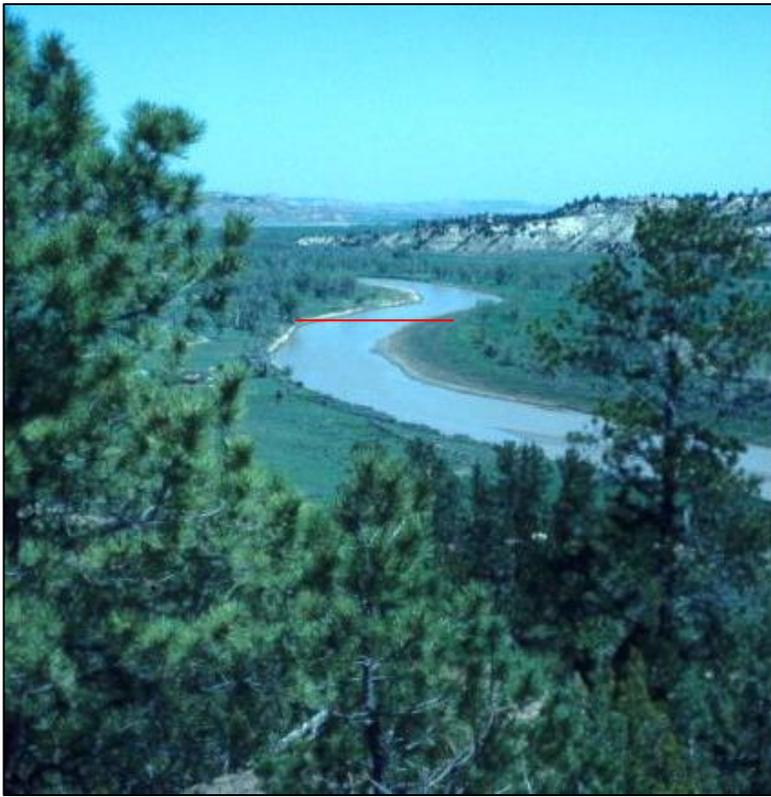
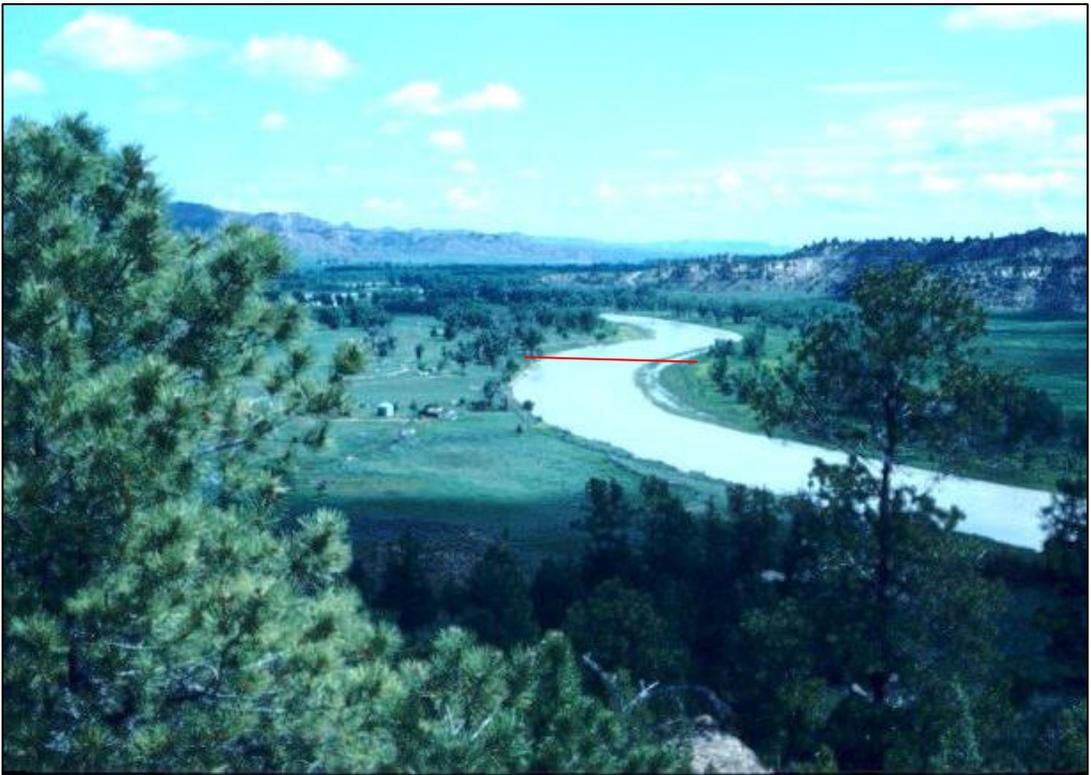
PR120. Top. 13 May 1993. View downriver. Discharge  $34 \text{ m}^3 \text{ s}^{-1}$   
Bottom. 9 June 1993. View downriver. Discharge  $170 \text{ m}^3 \text{ s}^{-1}$ .  
Note water in trough between new inset floodplain and old bank along right bank above and below section. Red lines indicate the approximate line of section.

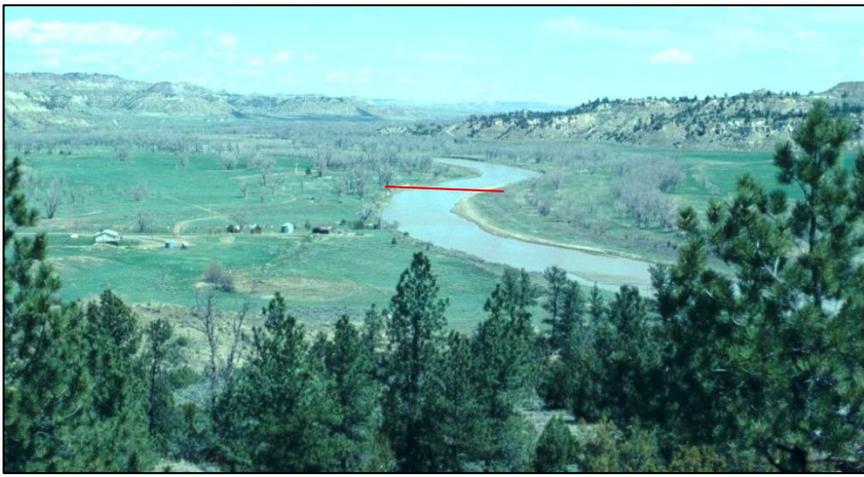
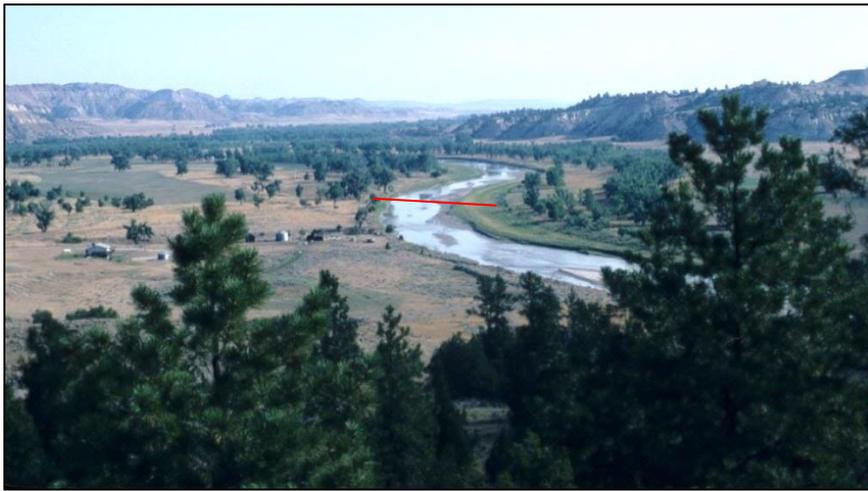
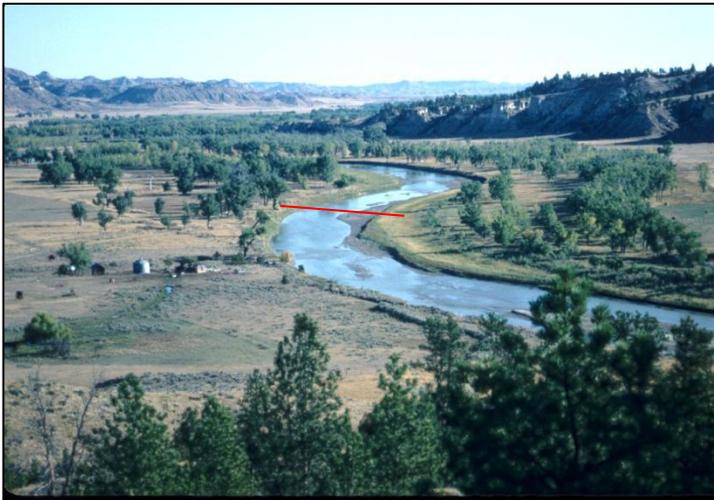
PR120. Top. 9 May 1994. View downriver, discharge  $17 \text{ m}^3 \text{ s}^{-1}$   
Middle. 23 August 1994. View downriver, discharge  $0.23 \text{ m}^3 \text{ s}^{-1}$ .  
Bottom. 24 September 1994. View downriver, discharge  $\sim 1.5 \text{ m}^3 \text{ s}^{-1}$ .  
Red lines indicate the approximate line of section.

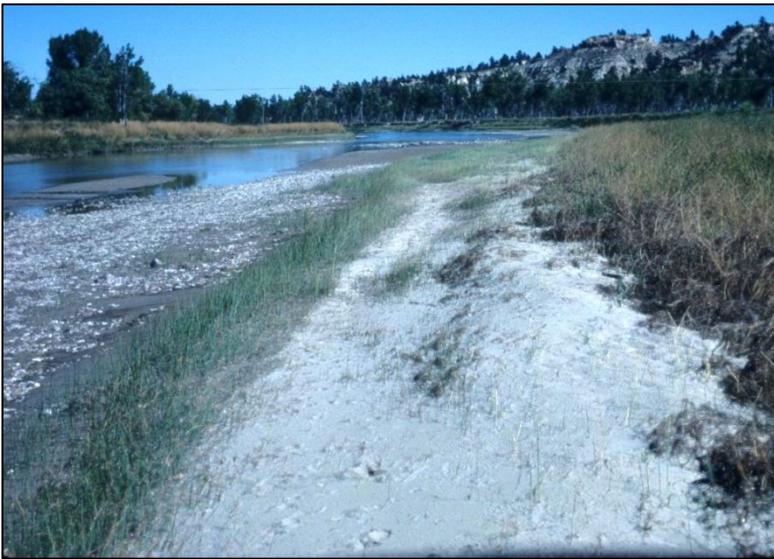
PR120. 14 September 1990. View downriver through station 60.

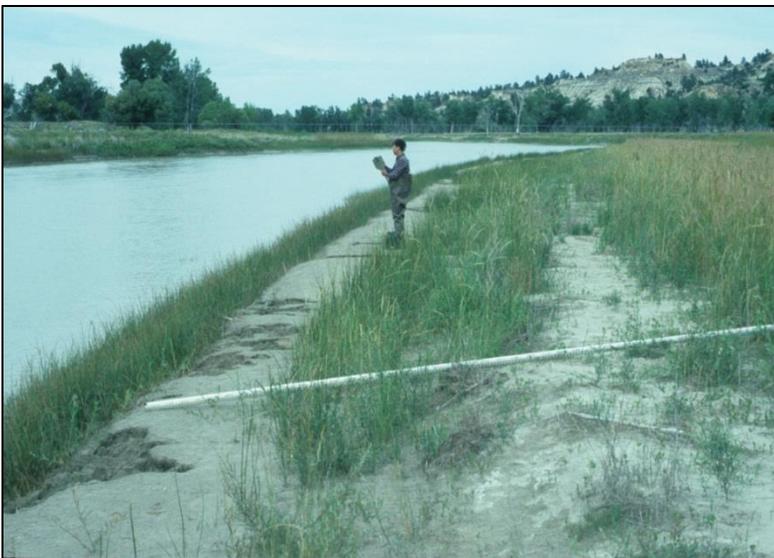
PR120. 25 August 1993. View is downriver and white survey rod is on the section.

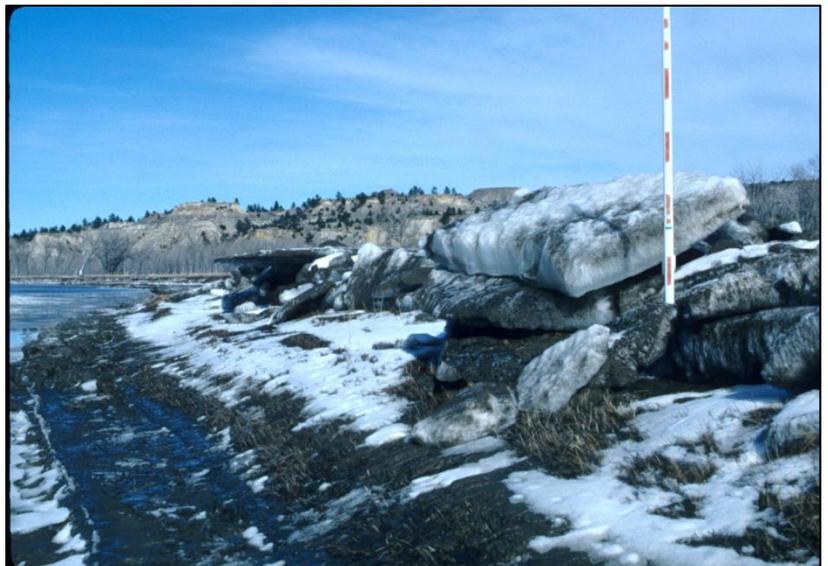
PR120. 10 March 1995. View downriver and white survey rod is on the section.

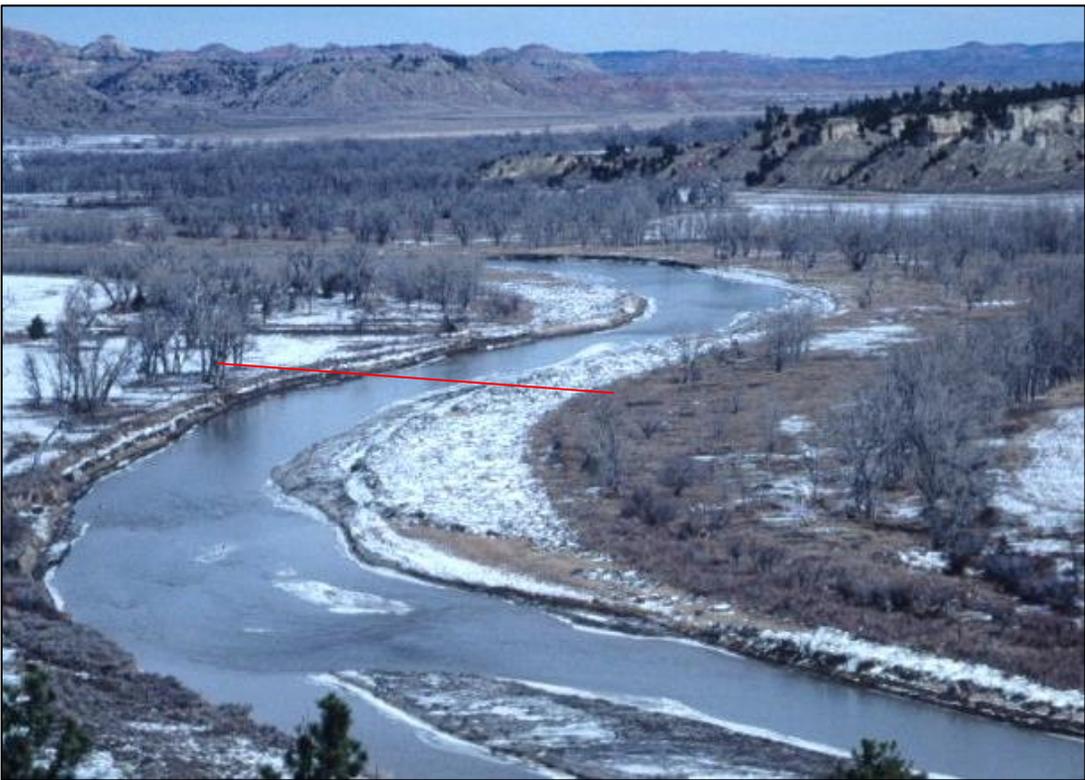
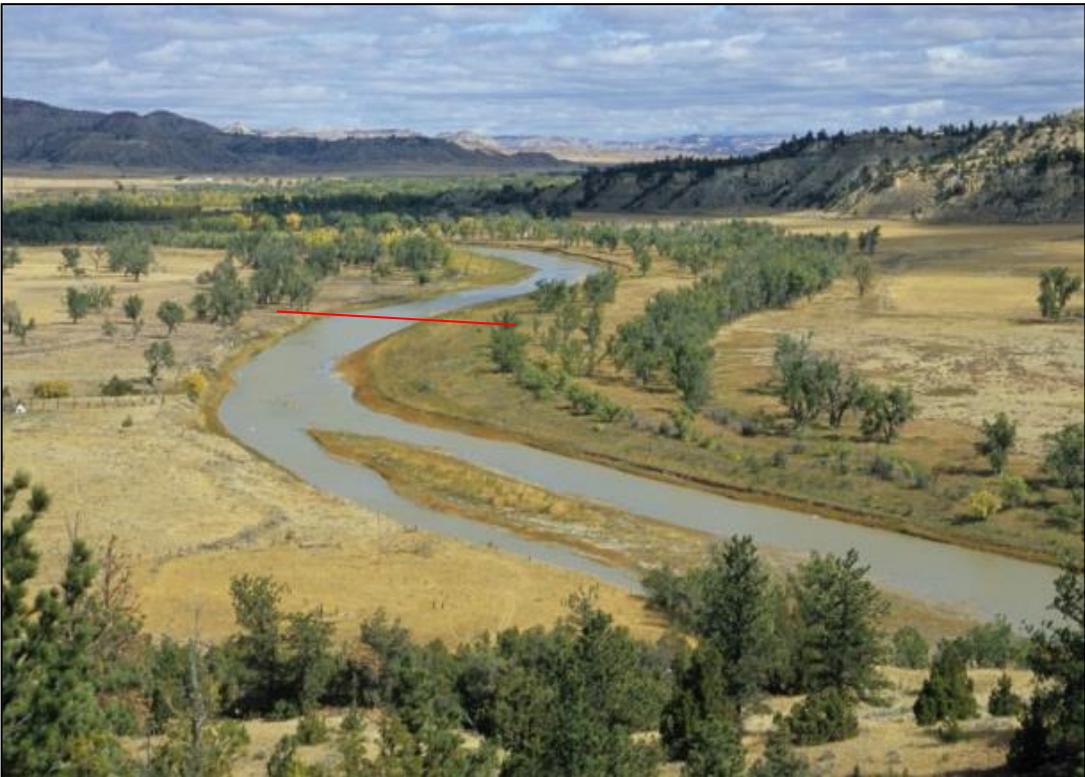
PR120. Top. 10 March 1995. View downriver, discharge  $3.1 \text{ m}^3 \text{ s}^{-1}$   
Bottom. 27 September 2006. View downriver.  
Red lines indicate the approximate line of section.
