Cross section PR141A was established in 1979 in a cutoff channel that had formed during the 1978 flood across the neck of a large meander bend in Powder River near the mouth of Bloom Creek. The 1978 cutoff channel began by following the course of a pre-flood headcut gully that had been sporadically active for decades, and had nearly cut through the neck of the bend by early 1978 (Gay et al., 1998, *their* Figure 7; Meade and Moody, 2013, *their* Figures 9 & 10). Because the actual cutoff at PR141A happened during the early stages of the flood of 1978, we infer that this left enough time for the flood waters to erode the adjacent flood plain across the neck, and to widen the new cutoff channel sufficiently so that new sand could be deposited therein. This new channel had a gentle downstream slope (0.00061, as compared with Powder River's average overall slope of 0.001) and a nominal radius of channel curvature of 125 m.

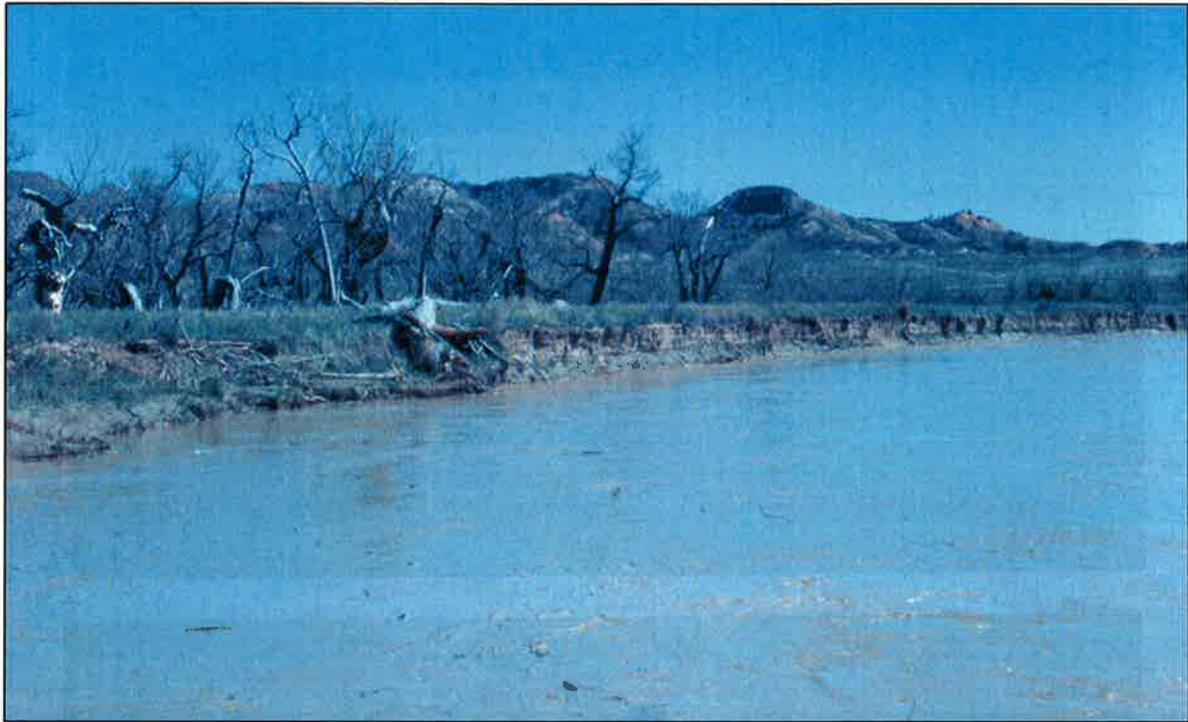
PR141A. **Top.** 10 May 1993. View is down river. This section of the left bank is about 100-200 m downriver from PR141A. High water level on 8 May 1993 was 987.06 m and the water level in the photo is 986.26 m.

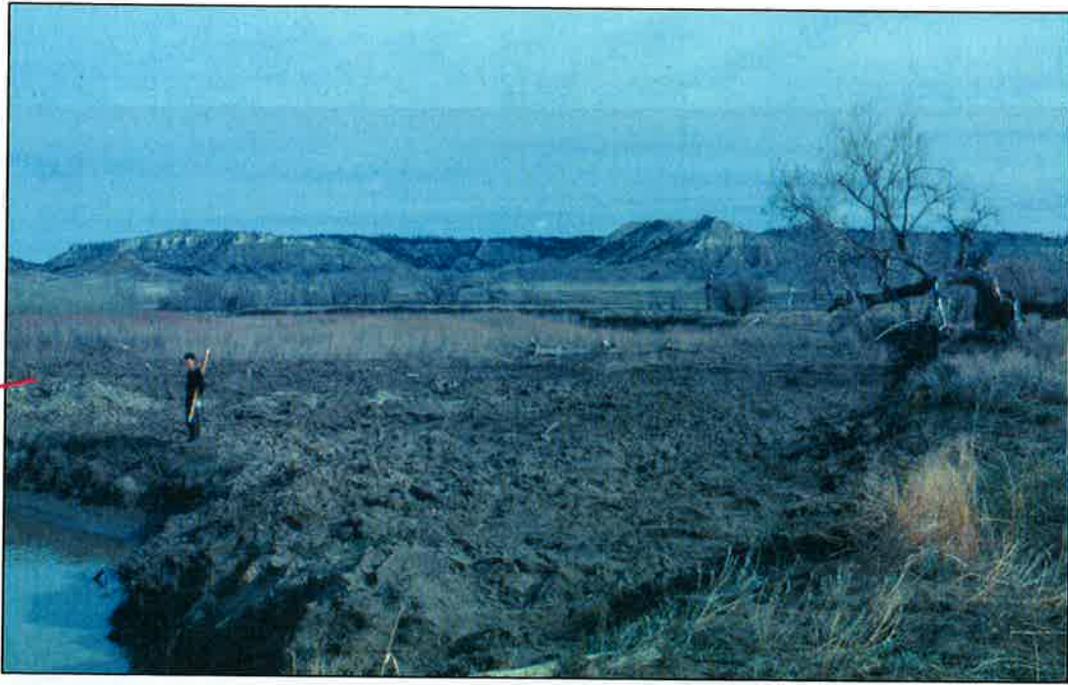
PR141A. **Top.** May 1994. View is upriver showing ice-deposited sand piles in the mouth of Bloom Creek and on PR141A, for which only a short segment (red line) shows in the photo. **Bottom.** May 1994. View is upriver showing a close up of ice-deposited sediment (see detailed survey of these deposits in data files). Orange level case is 0.17 m high.

Substantial thicknesses of new sediment (0.20-0.50 m) were deposited in 1994 during an ice-break-up flood that jammed downstream from the section causing the water to back up and overtop both banks at PR141A. This water carried ice floes that grounded on top of the bank with coarse sand and gravel frozen to the bottom, and it carried a large suspended-sediment load caused by the extreme turbulence of the tumbling ice floes striking the bed of the river and by ice flows ramming and eroding the river's banks.

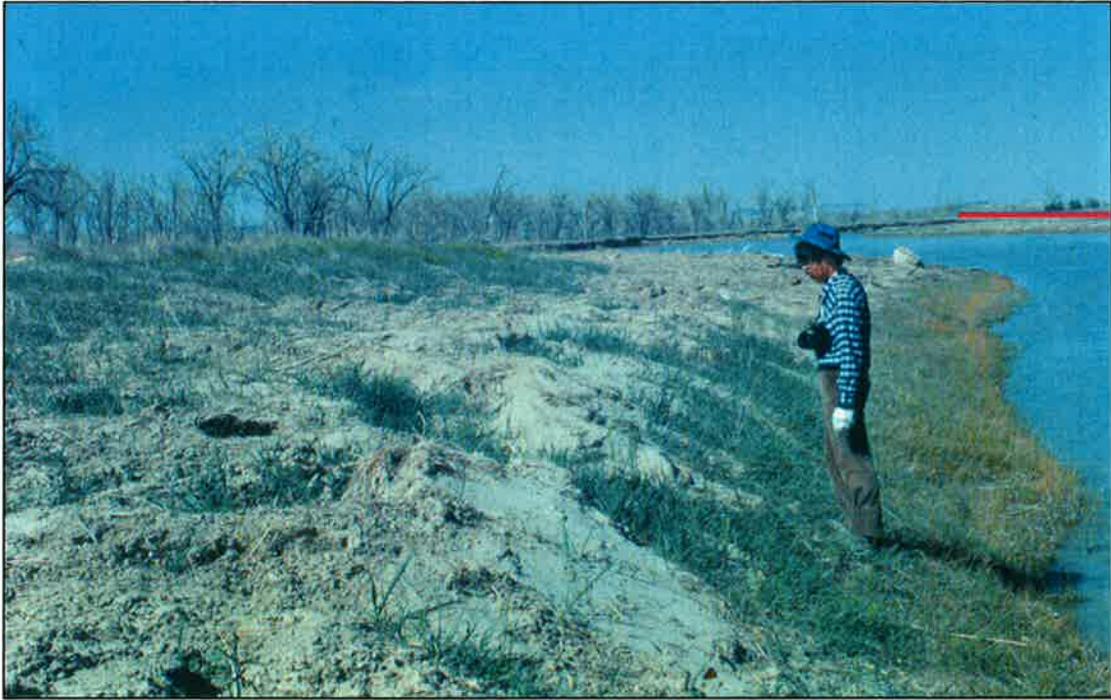
PR141A. **Top.** May 1994. View is down river. This section of the left bank with ice-deposited sediment is about 300 m upriver from PR141A (approximate location is shown by the red line). K. Fujita is about 1.8 m tall. Discharge is about  $17 \text{ m}^3 \text{ s}^{-1}$ .

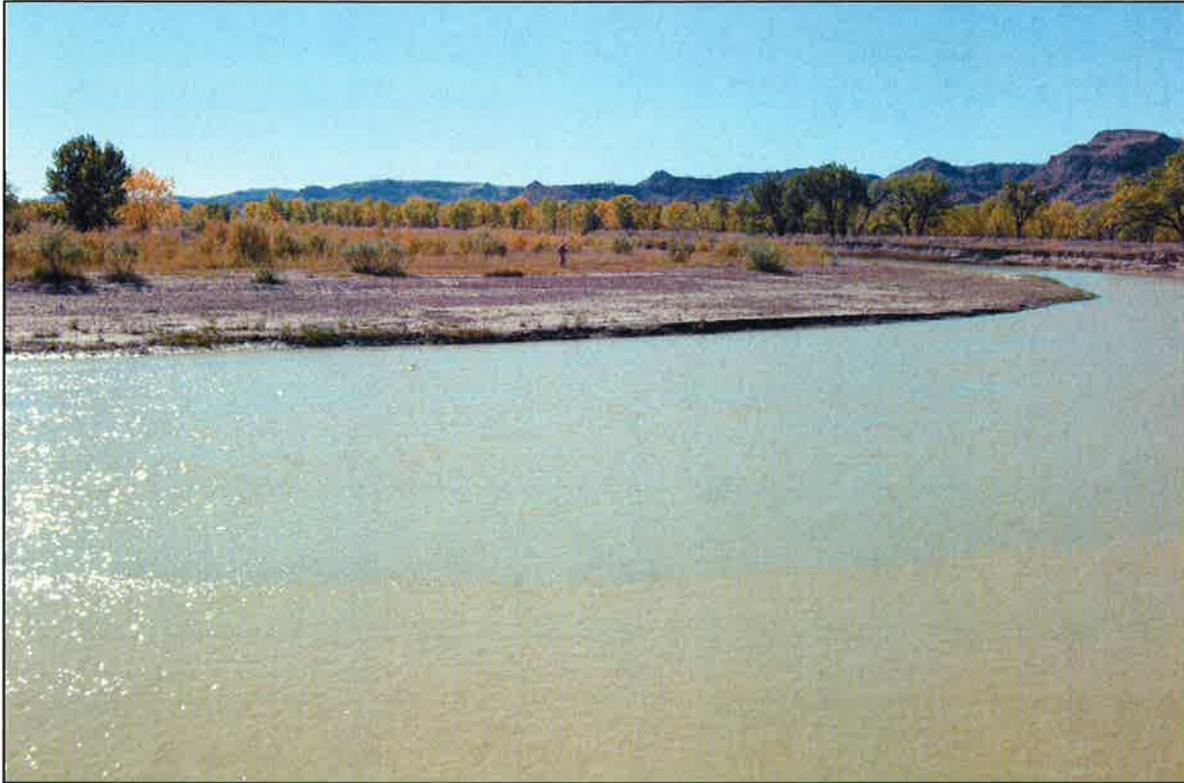
PR141A. **Top.** 1 October 2013. View is upriver. Dark green tree at left margin of photo is a cottonwood tree near station +80. J. Moody stands on line of section at station +20, which was the location of the left bank in 1979.
