Cross section PR147 was established in 1975 on a straight reach of Powder River that is stabilized, to a significant degree, by sandstone bedrock. Ledges of sandstone have been seen cropping out in the bed of Powder River, both upstream and downstream (within distances of 100-200 m) of section PR147. These ledges served, decades earlier, as crossing places in the river (e.g., Hubert Gay and his sister, in the 1920s and 1930s, fording Powder River to attend Huckins School). Section PR147 was re-surveyed annually from 1977 through 1980, not again until 1984, and then every following year through 1998. Because it had shown so little channel change over the years, it was not surveyed again until 2013.

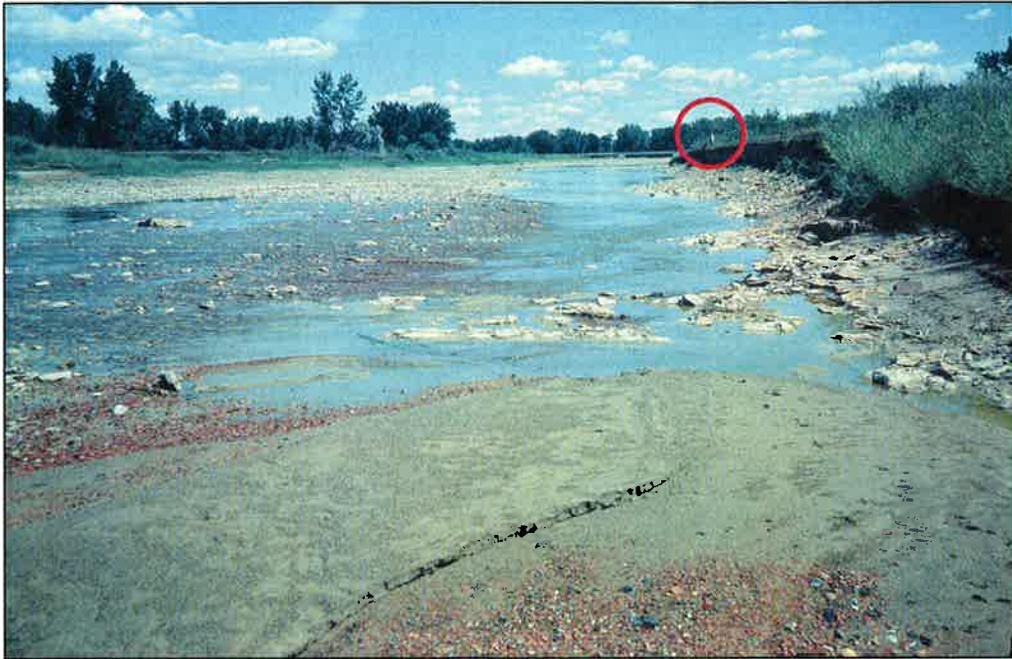
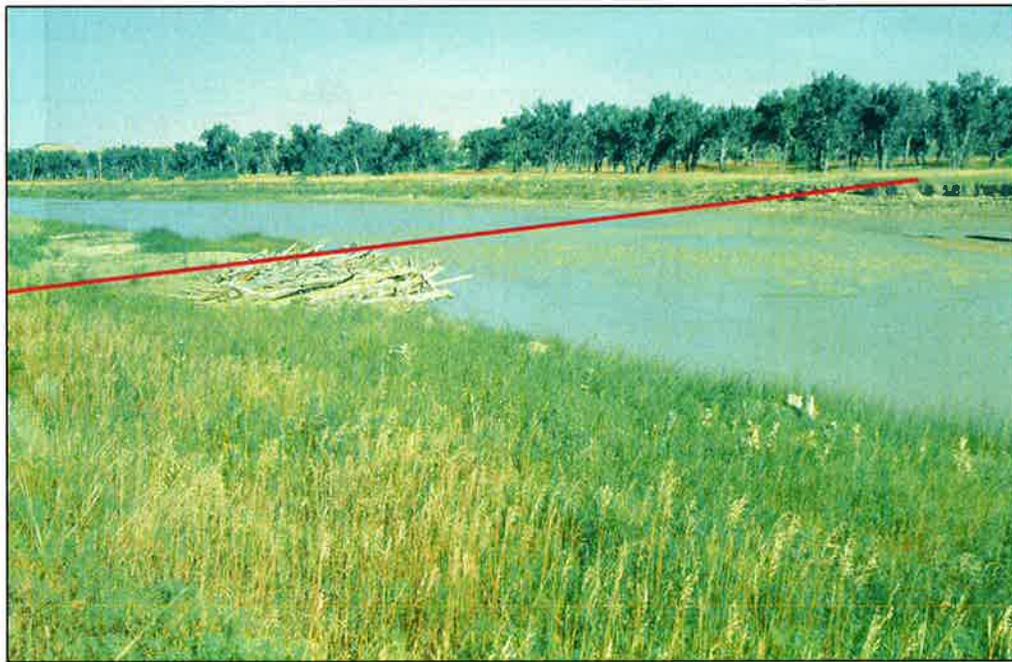
PR147. **Top.** 23 July 1977. View is downriver. E. Meade inside red circle is about 1.6 m tall is standing on the line of section on the right bank. **Bottom.** 28 August 1993. View is downriver from the left bank showing debris pile on section and new sand bar. Red line indicates the approximate line of section.

Cross section PR147 was both widened and deepened by the flood of 1978 (see Figure 5 of Meade and Moody, 2013). The right bank was eroded laterally by 5 m. The left bank developed a 6-m-wide scour hole, probably dug during the flood by the turbulence that must have been induced by the presence of a large pile of flood-deposited woody debris.

Change came slowly to section PR147 after the flood of 1978. During the next 35 years (1979-2013), the right bank was eroded by another 5.5 m -- 3.3 m of which happened during a single year, 1995; and 1.1 m of which happened two years earlier, in 1993. The left-bank scour hole was refilled, mostly during 1991 and 1993, until, by 1995, a new flood plain had developed between stations 15 and 27. The riverward bank of the new flood plain was eroded laterally during 1996 and at some other time(s) after 1998, so that by year 2013 (when the next re-survey was completed), the edge of this bank had retreated to station 22. At some time between 1998 and 2013, a 6-m-wide bench of new (flood-plain?) sediment was deposited under the right bank, adding to the cross section a volume of new material approximately equivalent to the volume removed from the left bank during the same 15-year period.

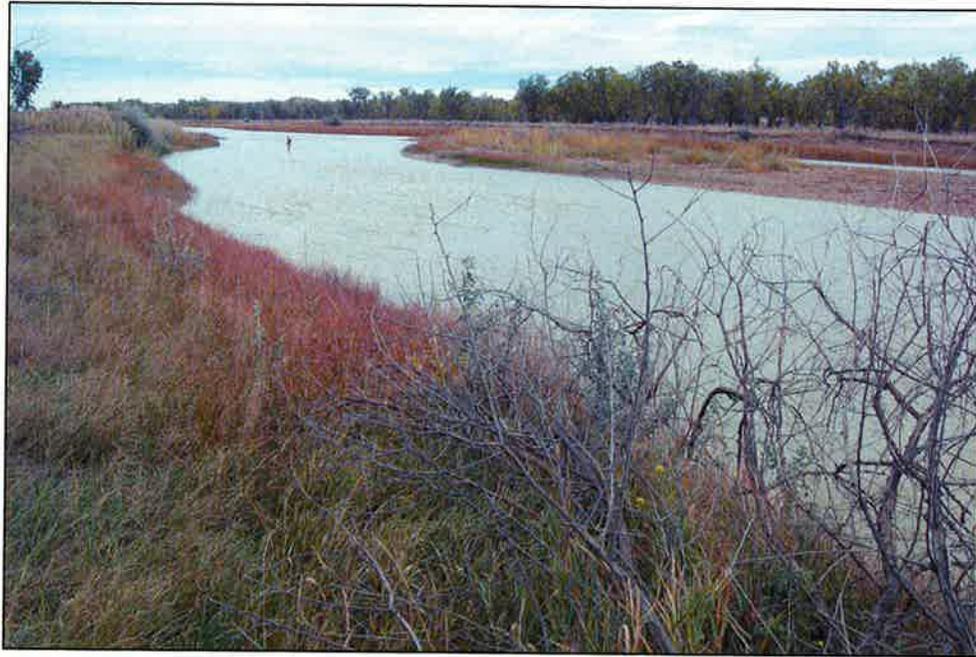
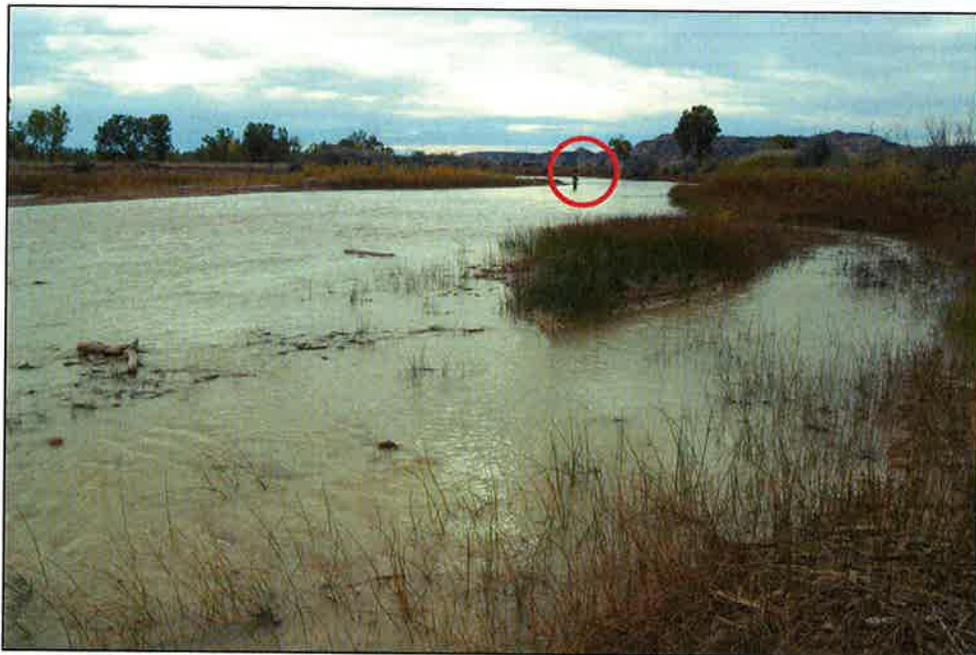
PR147. **Top.** 29 September 2013. View is downriver. J. Moody (~1.9 m tall) in the river is on the line of section. Mid-channel island is in the upper right of the photo. **Bottom.** 29 September 2013. View is upriver similar to photo in 1977. J. Moody (inside red circle) is on the line of section at station 39. Small island at right center is just below the pile of debris in the 28 August 1993 photo.

The other notable feature of cross section PR147 is a mid-channel sandbar that developed on the downslope of a gravel-bedded riffle whose crest intersected the section between stations 32 and 40, as it extended from the right bank of the river ~150 m above the section to the left bank of the river ~ 30 m below the section. After the 1995 flood, this sandbar began to emerge when about 0.2 m of new sediment was left on top between stations 57 and 79, and by 1996 it was populated with cottonwood seedlings growing in an additional 0.5 m of sediment between stations 62 and 72. This was probably the foundation on which a larger island evolved in the middle of the channel between 1998 and 2013, and had increased in elevation by about 0.7 m during this period.
